# EEA Conference & Exhibition 2021, 30 June - 1 July, Wellington

## **Detection of rebar corrosion in concrete power poles**

**Joseph Bailey<sup>1</sup>, Nick Long<sup>1</sup> and Gideon Gouws<sup>2</sup>**

<sup>1</sup> Robinson Research Institute, Victoria University of Wellington

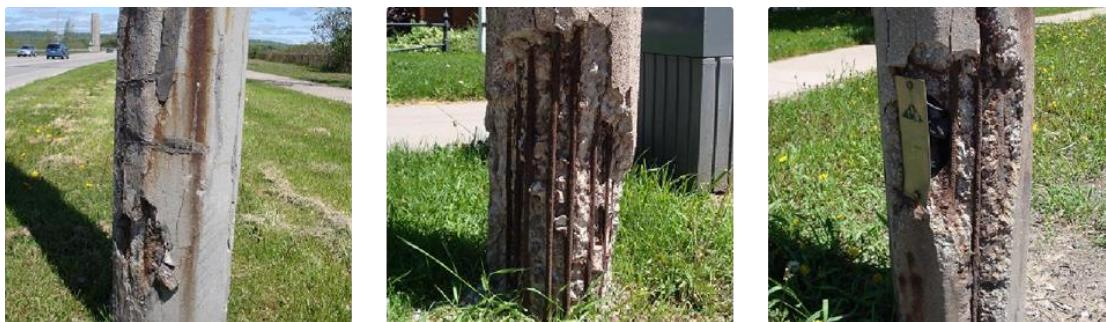
*Figure 1 Examples of spalling concrete power poles where the corrosion has expanded and caused the concrete to crack and fall off making a clear visual sign of an issue.[2]*

Typically, when the rebar inside a concrete power pole corrodes the expansion of the corrosion will cause the concrete to spall as shown in Figure 1, giving a clear visual indication before the pole is in danger of collapse. However, some conditions exist when corrosion can progress to a dangerous level without any visual indications. This includes corrosion below the ground line, corrosion in hollow poles where the spalling can occur internally, corrosion in low oxygen environments where low volume corrosion products that are generated do not cause spalling. In some pre-stressed power poles small amounts of corrosion can also occur in the thin pre-stressing wires, reducing the strength to a point where the pole will fail unexpectedly without any outward indication.

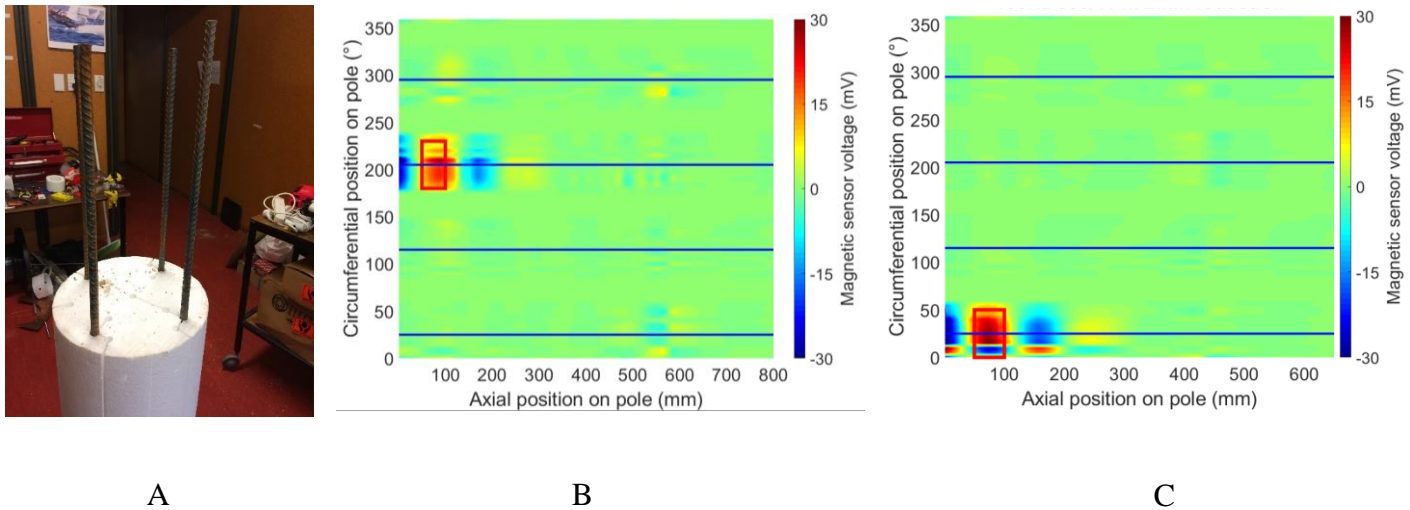
Figure 11 A) Mock mass reinforced concrete power pole with polystyrene replacing concrete. B) Radial magnetic field of mock power pole with 1 mm diameter reduction C) radial magnetic field mock power pole with 2 mm diameter reduction. Red box shows location of diameter reduction.

The first test with the prototype system was on a basic mock mass-reinforced concrete power pole. A polystyrene former was used to hold four 12 mm rebars vertical at the corners of a 150 mm square. The polystyrene was arranged to simulate a 50 mm concrete cover. The corrosion was simulated by reducing the diameter of the rebar in a 50 mm section by 1 mm and 2 mm with an angle grinder. The measured radial field for each of these simulated corrosion shapes is shown in Figure 11, with the red box showing the approximate. location of the diameter reduction and the blue lines showing the location of the rebar.

Figure 11 show clear peaks in the radial magnetic field against a near zero background magnetic field as was predicted by the simulations in section 3.2. In addition, the large diameter reduction produced larger peaks again as expected from the simulations. This result shows both that the simulation methodology is effective in predicting the magnetic field and that small changes in the rebar diameter can be easily be detected by an eddy current testing prototype without any requirement for data-processing or identification algorithms.

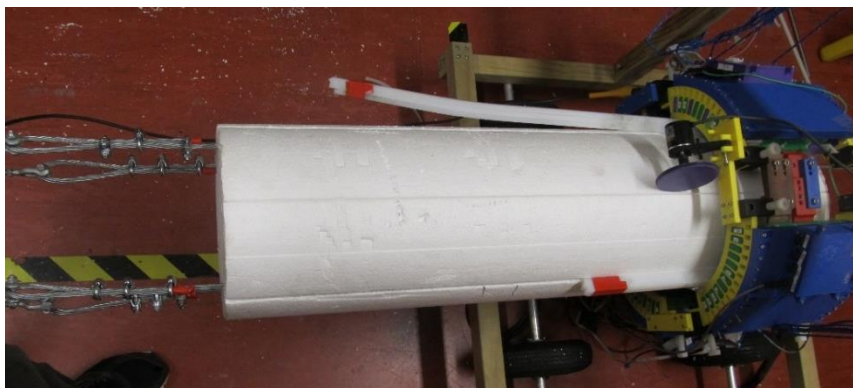
Figure 12 Experimental setup for testing mock pre-stressed power pole with eddy current testing system

As mentioned in section 1.1 prestressed concrete power poles are particularly exposed to failure without the pre-warning that concrete spalling provides. A similar method to that in section 4.2 was used to make a mock prestressed power pole to test with the prototype system. Instead of 12 mm rebar, 7.5 mm wire rope was used, spaced out by polystyrene on the corners of a 110 mm by 190 mm rectangle. The wire was tensioned so that it was straight. The prototype system was placed on the mock power pole and moved down its length as seen in Figure 12. The corrosion was simulated by using a file to remove 50 % or 80 % of one strand. The radial magnetic field measured on these two mock prestressed power poles is shown in Figure 15.
