HUMAN ACTIVITIES AND FLOOD HAZARDS AND RISKS IN THE SOUTH WEST PACIFIC: A CASE STUDY OF THE NAVUA CATCHMENT AREA, FIJI ISLANDS

A thesis

submitted to Victoria University of Wellington

Physical Geography

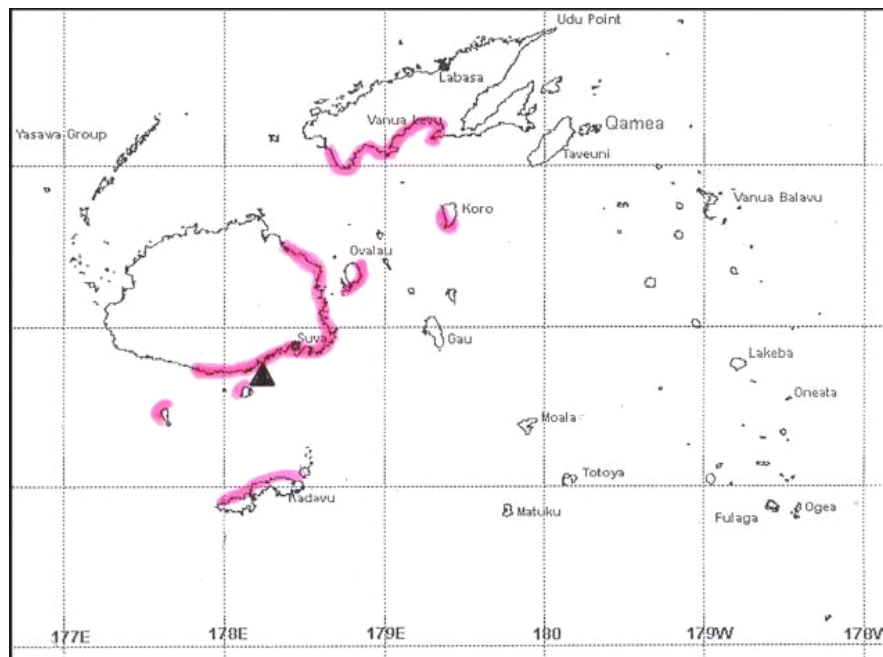
Figure 3.4: The extent of impact of the tsunami waves in 1953.

Source: Fiji Mineral Resources Department and extent of tsunami waves highlighted in pink.

In 1953, an earthquake with a magnitude of M_s 6.7 occurred 25km southwest of Suva with a focal depth of 15km. The map above indicates this location with a triangle. The earthquake triggered a submarine landslide outward and downward towards the fault line trending northeast of Viti Levu. The landslide was fan like in its spread activating tsunami waves which reached the Suva – Navua corridor within 8 minutes of the earthquake. Its impact was felt as far as Vanua Levu, Kadavu and Koro, as highlighted in the map above. The bulk of the impact was felt between Suva and Navua. Suva was inundated with waves of 5 metres in height. At that time it had a population of 10, 000 people and suffered 3 fatalities. Extensive damage was felt on the waterfront and harbour area, particularly to the wharf and seawalls along the harbour. The Suva wharf was displaced by about half a metre as a result of the earthquake. The pictures on the next page show this displacement and extent of damages of the tsunami. Other damages were to the piles that support the dock area as well as to the boats marooned within the harbour. Many parts of the seawall along the waterfront were washed out by the tsunami waves. Kadavu was impacted with waves of a height of 5 metres as well. Its population of 9000 lost five people. Three metre high waves were also felt in Savusavu on Vanua Levu.
