Valued but broken:

RECONSTRUCTING DAMAGED BUILT HERITAGE.

Master of Architecture (Professional)

Victoria University of Wellington

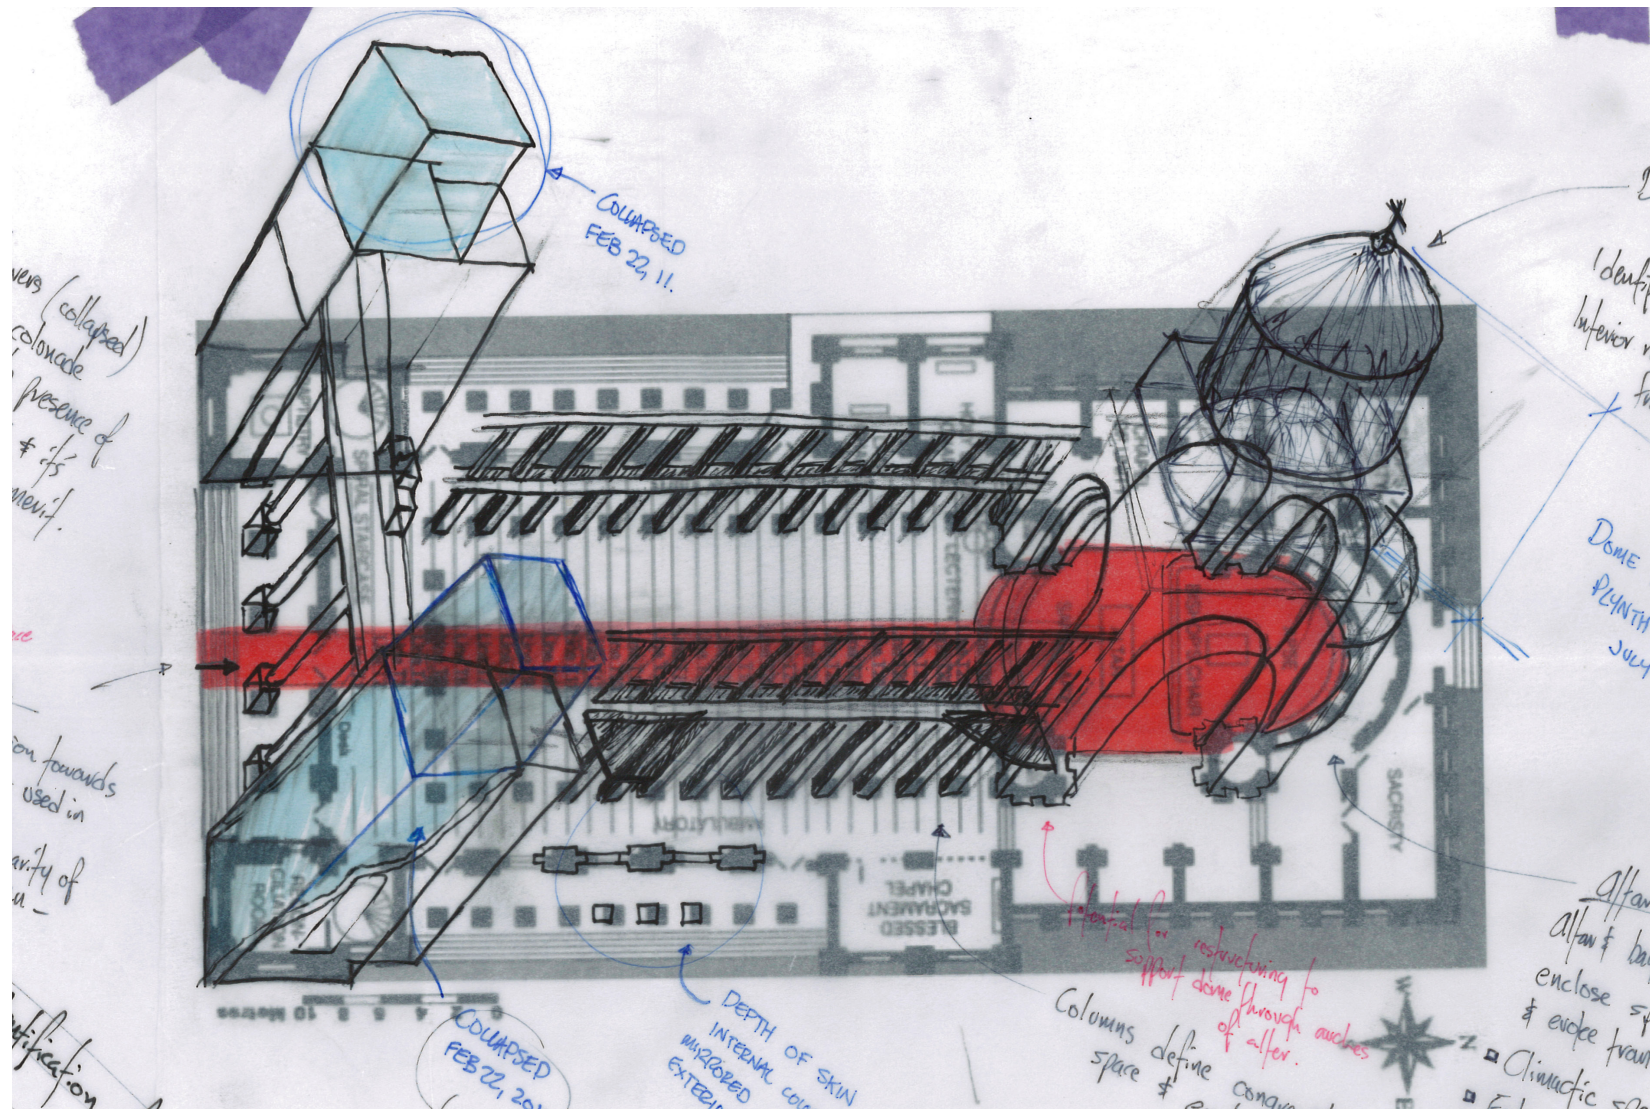
Sketch showing 'High significance' and 'Significant' fabric of the Cathedral of the Blessed Sacrament.

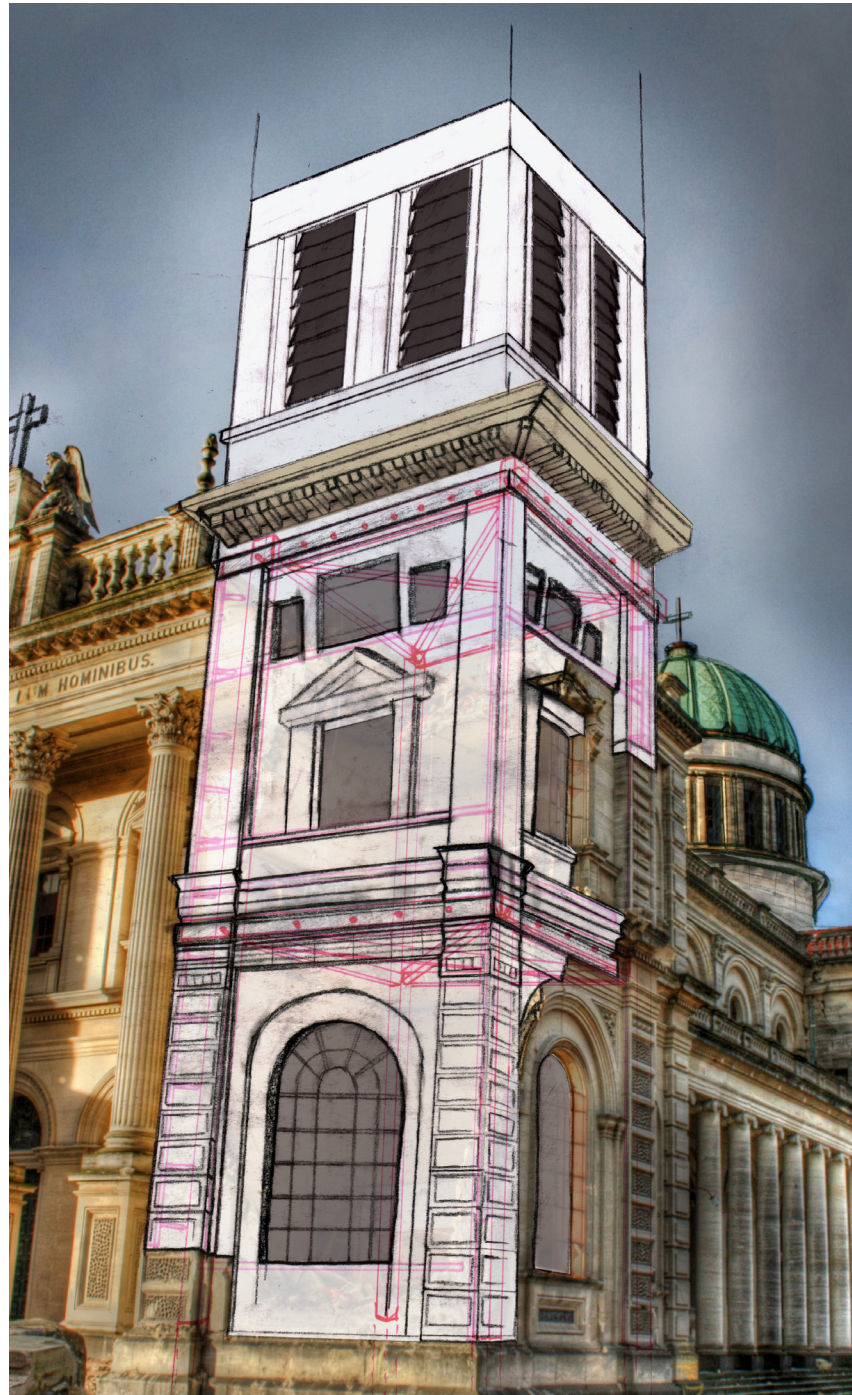
Concept drawing by author.

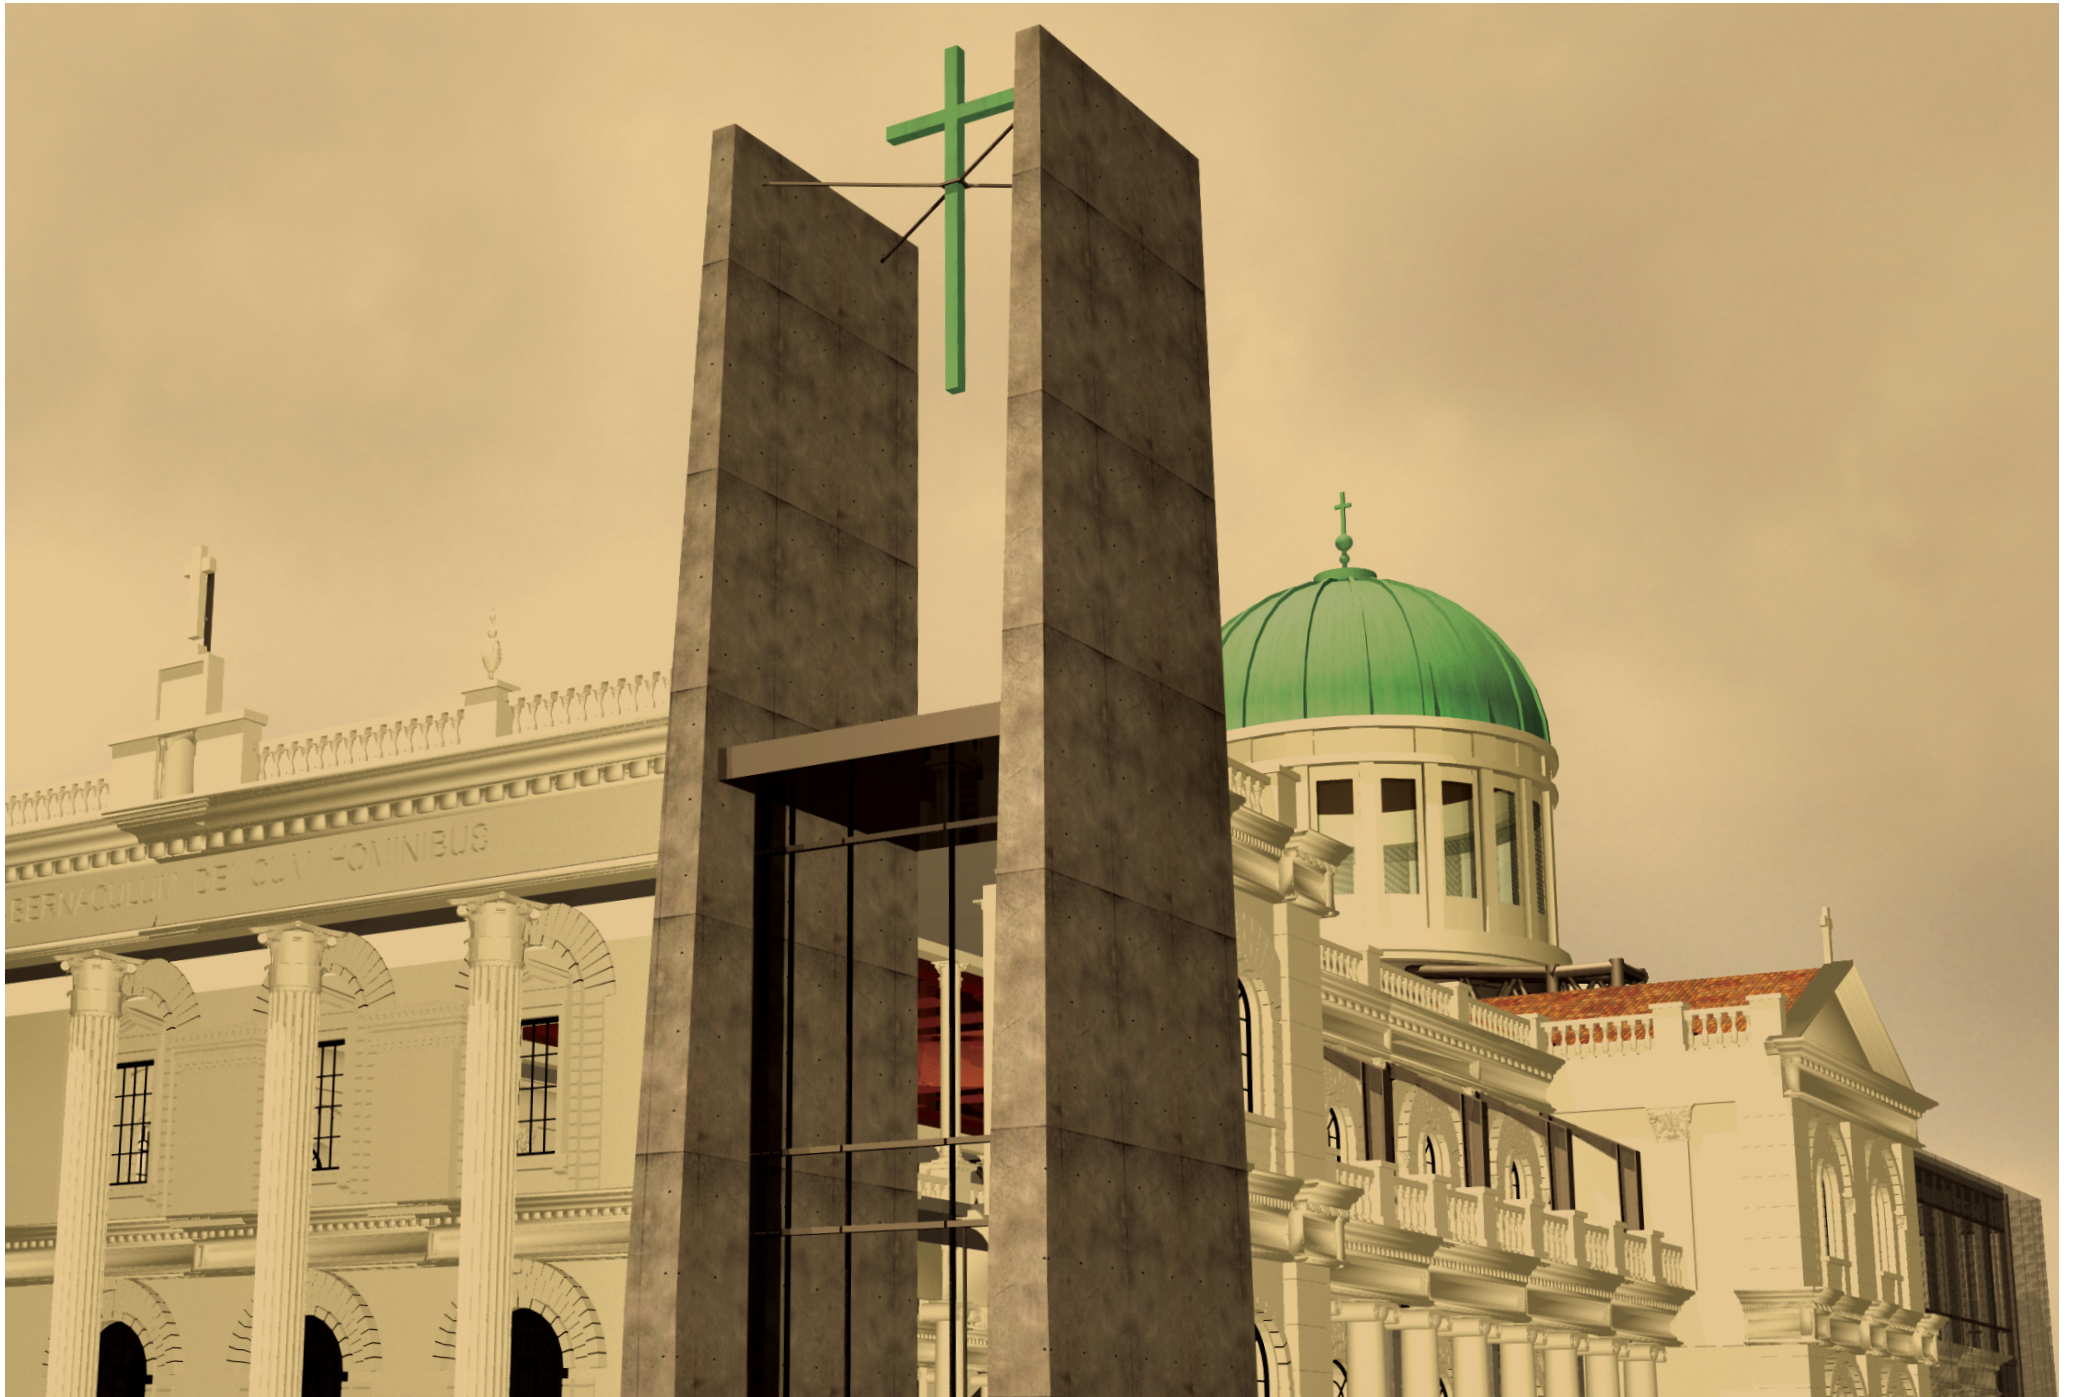
The two parallel concrete sheer walls rising to the height of the original tower and belfry create the mass and body of the new South tower. A glazed frontage, capped off at roof level allows an angled view into the interior of the Cathedral, revealing and celebrating the preserved interior architecture and revealing the worship within. At the top of the tower a copper cross, made from the copper roof tiles of the collapse belfry is suspended between the concrete sheer walls to give it the appearance that it is floating.

The concrete sheer walls are a tribute to the original architect and represent the Cathedral's construction and the fracturing and damage of the earthquake. The Cathedral's architect, Francis William Petre was a pioneer of concrete construction in New Zealand. The Cathedral was constructed with a concrete core inside a permanent formwork of Oamaru stone on the interior and exterior. This concrete had been hidden for a century before being revealed in the destruction of the February 2011 earthquake. The tower's concrete construction embodies these and the two walls represent the fracturing caused to Christchurch city by the earthquake.

The tower's glass frontage allows the interior of the Cathedral to be more visible and allows for greater external appreciation of the preserved heritage fabric. Since the September 2010 earthquake the diocese has not been able to use its Cathedral. They have moved to other buildings and their efforts in the wake of the February 2011 earthquake were focused largely on community support. The glass frontage of the South tower is a window out to and for the community. It represents the outward focus of the diocese post-earthquake and on their return to their Cathedral allows the public to view into the Cathedral to witness their worship and to also celebrate the preserved interior architecture.

The use of concrete and the revealing of the interior was shaped by Carlo Scrapa's intervention at Castelvechio where he layered the edges of the buildings elements to reveal the architecture's layers of history. Here, the South tower extrudes these layers into a new gesture for post-earthquake Catholicism and Christchurch. The relationship expressed here of new and old interweaving was influenced by Sir Basil Spence's intervention at Coventry Cathedral and how he interwove old and new into one living Cathedral.

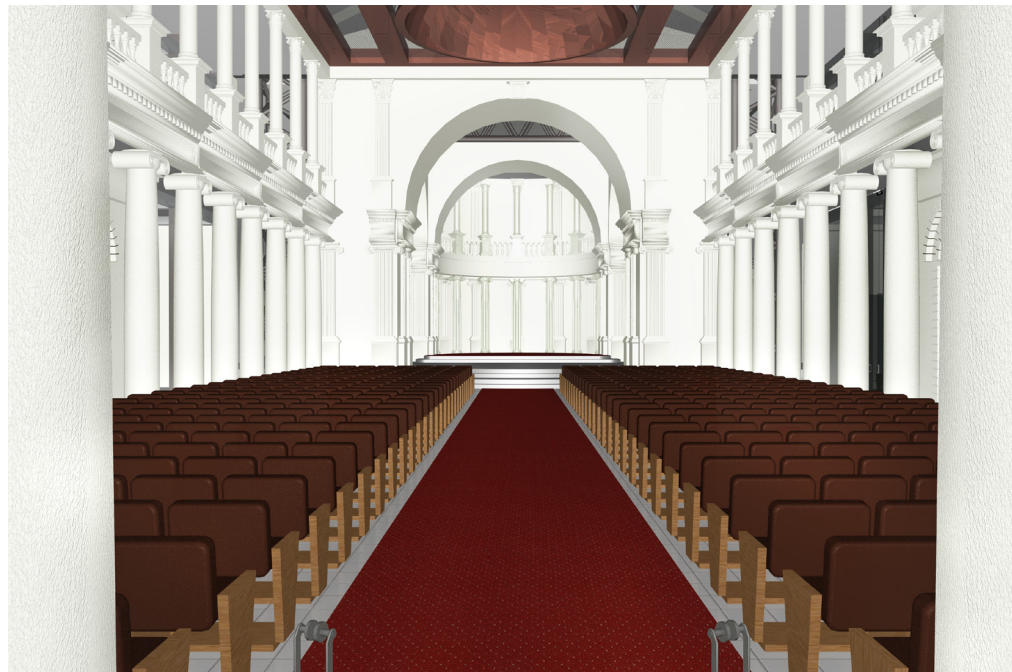
This design for the dome's reconstruction aligns with the guidelines and recommended practices of the Historic Places Trust.⁵ The process of 'forensic deconstruction' provides sufficient information to guide the reconstruction of the dome out of the preserved original fabric. The supporting structure for the dome is a distinctly new gesture that is both a practical structural

system and an architectural gesture.

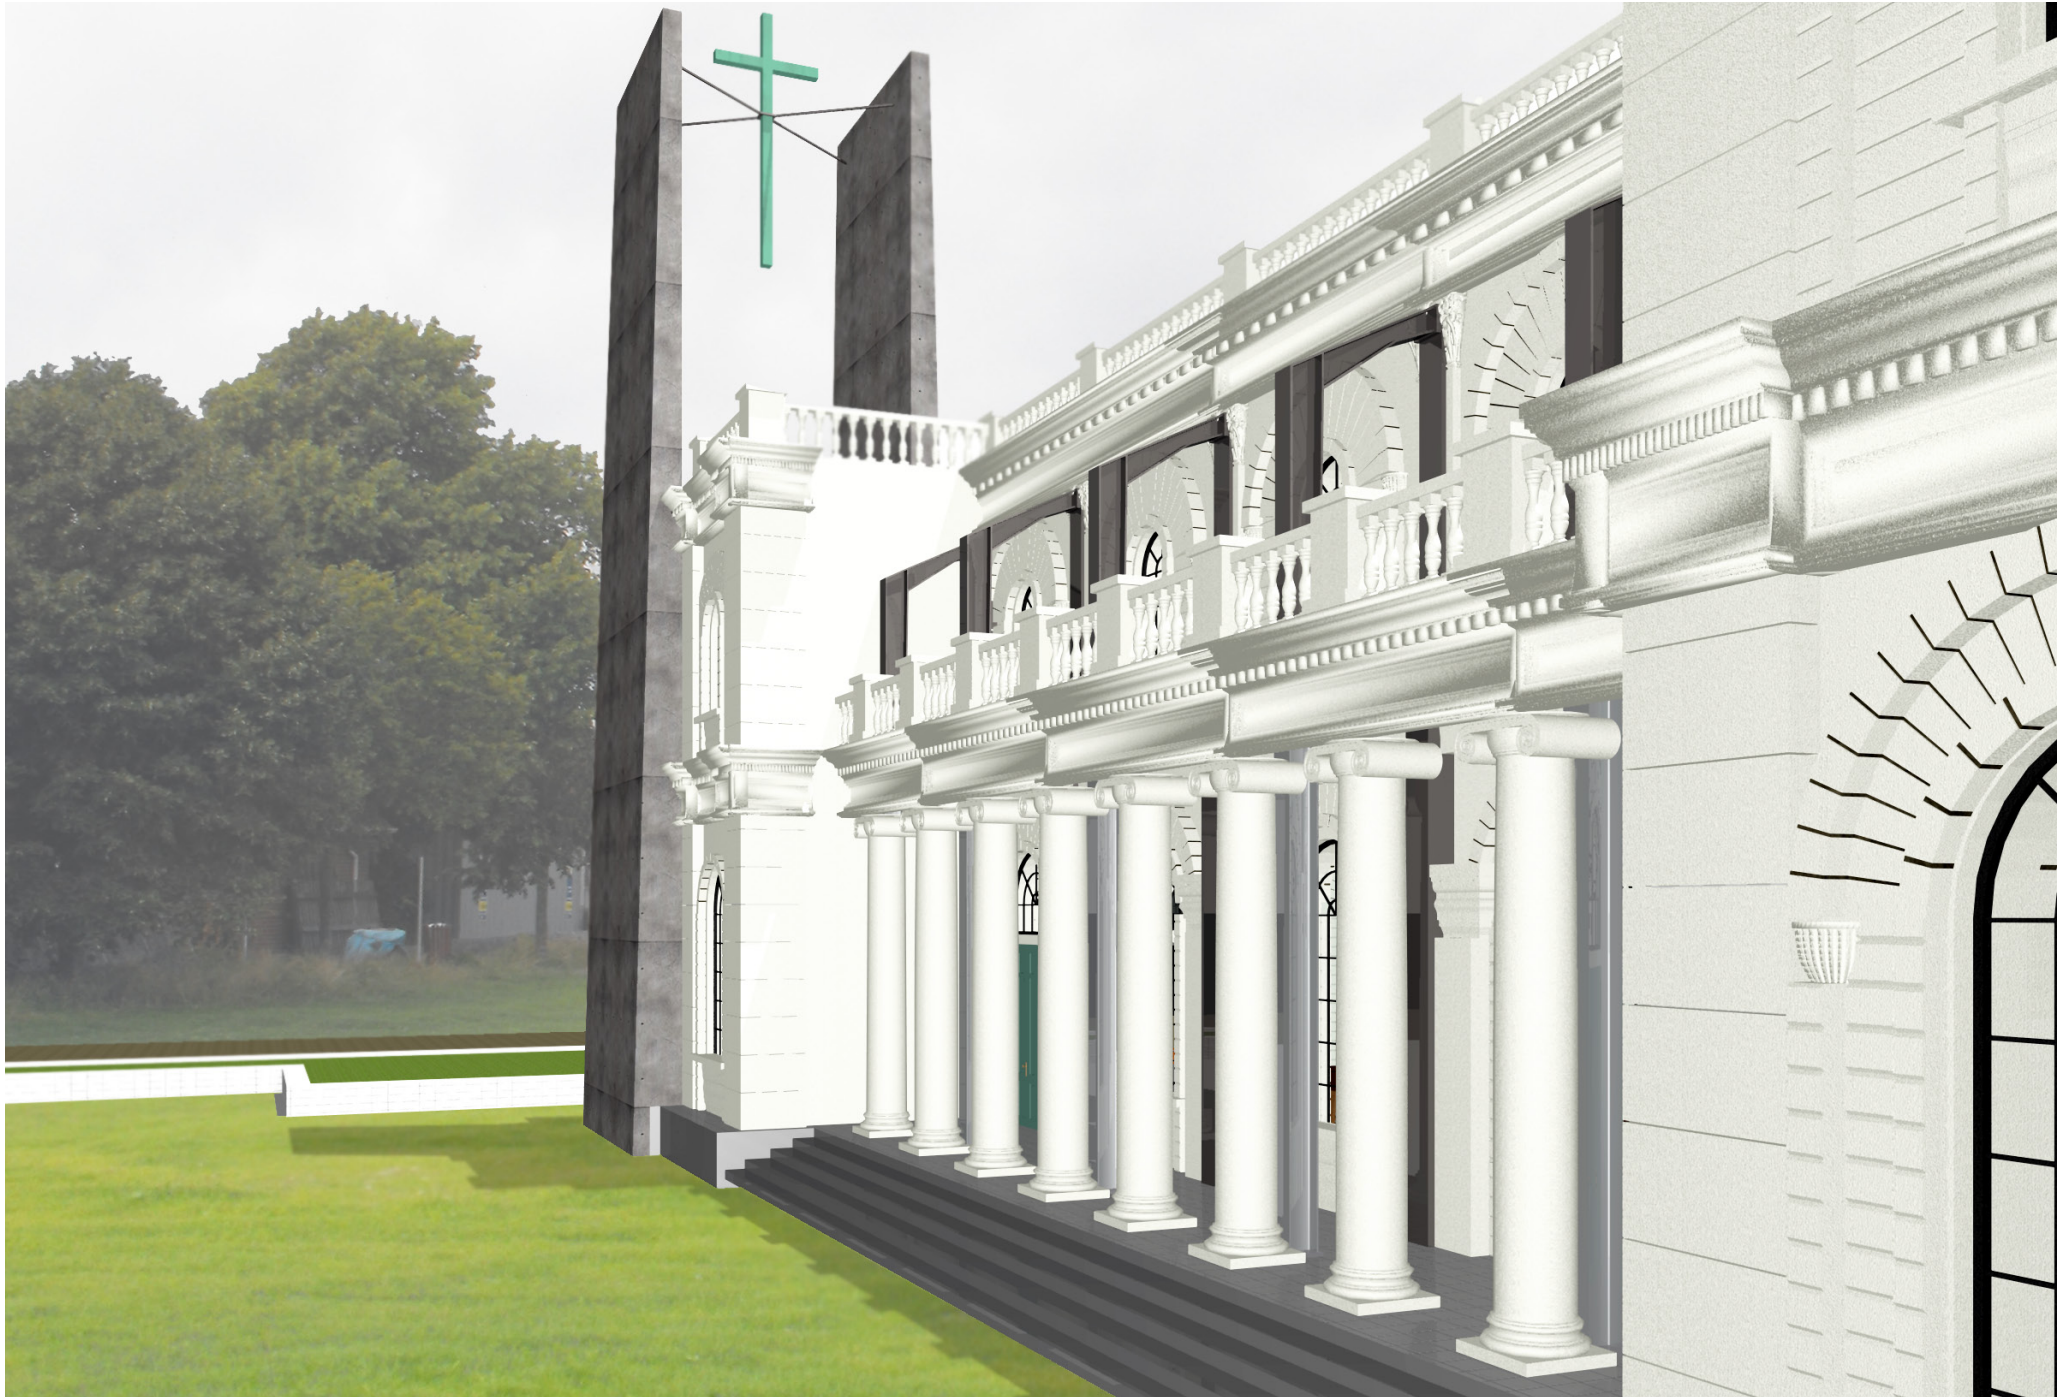
The transparency introduced through the Southern tower is continued in the replacement of the Cathedrals wooden entrance doors with glass doors. Inside the glass doors will be an internal glass foyer that is located in the area under the next level's floor. The glass doors allow

the community to get a view of the Cathedral's interior when it is not open. The glass foyer adds a functional space to the church between the main area and the entrance. It is conceived to be a foyer that can be open to the public to look into the building during the day. The reconstruction of the Cathedral will draw visitors back to the Cathedral who will have a renewed appreciation for the building they almost lost.
