**IMPROVING INTEGRATION OF SEISMIC RETROFIT
AND ARCHITECTURE IN UNREINFORCED MASONRY
BUILDINGS**

A thesis submitted to the Victoria University of Wellington
in fulfilment of the requirements for the degree of
Doctor of Philosophy
in Architecture

Victoria University of Wellington

2018

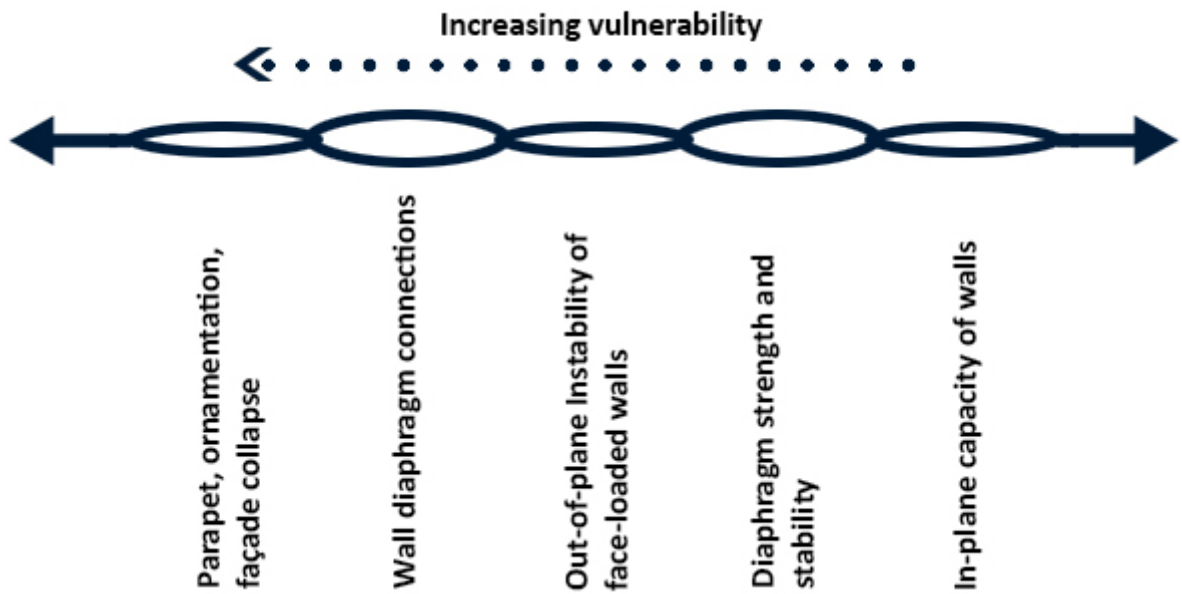
Figure 2. Capacity chain presenting a hierarchy of vulnerability among URM building components (Source: NZSEE et al., 2017)

In New Zealand, URM buildings are typically composed of exterior URM walls arranged in orthogonal directions, timber floors taking on the structural role of diaphragms, and a wooden lightweight roof (Russell, 2010). While these buildings generally possess regular plan configurations allowing their URM walls to be part of the in-plane resisting system, they commonly possess several failures. These failures can be hierarchised depending on the vulnerability of the building's components they are related to. The “*capacity chain*” (NZSEE, SESOC, NZGS, MBIE, & EQC, 2017) below displays a decreasing vulnerability from left to right among the URM building components (Figure 2).

The first two most vulnerable groups of components may suffer from inadequate connections. They include poorly restrained elements located at height such as parapets and chimneys. They also relate to the lack of strong connections between diaphragms and walls (Charleson, 2008).

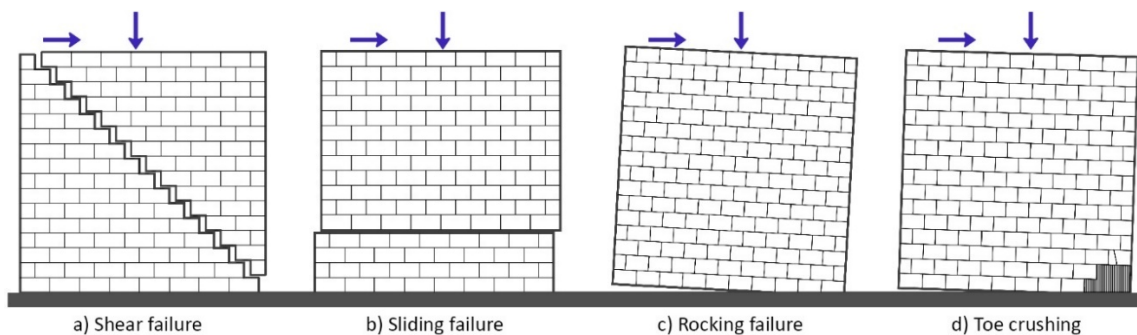
Figure 3. Different in-plane failure modes of a laterally loaded URM wall

Finally, the in-plane failures include different issues summarised by Magenes & Calvi (1997) and represented below (Figure 3).

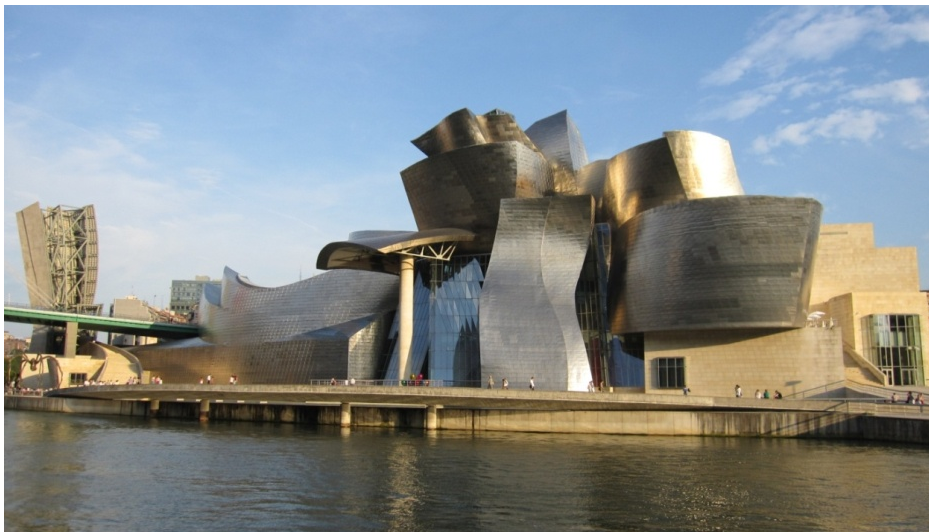
Figure 5. Guggenheim Museum (Source: <http://wordpress.com>, accessed April 2015)

The Guggenheim Museum (Bilbao, Spain, Frank Gehry, 1997) displays a completely opaque cladding, making the structural system invisible, and creating large continuous curved volumes with titanium panels (Figure 5). The concealment of the structure allows the forms, surface, and materiality of the volumes to act in correspondence with the Nervión river.

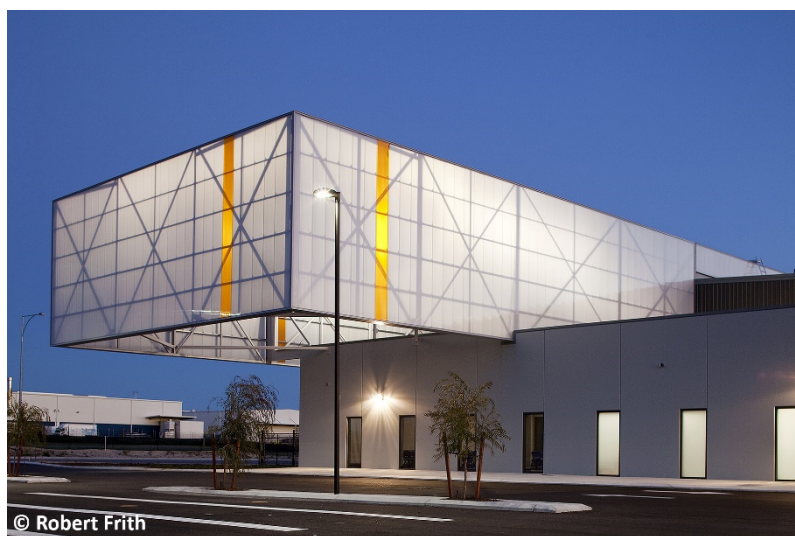
Figure 6. Patrick Autocare (Source: <http://dna-architects.com.au>, accessed April 2018)

The industrial facility designed by DnA Architects (Perth, Australia, 2010) achieves a different aesthetic using a translucence polycarbonate cladding. This approach provides a diffuse appearance of the internal structure (Figure 6). The external cladding thus influences the perception of the human eye. The boundaries of the structure are perceivable but slightly blurry, creating a sense of evanescence as some parts of the structure are more highlighted than others by the internal lights.

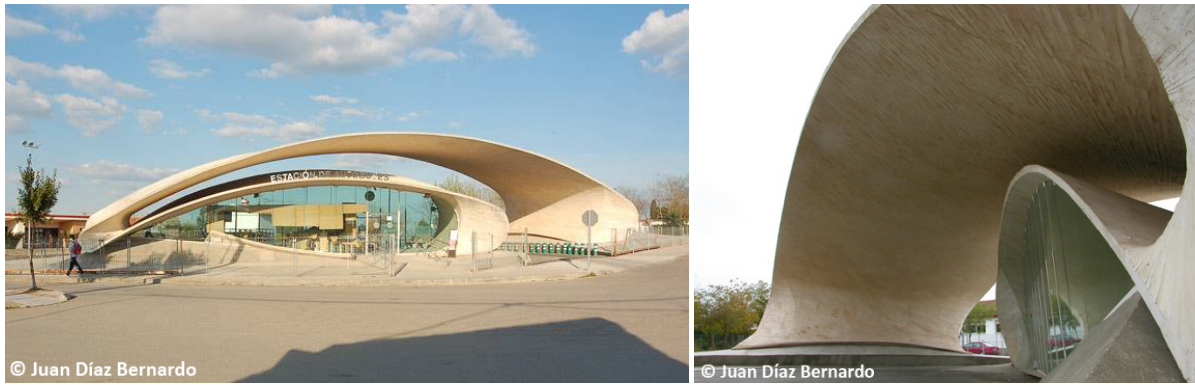
Figure 8. Bus station of Cáceres (Sources: <http://www.spainisculture.com> and <http://www.justogarcia.com>, accessed April 2018)

The bus station of Cáceres (Spain, Justo García Rubio, 2004) uses reinforced concrete shell structures (Figure 8). Responding to both structural and architectural requirements, the building is considered a “functional sculpture” (Ayuntamiento de Cáceres, n.d., p. 13). Variations of thickness respond to the technical requirements while also creating unique sculptural geometry (Eguiluz, 2015; Mendoza, n.d.). Structural form merges with architectural form, making its identification as a technical component difficult to perceive.

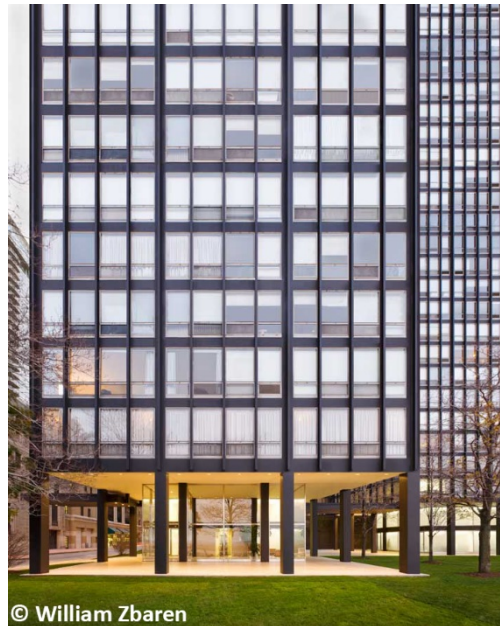
Figure 9. Lake Shore Drive (Source: <https://www.e-architect.co.uk>, accessed May 2015)

Modern architecture, and particularly the International Style, has led to breakthroughs in expressiveness and structural exposure. A sense of simplicity was brought, relating the building form to its function, excluding use of ornament and respecting the true nature of materials used. Mies van der Rohe, while in the United States, regularly used steel-skeleton as the primary structure for many of his projects. He said "*what I tried to do in architecture is to develop a clear structure ... [and that] we just should call it [my kind of architecture] a structural approach*" (Peter, 1994, p. 161). He thus developed a steel and glass-based architecture. The glass allows the constructive principle to be revealed (Van der Rohe, 1922). The exposure of structure was driven by Mies' desire to develop a "*structural architecture*" (Spaeth, 1985, p. 16). Architect Robin Evans (1990) remains however perplexed with Mies' work, especially the Lake Shore Drive Apartments (Chicago, USA, Mies van der Rohe, 1949) (Figure 9). Evans notes the skeleton structure and lightweight cladding remove any sense of a load-bearing system. He queries: "*How, then, have his buildings maintained their reputation as expressions of structural truth and structural rationality?*" (Evans, 1990, pp. 59-60). For Evans, structure, as used by Mies, does not represent its true role. This raises the issue of the representation of visually expressed structure.

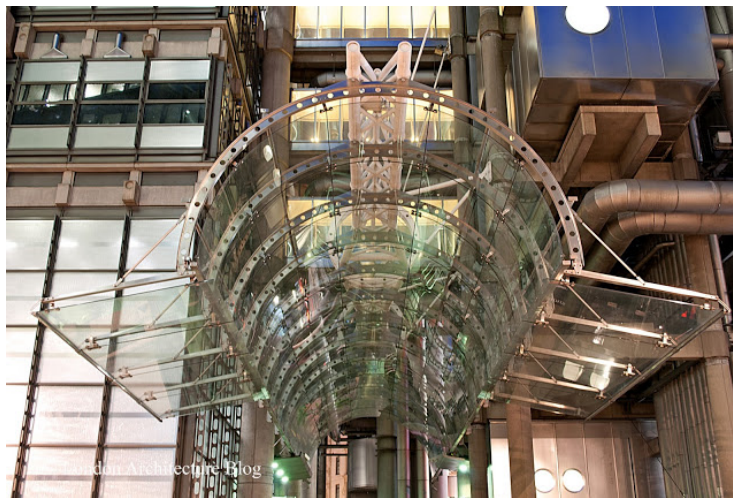
Figure 10. Lloyds headquarters (Source: <http://www.londonarchitectureblog.com>, accessed May 2015)

secondary. Structure is dictated by aesthetic purposes and representing an image of technical progress and prowess. The sizes, forms and arrangements of the structural components are determined by visual decisions. Macdonald (1997, p. 32) uses the word "*dishonest*" regarding this approach, pointing out that High-Tech, while celebrating and praising technology and technical excellence, actually generates buildings with poor structural efficiency. He stresses that this approach frequently compromises the structural design and that it is an "*inevitable consequence of this method*" (Macdonald, 1997, p. 30). He notes the entrance canopy of Lloyds (London, UK, Richard Rogers and Partners, 1986) (Figure 10) and stresses that the architectural perforation of the curved steel increases the risk of the canopy being blown away by the wind (Macdonald, 2001).

Macdonald criticises the weakening of the structural design due to this symbolic approach. The use of the structure primarily for aesthetics, and secondary for engineering purposes reduces its technical efficiency, impacts on economy of means and leads to structural deficiencies. Nonetheless, the degree of optimisation of structure may be balanced between the architect, engineer and client.

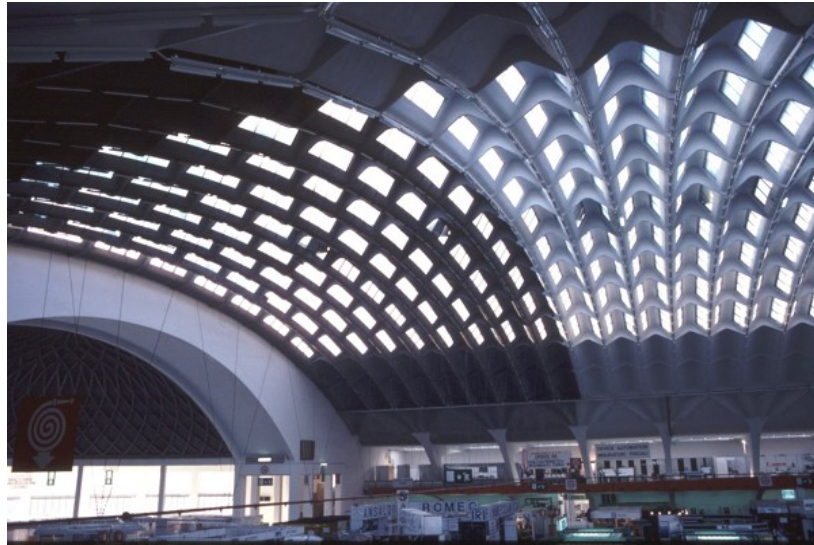
Figure 11. Exhibition hall (Source: <https://structurae.net>, accessed June 2017)

alteration of structure for visual purposes. The stronger the styling of pure structural components, the less the difference between "*Structure as architecture*" and "*Structure symbolised*". Von Meiss even acknowledges that examples he refers to as structurally truthful, such as the Exhibition hall Giovanni Agnelli (Turin, Italy, Nervi, 1949) (Figure 11), are not only technical necessities.

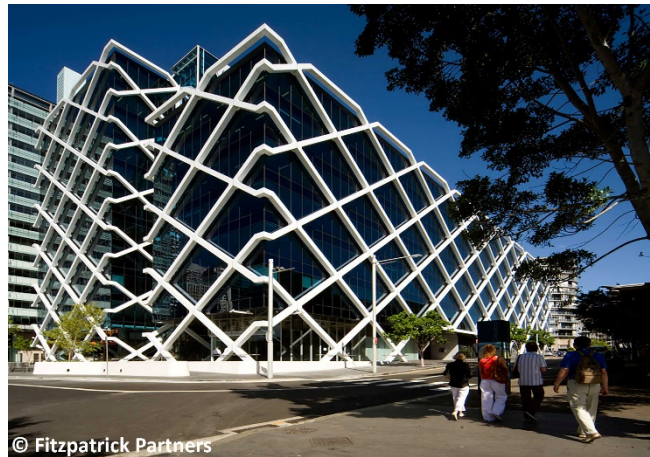
Figure 12. Macquarie Bank building (Source: <https://www.fitzpatrickpartners.com>, accessed April 2018)

The Macquarie Bank building (Sydney, Australia, Fitzpatrick + partners, 2009) presents an external structural diagrid system (Figure 12). The location of the steel structure is primarily justified by the opportunity to avoid perimeter columns and maximise internal space (Yudelson & Meyer, 2013). The architect also refers to the design as a structural play permitting a unique external visual character (McDonald, 2008). The structure, through colour and geometry, creates a simple diamond pattern highlighted by its visual and physical distance with the sleek glazed envelope behind.

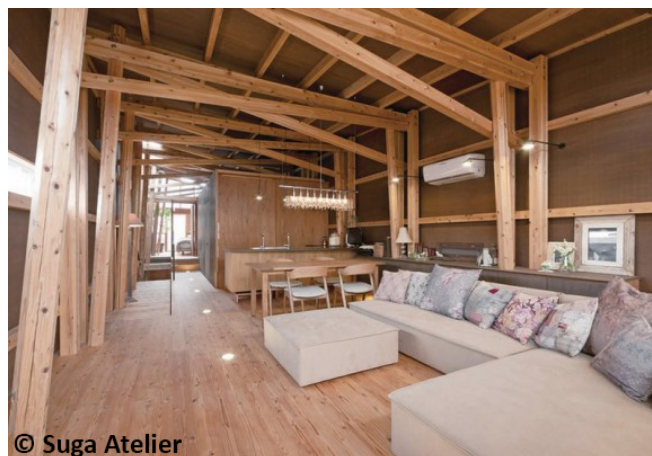
Figure 13. House of Cedar (Source: <https://divisare.com>, accessed April 2018)

Interior expressed structure also has the ability to participate in composition of surfaces. For Michel (1995), such use is twofold. The composition of internal structural surfaces allows creating aesthetic patterns while also accentuating spatial boundaries. These characteristics are noticeable in the House of Cedar (Osaka, Japan, Suga Atelier, 2012). An internally exposed wooden frame structural system of nine transverse structural frames is purposefully detailed using small timber components (Figure 13). The structure recalls tree trunks and branches, creating a unique interior aesthetic (Parafianowicz, 2012). No panels cover the perimeter walls and ceilings, leaving the struts and joist fully exposed and allowing them to contribute to the composition of the interior surfaces.

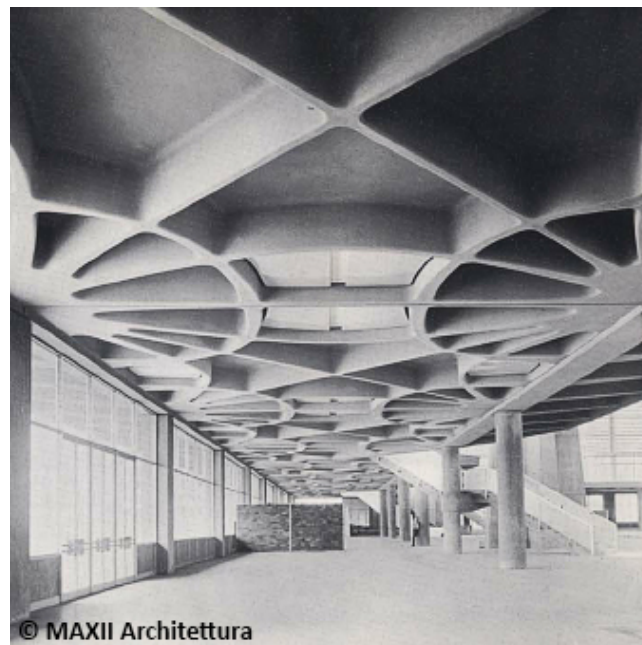
Figure 14. Palace of Labour (Source: Cresciani & Forth, 2014, p. 60)

This second option is found in the Palace of Labour (Milan, Italy, Pier Luigi Nervi, 1961), where an isostatic mezzanine slab runs along the building perimeter wall (Figure 14). The structure displays ribs representing strain-lines of the principal bending moments within the ferroconcrete slab (Cresciani & Forth, 2014). For Sharp (2002, p. 245), such “*energetic exhibition*” of the structure defines Nervi’s architectural aesthetic.

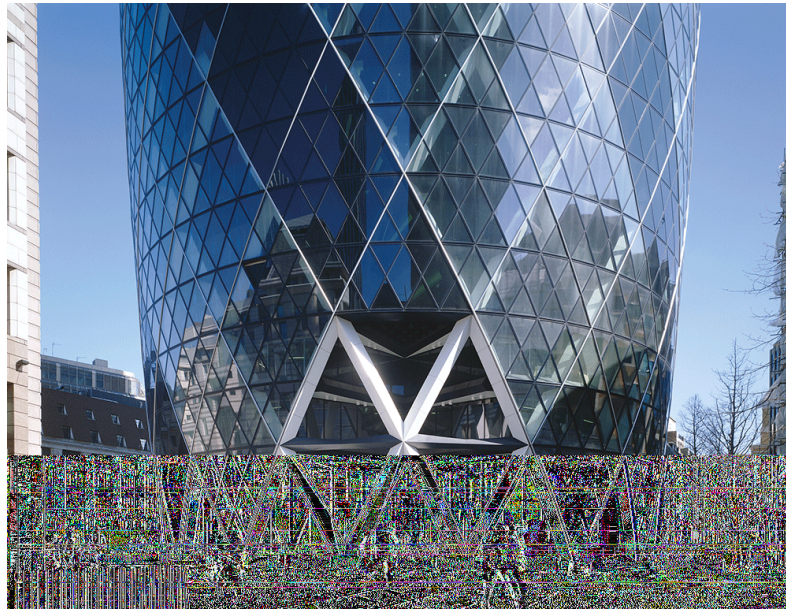
Figure 15. Entrance of the 30 St Mary Axe building (Source: <http://miesarch.com>, accessed April 2018)

Structural expressiveness is not solely limited to expression of physical representation of structural load paths. Structure can be used to express and enhance different aspects. Al-Kodmany & Ali (2016) indicate how the 30 St Mary Axe building (London, UK, Foster and Partners, 2003) features a cut-out allowing exposure of the diagrid structure (Figure 15). This treatment of the façade combined

with the expressiveness of the structure emphasises both the entrance and the threshold between exterior and interior.

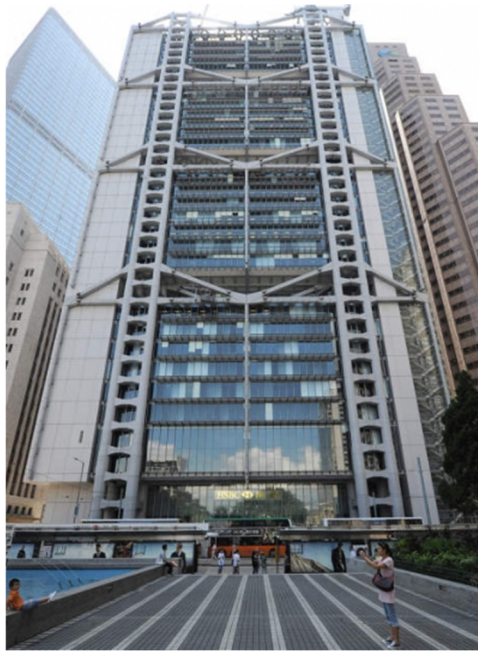
Figure 16. Hong Kong and Shanghai Bank (Source: <http://keywordsuggest.org>, accessed April 2018)

Al-Kodmany & Ali (2016) also appreciate structural expressiveness as an opportunity to highlight the iconic identity of a building. Externally, expressed structure defines the exterior architectural character. Like Macdonald (1997), the authors are aware that some structures may not be the result of sole technical requirements, taking the Hong Kong and Shanghai Bank (Hong Kong, China, Foster Associates, 1986) as an example (Figure 16). The mega-frame, while defining the external character, is not representative of the building's structural necessities. Nevertheless, Al-Kodmany & Ali (2016) acknowledge the aesthetic expressiveness of the external frame. Charleson (2014) explores this expressive purpose of the external structure, explaining how the mega-frame expresses inner functions and organisation within the building. The masts separate the offices and main hall at the centre from the service areas at the ends. Vertically, the spacing between trusses reflects the five distinct corporate banking divisions, expressing the functional inner program.

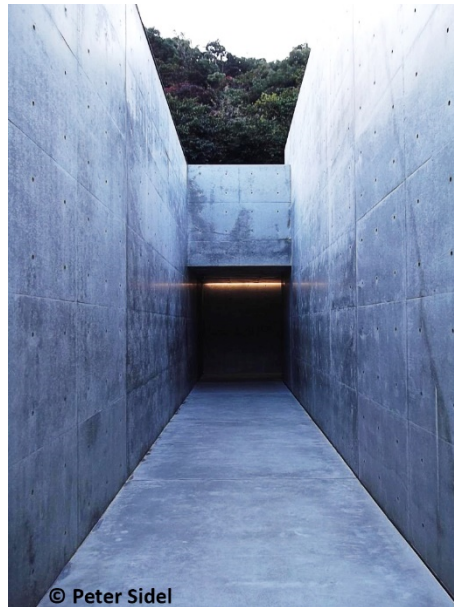
Figure 25. Entrance of the Ufan Museum (Source: <https://a2.cdn.japantravel.com>, accessed April 2018)

The first corresponds to ‘enclosed’ circulation space and is defined by a corridor created by side walls. This circulation area is connected to the spaces of the building through openings in the wall plane or at end of the corridor. The Lee Ufan Museum (Naoshima, Japan, Tado Ando, 2010) displays a path flanked by two massive raw concrete walls leading to the building’s entrance (Figure 25). The width of the path can be justified by Salvan (1999, p. 298) who explains “[a] *narrow, enclosed path will encourage movement*” therefore further inviting the visitor to enter the building. In contrast, corridors can be widened to create “*pausing, resting, or viewing*” areas.

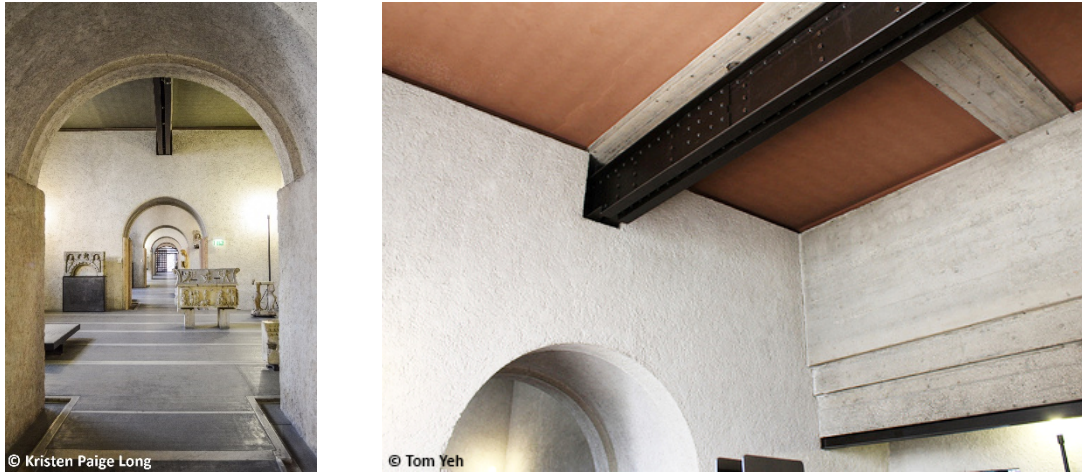
Figure 28. Castelvechio Museum (Sources: <https://rivaspring2016.wordpress.com> and <https://www.flickr.com/photos/yeh-tom>, accessed April 2018)

The second option corresponds to structure simply suggesting the route for users to take. Users have entire freedom of movement yet, structure acts as a visual signal emphasising the direction of movement. In the Carserra wing of the Castelvechio Museum (Verona, Italy, Carlo Scapa, 1964), five identical galleries are successively aligned and arched openings allow circulation between them. In addition, an H steel beam supporting the ceiling and perfectly aligned with the openings runs

through the entire wing (Figure 28). The beam is characterised by its singular materiality and colour, as well as by its detailing which includes carefully located supports and steel bearings giving the impression that the beam is floating. Thanks to its unique presence, the beam emphasises the path for users to take (Onniboni, 2014; Scarpa, Olsberg, & Guidi, 1999).

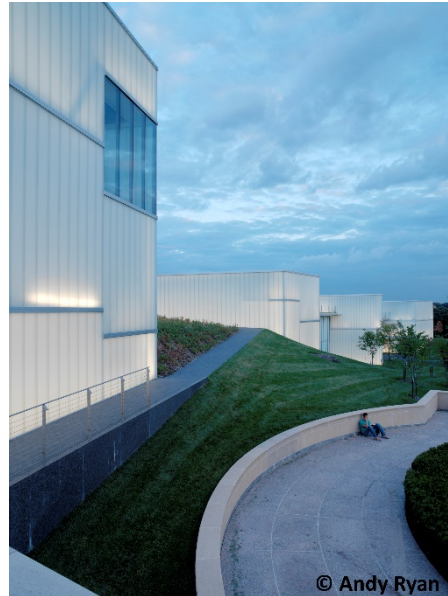
Figure 30. Exterior of the Nelson-Atkins Museum of Art (Source: <http://www.stevenholl.com>, accessed April 2018)

Arnheim (1974) provides a third approach and attributes to lit objects the value of light sources. The focus is therefore not solely on a single source of natural light coming from the sun but also on the objects as sources of light. Von Meiss (1990, p. 121) applies this approach to architectural design which he considers as *"the art of placing and controlling light sources in space"*. In this scenario, structure may be attributed the role of light source as much as any other architectural component. It is the structure being illuminated but also its capacity to block or facilitate the introduction of light that makes it a source of light. Steven Holl takes this approach to an extreme level with the Nelson-Atkins Museum of Art (Kansas City, USA, Steven Holl Architects, 2007). In this project, the five pavilions do not rely on conventional lighting to display their volumes. Instead, each one of them

glows from within and emit their own light to the outside (Figure 30). Each pavilion becomes literally sources of light, with Holl explaining that the “*building seems to be completely constructed out of luminous material*” (Descottes & Ramos, 2011, p. 121). The load-bearing structure, along with other architectural components, contribute to that effect. Chris McVoy states that a series of T-shaped walls forming the structural spine of each building ensures that not only internal galleries gain natural light but also that each building projects light at night (Donoff, 2007) (Figure 31).

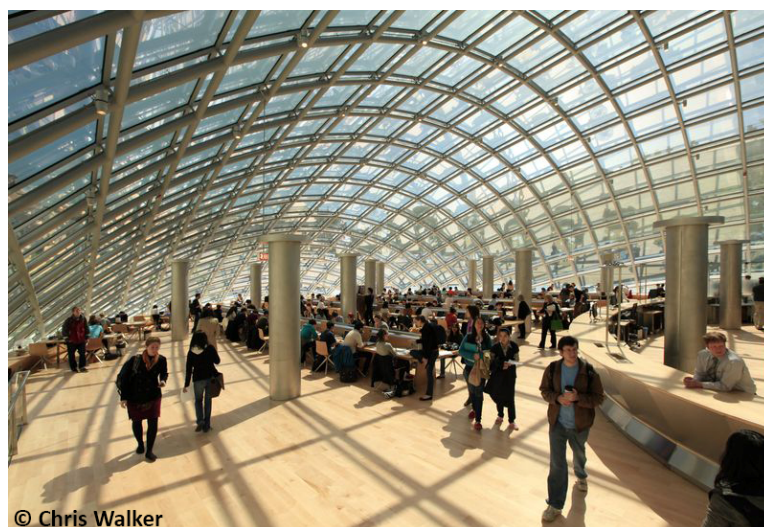
Figure 32. Interior of the Joe and Rika Mansueto Library (Source: <http://featuresblogs.chicagotribune.com>, April 2018)

The Joe and Rika Mansueto Library (Chicago, USA, Helmut Jahn, 2011) provides maximum freedom to natural light. The building is an elliptical glass dome supported by a grid shell structure (Figure 32). The structure is composed of 150 mm diameter steel tubes parallel to the ellipse axis and spaced about 1800 mm in each direction. The thin section of the structure combined with its grid pattern allowed to minimise the structural silhouette. Lighting designer Michael Rohde explains that with little interference, natural daylight was maximised within the building thus avoiding the use of artificial light (Madsen, 2012).

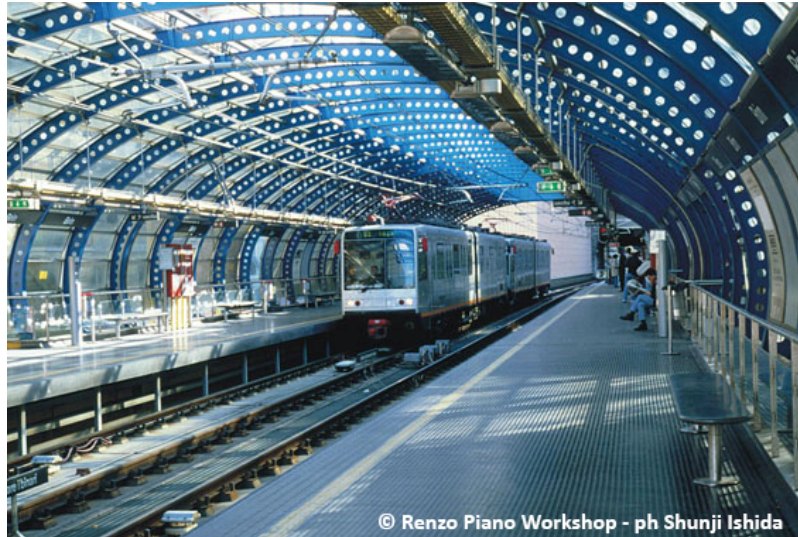
Figure 33. Genoa Subway Station (Source: <http://www.rpbw.com>, accessed May 2015)

While minimising the dimensions of structural members allows maximising the entrance of light, another approach consists in penetrating the structure (Charleson, 2014). Wiendahl, Reichardt, & Nyhuis (2015) thus highlight the capacity of castellated beams and truss girders to spread natural light in a space. This approach is used by Renzo Piano when designing a five subway stations project (1983-2003) in Genoa, Italy. Some of these stations are designed using perforated curved steel beams which, despite structural constraints let the light flow largely uninterrupted (Figure 33). Combined with glazing over the structure, the overall design creates a light-filled space.

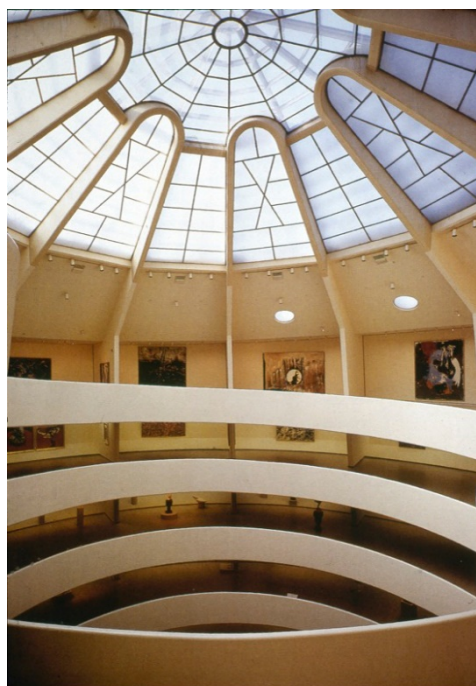
Figure 39. Skylight of the Solomon R. Guggenheim Museum (Sources: <http://www.romanovgrave.com>, accessed April 2018)

This mutual benefit for structure and natural light is also noticeable in the Solomon R. Guggenheim Museum (New York, USA, Frank Lloyd Wright, 1959). On the last floor, a skylight is composed of structural members arising from the uppermost walls and meeting at their ends to form a series of hairpin like shapes (Figure 39). The structure is an integral part of the skylight both supporting it and composing with the steel and glass components of the roof to create a unique pattern (Michel, 1995). The resulting skylight provides an abundant amount of light which then highlights the pattern created by the structural components (Kutlu, 2000).

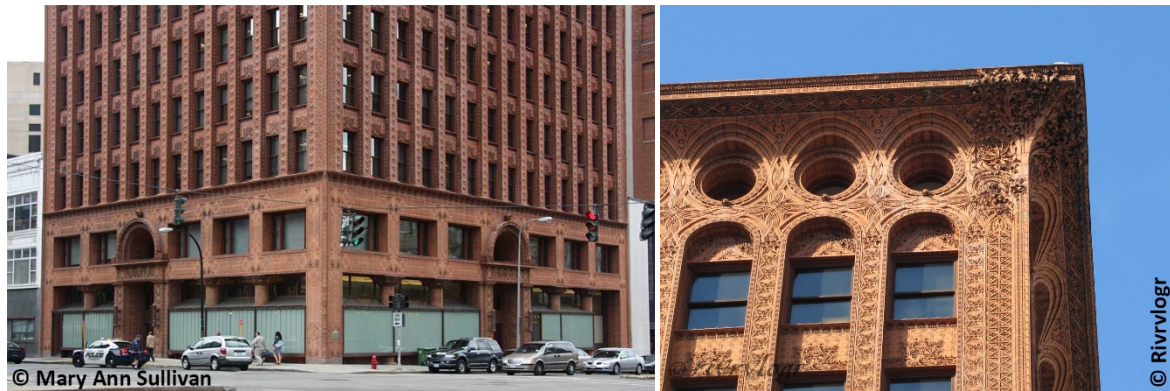
Figure 43. Guaranty Building (Sources: <http://www.bluffton.edu> and <http://www.skyscrapercity.com>, accessed May 2015)

An example of Sullivan's approach may be seen in the Guaranty Building (New York, USA, Sullivan & Adler, 1914) in which the steel-frame structure is covered by highly ornamented terra cotta cladding (Figure 43). The building expresses on its façades the division of a classical column with a base, shaft, and capital (Whiffen & Koeper, 1983). At its ground and first floor, the large spans between structural piers display delicate ornamentation, more highly expressed at the junctions of the steel members. On the shaft, or upper levels, ornamentation is more richly detailed and expressed. The vertical lines of the steel columns are thus more accentuated. Finally, the capital is expressed by a highly elaborated cornice composed of a row of round windows. Despite the fact that some aspects of the building express the association of ornament and structure, it appears that their

interdependence may not be as strong as Sullivan states. The role of the structure, apart from its load bearing purpose, appears to mainly be a physical support for ornament.

A second relationship is defined by Robert Kerr as "*Structure Ornamented*" (Beeby, 1977; Bothireddy, 2007, p. 23; Collins, 1998, p. 125) and describes applied or surface ornamentation. Structural components and ornament are in this situation clearly distinct. This approach was strongly criticised by Loos but fully applied by Sullivan in many of his projects such as the Guaranty building (New York, USA, Sullivan & Adler, 1914).

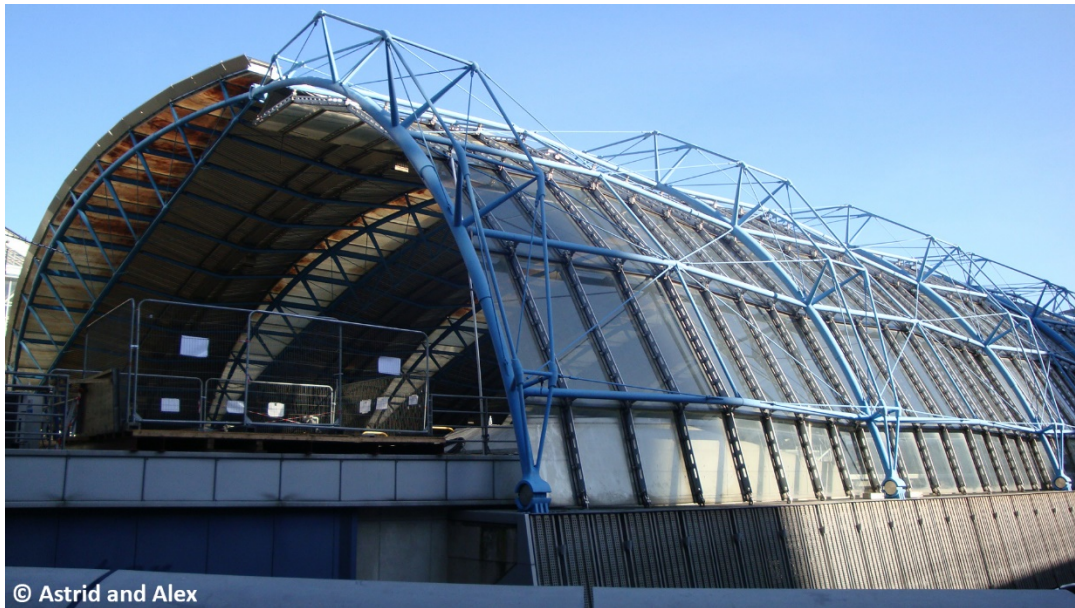
Figure 45. Waterloo International Terminal (Source: <https://changehere.wordpress.com>, accessed May 2015)

The first relationship is defined by Macdonald (2001, pp. 73-77) as "*Ornamentation of structure*". In this scenario, structure is fully justified from a technical point of view and expresses the structural engineering state-of-the-art. This goal is different from Sullivan's desire to ensure that the exceptional work undertaken by the designers is fully acknowledged (Jones, 2001). First, "*Ornamentation of structure*" exposes the structural component instead of hiding it behind an added layer of ornamented cladding. Second, unlike Sullivan's approach in which structure is ornamented to express a specific character of the building, here, structure is tectonic and reveals the techniques of construction. It is also conceivable some structural components would be considered as 'organic ornament' thanks to their materiality. Stainless steel structures would mostly likely fall in this category. The structure of the Waterloo Station (London, UK, Nicholas Grimshaw, 1993), while being technically fully justified, contributes aesthetic value through its technical vocabulary (Figure 45). The arches of the train shed roof are composed of two dissimilar curved trusses, triangular in section. Arches are attached to each other by a secondary tubular steel structure cross-braced by steel tension rods (Waterloo International Terminal, 1993). The ornamental quality displayed by the structure may be read in two ways. First, the structural hierarchy between the components and their repetition establishes an ornamental pattern all along the roof. Second, the refined detailing of some components such as the pin jointed connections at the base of each truss enhances the elegance of the engineering work.

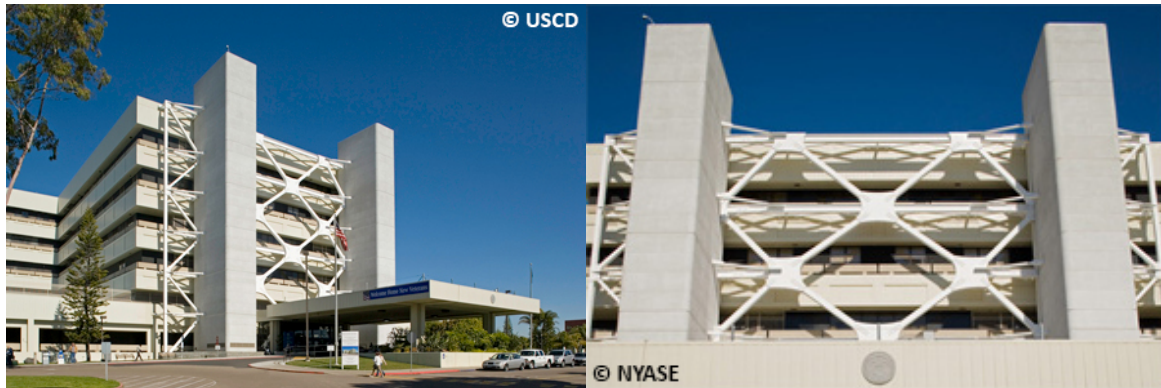
Figure 49. Veterans Affairs San Diego Medical centre with braced frames expressing an ornamental pattern (Sources: <http://surgery.ucsd.edu> and <http://www.nyase.com>, accessed July 2015)

building during a quake, it must function ornamentally at other times". This statement can be appreciated in buildings such as the Veterans Affairs San Diego Medical centre, in which new braced frames installed on the building's four sides provide ornamentation to the otherwise bland façades (Figure 49).

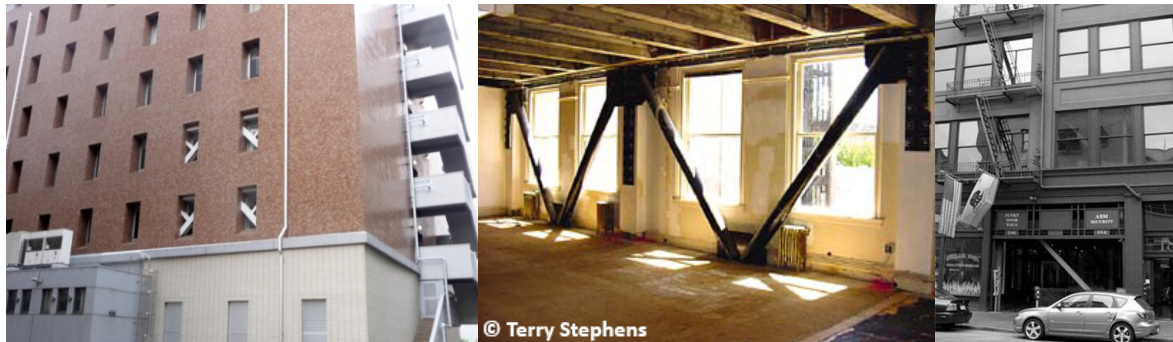
Figure 51. Seismically retrofitted buildings (Left: Student apartments, Tokyo; Centre: Skinner Building, Seattle; Right: Office building, San Francisco) (Sources: Andrew Charleson, <http://www.djc.com>, accessed July 2015, and Charleson, 2008, p. 188)

understanding of the building's architecture to the damage and loss of architectural features and qualities (Cattanach et al., 2008; Goodwin et al., 2009). Examples of buildings with inadequate integration of seismic retrofit structure and existing architecture may be found in all earthquake-prone countries (Figure 51). Often, these retrofitted buildings suffer from functional, circulation and aesthetic disturbances causing problems to the building and its users.

In the case of the above examples, it appears that neither the potential architectural characteristics of the structures nor their impacts have been considered. As a result, the seismic structures fail to enrich existing architecture and actually disturb already established architectural features. Overall and in each example, the added seismic structure fails to be considered as one of the building's legitimate and coherent components. These are examples of poor or a lack of integration of seismic structure and architecture.

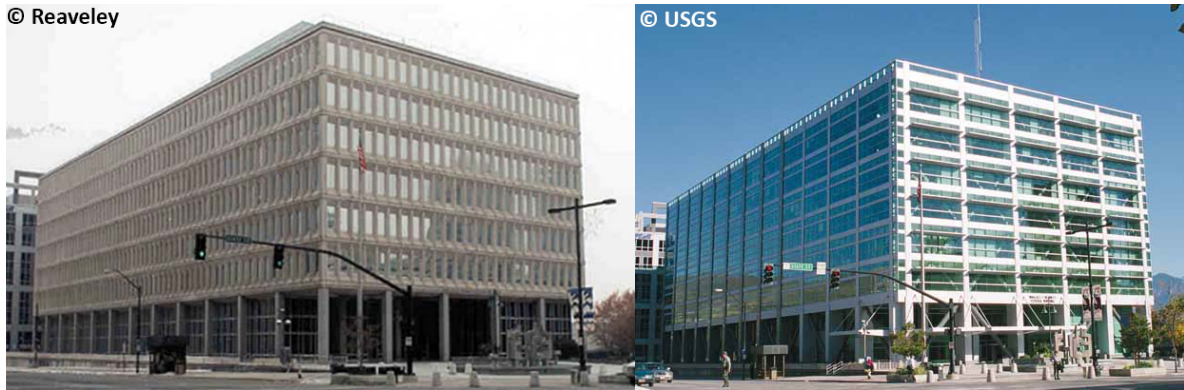
Figure 55. Wallace F. Bennett Federal Building (Right: before retrofit; Left: After retrofit) (Sources: <http://www.reaveley.com> and <http://forum.skyscraperpage.com>, accessed July 2015)

The Wallace F. Bennett Federal Building (Salt Lake City, USA, 1963) is an eight-storey structure made of reinforced concrete. In 2001, the building was seismically retrofitted in conjunction with a renovation design (GSBS Architects) (Figure 55). Its seismic retrofit structure consists of a series of steel braced frames installed on the building perimeter and placed in front of existing reinforced concrete columns (Figure 56). The seismic retrofit could have been completed as such, leading to an interaction between the newly added structure and some existing architectural features. However, designers decided to take advantage of the seismic strengthening to *"replace the existing pre-cast exterior cladding with a modern, attractive and energy-efficient curtain wall system"* (Brown, Aiken, & Jafarzadeh, 2001, p. 32). This new architectural element does not participate structurally in the seismic solution but rather architecturally in the building's renovation. It brings new architectural qualities to the building such as a maximising natural light thanks to larger windows. This aspect might at first sight be seen as an additional quality unrelated to the seismic retrofit design. Yet, this new façade and its rhythm are modulated by the presence of slabs and the new structural frames. They redefine the new exterior architectural character of the building. This building highlights the fact that the integration between seismic retrofit and architecture should not only be considered with respect to existing architectural qualities but also, in some cases, to new ones as well.
