# Flight of the Factory

Design guidelines for the use of laminated  
timber in the adaptive reuse of unreinforced  
masonry industrial heritage buildings in rural  
New Zealand

A thesis  
submitted to the Victoria University of Wellington  
in fulfilment of the requirements for the  
Masters of Architecture (Professional)

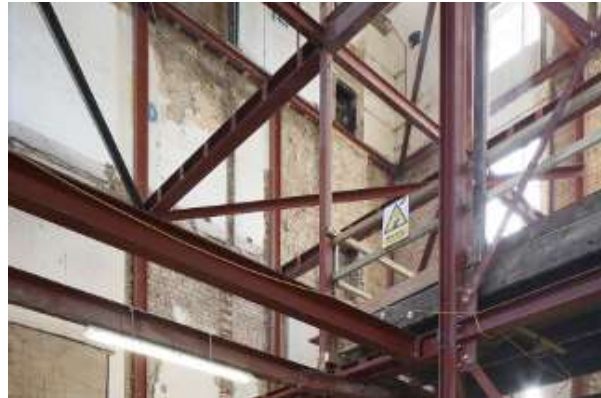
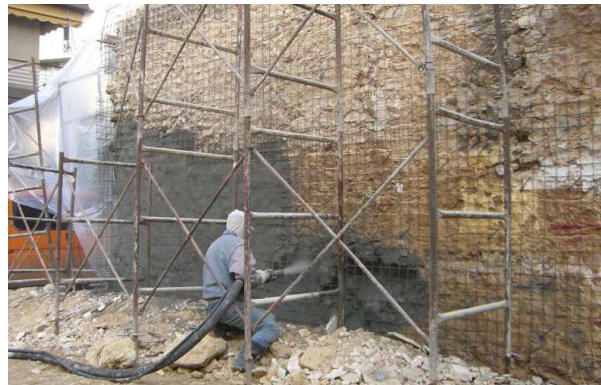
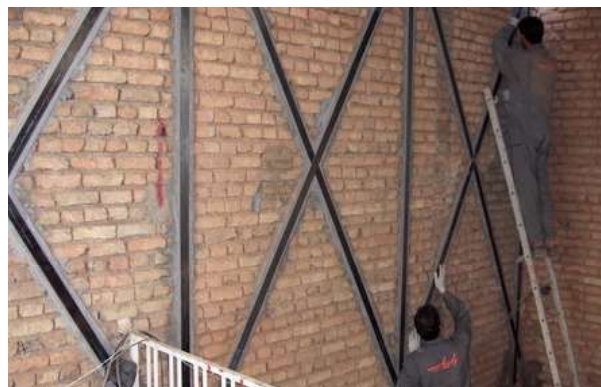
*Figure 14 Steel portal structure reinforcing.*

These are examples of typical strengthening solutions to U.R.M buildings. The three most common methods are retrofitting structural steel, shotcrete (application of a layer of reinforced concrete to masonry wall) and fibre reinforcement.

These are practical solutions and the choice of method depends on the building. However, these methods can be unsuitable when considering heritage buildings, as they are unsympathetic, invasive and irreversible to the fabric of the existing building.

Figure 14 Steel Portal Structure, Hill Road. CASE. Retrieved December 13, 2017 from [http://www.civilandstructuralengineering.com/about\\_us.html](http://www.civilandstructuralengineering.com/about_us.html)

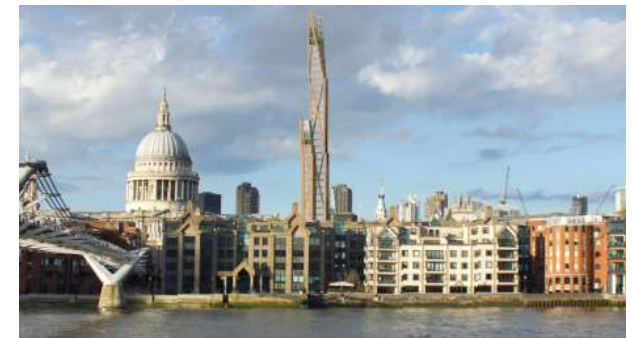
Figure 21 Proposal for the world's first C.L.T skyscraper.  
Source: PLP Architecture

Laminated timber is generally used in the construction of new buildings. This research investigates the potential for laminated timber to be used in existing buildings, and how its properties allow a new programme to occur.

Figure 21 Proposal for the world's first C.L.T skyscraper. PLP Architecture. Retrieved February 17, 2018 from [https://www.dezeen.com/2016/04/08/plp-architecture-cambridge-university-london-first-wooden-skyscraper-barbican/#disqus\\_thread](https://www.dezeen.com/2016/04/08/plp-architecture-cambridge-university-london-first-wooden-skyscraper-barbican/#disqus_thread)

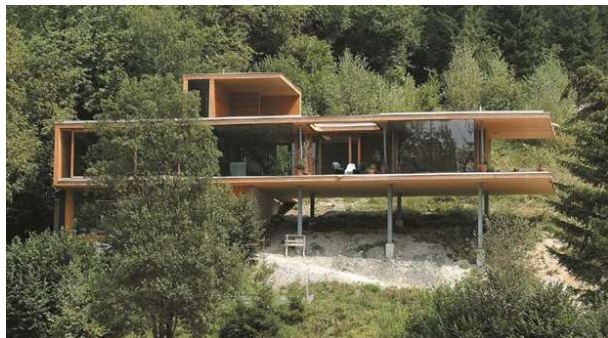
Figure 25 C.L.T House, Austria.  
Source: KLH

C.L.T consists of lengths of solid timber layered on top of each other in opposing directions. This creates a panel that has strength in both directions. C.L.T panels can be used for floors, wall and roofs. C.L.T panels can come in any size up to 15 metres long and 3.5 metres wide. Panel thickness depends on the intended load and span. The most common configurations have 3, 5 or 7 layers, ranging in thickness from 60mm – 250mm.

Figure 25 C.L.T house in Austria. KLH. Retrieved February 17, 2018 from <http://www.architectureanddesign.com.au/features/features-articles/get-ready-for-the-cross-laminated-timber-clt-revol>

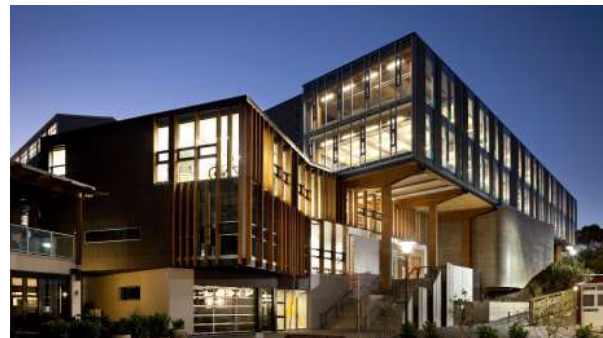
Figure 26 L.V.L in College of Creative Arts, Wellington  
Source: Nelson Pine

L.V.L is created by laying up multiple thin sheets of veneered timber, the high number of laminations ensures that the product is of consistent strength through the length of the member. L.V.L can come on panels or beams.

Figure 26 L.V.L in College of Creative Arts, Wellington. Nelson Pine. Retrieved February 17, 2018 from <http://www.nelsonpine.co.nz/wp-content/uploads/NelsonPine-LVL-Brochure-web.pdf>

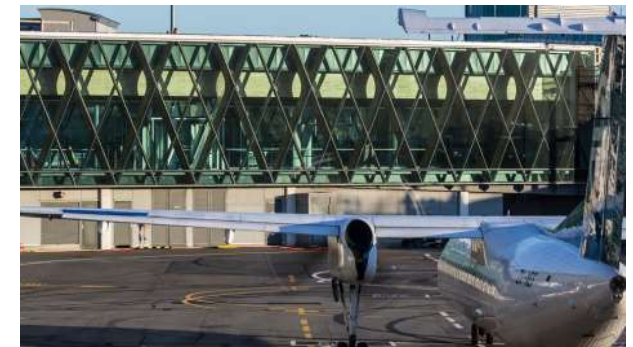
Figure 27 Glulam Structure, Airport Extension, Wellington  
Source: Warren + Mahoney

Glulam is lengths of timber running in the same direction laminated on top of each other and is used to create beams, columns and portal frames. Glulam members can be straight or curved and can span very large distances.

Figure 27 Glulam Structure, Airport Extension, Wellington. Warren + Mahoney. Retrieved February 17, 2018 from <https://warrenandmahoney.com/portfolio/wellington-international-airport-south-terminal-expansion>

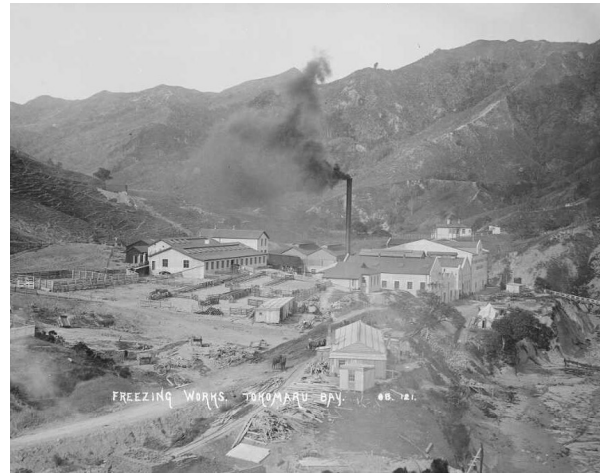
*Figure 39 Overlooking the Tokomaru Sheepfarmers' Freezing Company Ltd works at Waima, Tokomaru Bay.  
Source: William Price*

Opened in 1910, the freezing works were “built to last with solid brick construction and concrete floors. One and quarter million bricks were used” (Gundry, 20). The works could handle 2500 sheep and 60 cattle daily and provided hundreds of jobs for the local community. A reinforced concrete extension to the freezing chambers was added in 1917. Facing the ocean, the works are tucked into the hills behind with a stream nearby. The freezing works are a “group of plastered-brick and concrete buildings with timber internal partitions and gabled roofs, between one and three stories high. Several buildings were constructed adjoining each other and formed a continuous façade along the road” (NZHPT).

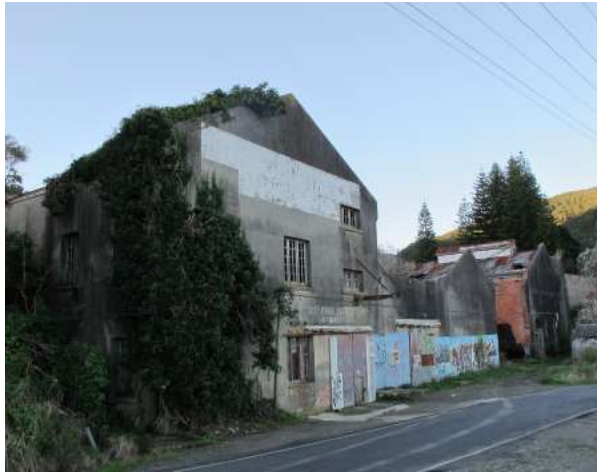
The freezing works closed in 1952 and was stripped of all salvageable material. Large portions of the works demolished in 1954.

What remains of the works is in disrepair and is overgrown.

*Figure 45 Tokomaru Bay Freezing Works, Waima Cove.  
Source: Authors Image*

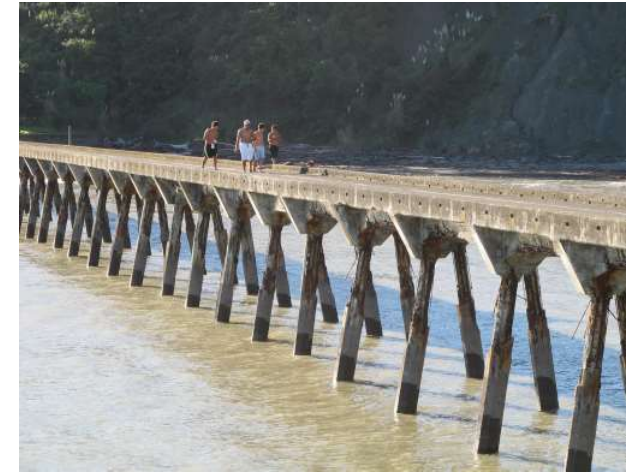
Salt water has not been kind to the wharfs foundations and today the wharf is officially closed, although one can still walk to the end of the reinforced concrete section at their own risk. Fundraising for the wharf's \$2 million restoration has been underway for a number of years by the local community.

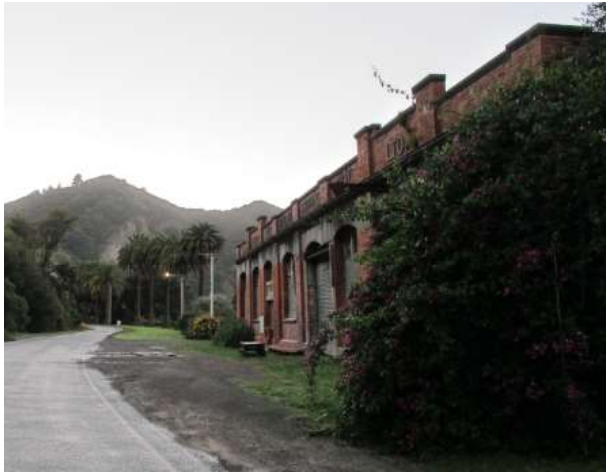
The building was sold by the district council and is now privately owned. The building is currently used for storage by locals and in disrepair with sections of the roof beginning to collapse.

*Figure 47 Wool Store, Waima Cove.  
Source: Authors Image*

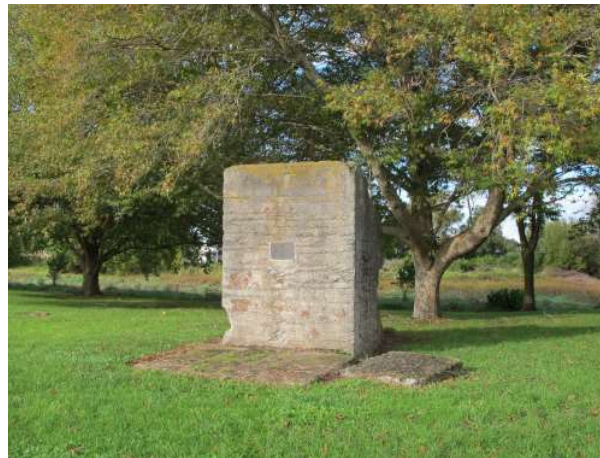
*Figure 62 Footing form the base of the smoke stack is all that remains of Taruheru works. Source: Author's Image*

Timber construction.  
100% demolished, foundation of smoke stack with plaque all that remains. Land subdivided and used for housing/ public reserve.

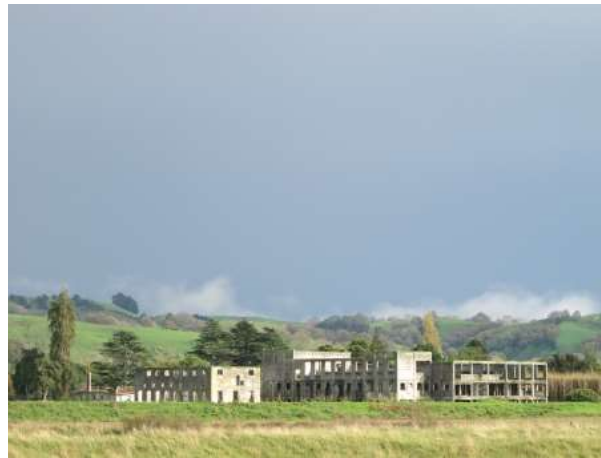
Reinforced concrete construction. 100% ruins, with only the concrete structure remaining in the middle of a paddock.

*Figure 68 Concrete structure remains of the Waipaoa Freezing Works dominates the landscape.  
Source: Author's Image*

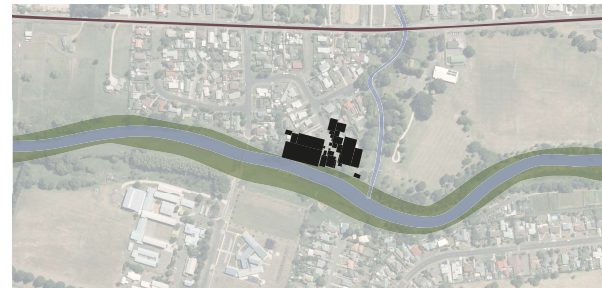
Figure 70 Site Plan and Building Footprint of Taruheru.  
Source: Author's Image

- Size of building footprints dictated by building materials used and programme requirements of each space.
- Freezing works in direct connection with water have an obvious frontage and are more compact in their design (Taruheru, Kaiti, Tokomaru Bay). Freezing works set back from water have less spatial constraints, and master plans are more spread out (Waipaoa, Hicks Bay).

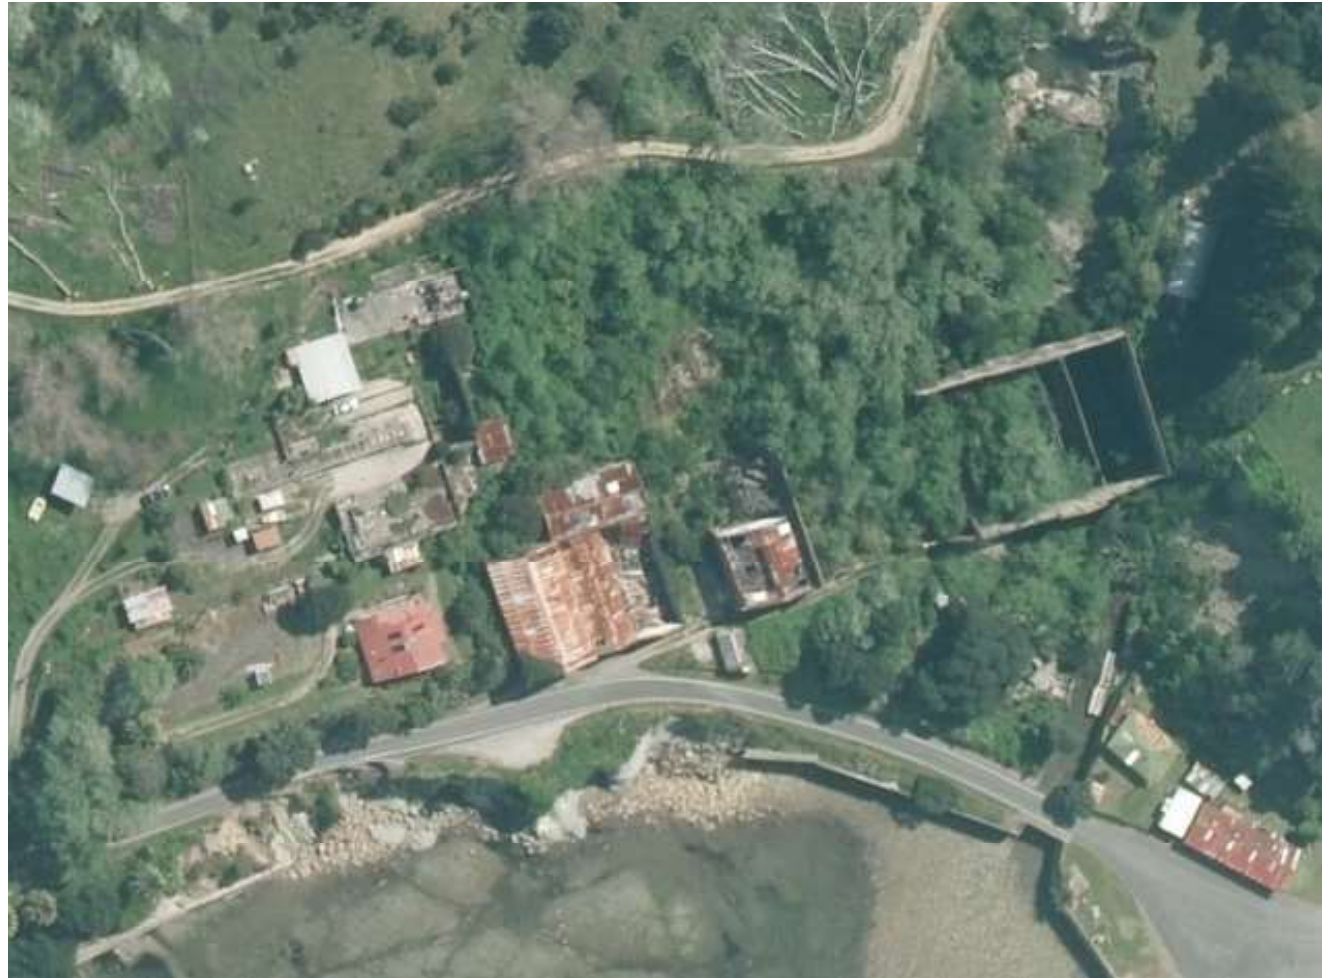
65 years after their closure, the freezing works buildings are in various states of disrepair.

The slaughterhouse has been demolished with only concrete footprints remaining. The manure and tallow works, and the engine rooms are the most intact buildings. Although their roofs are collapsing, the walls are still standing. The freezing chambers are the most overgrown areas of the complex, with the impressive reinforced concrete extension, built over the stream, standing tall above the trees.

*Figure 75 Aerial of Tokomaru bay Freezing Works ruins 2017.  
Source: L.I.N.Z*

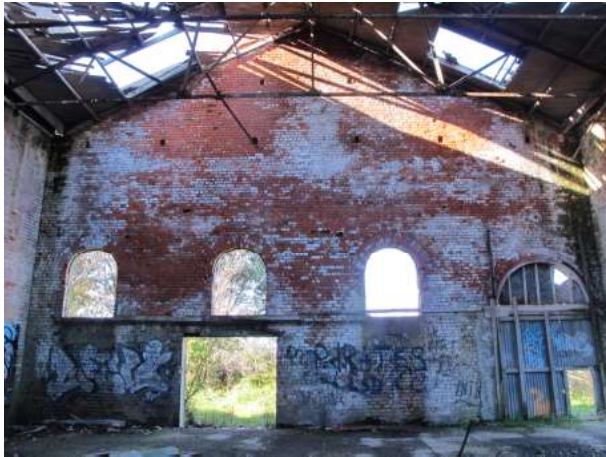
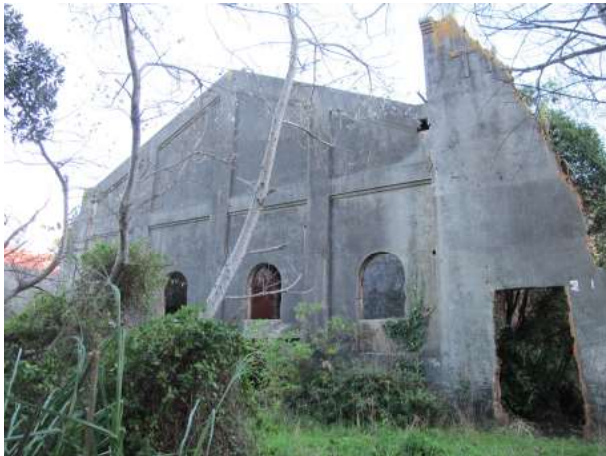
Figure 78 (above) Engine room interior.  
Source: Author's Image  
Figure 79 (below) Engine room exterior.  
Source: Author's Image

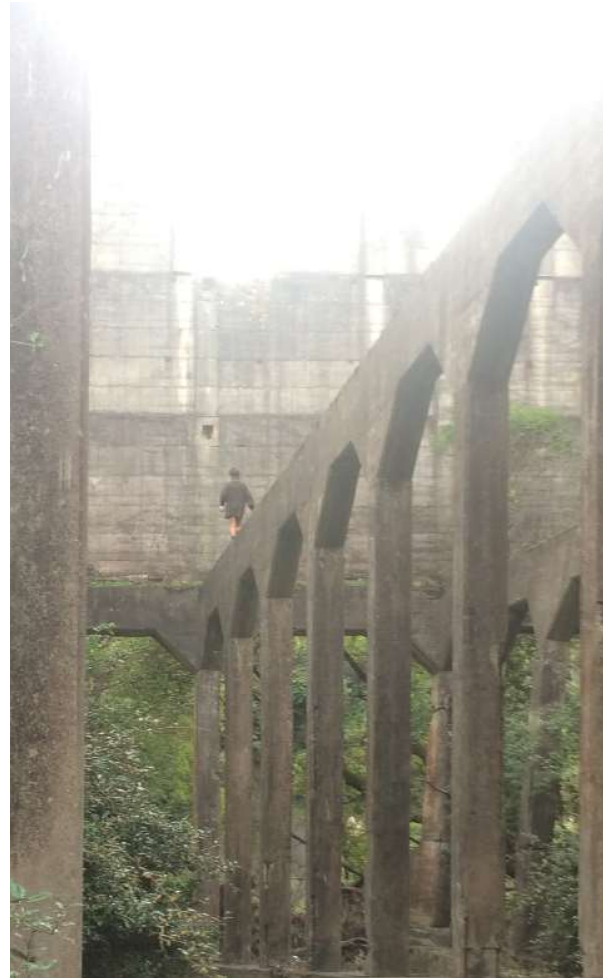
Figure 76 Local girl walking along the freezing chamber extension as seen from the stream.  
Source: Author's Image

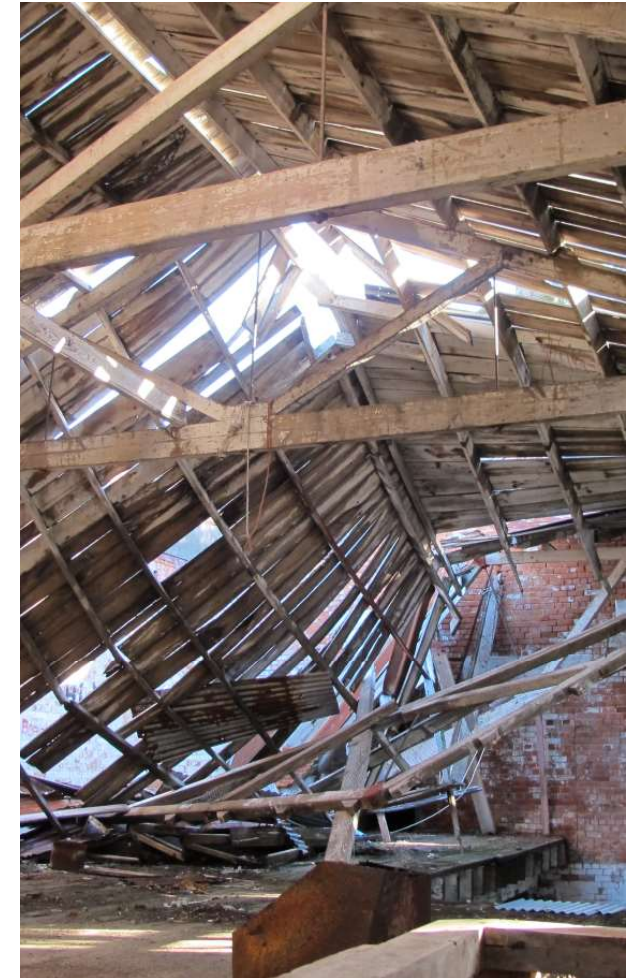
Figure 77 Manure works roof beginning to collapse.  
Source: Author's Image

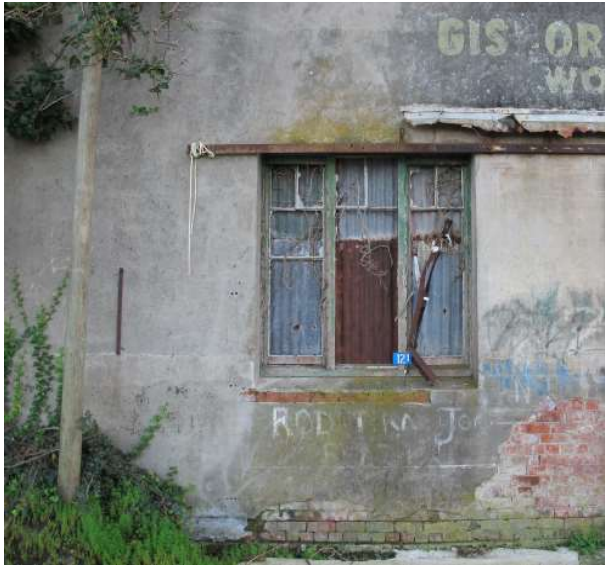
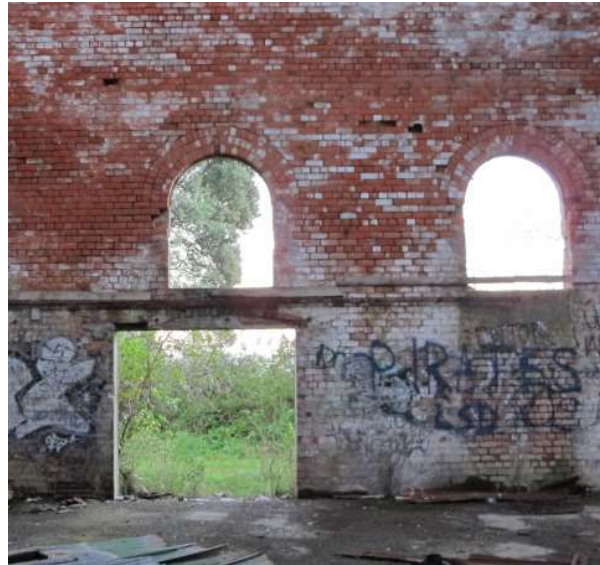
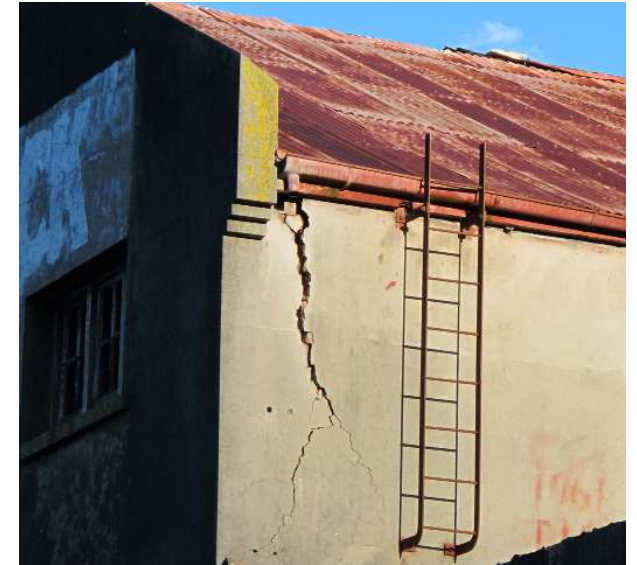
*Exterior Masonry with Plaster*

*Interior Exposed Masonry*

*Unreinforced Masonry*

Figure 82 Exterior treatment of masonry buildings.  
Source: Author's Image

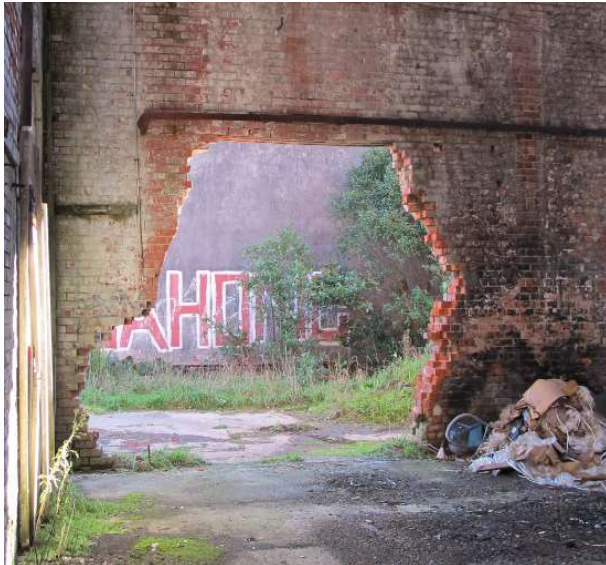
*Figure 85 Opening in the former engine room.  
Source: Author's Image*

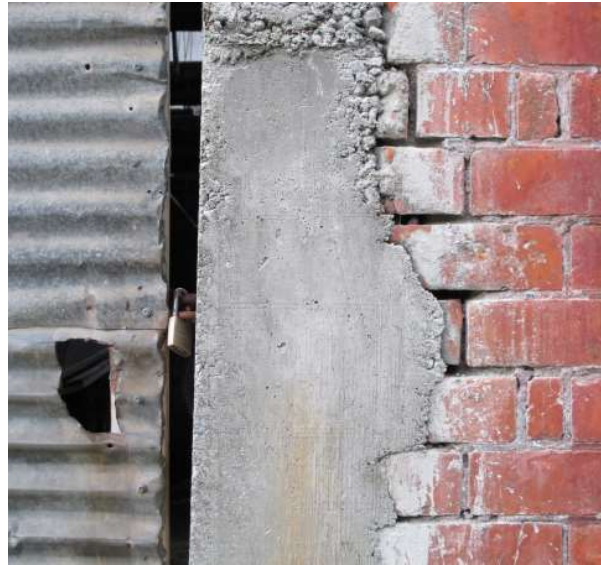
*Figure 86 Patch up repairs to an opening on the woolstore.  
Source: Author's Image*

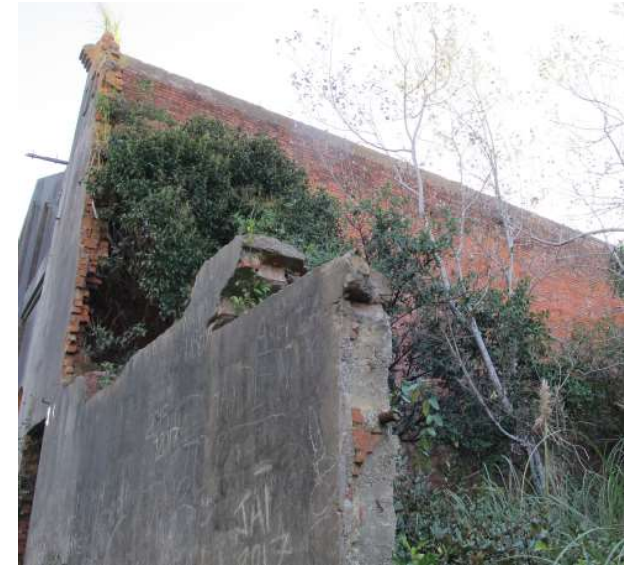
*Figure 87 Freezing chambers overgrown.  
Source: Author's Image*

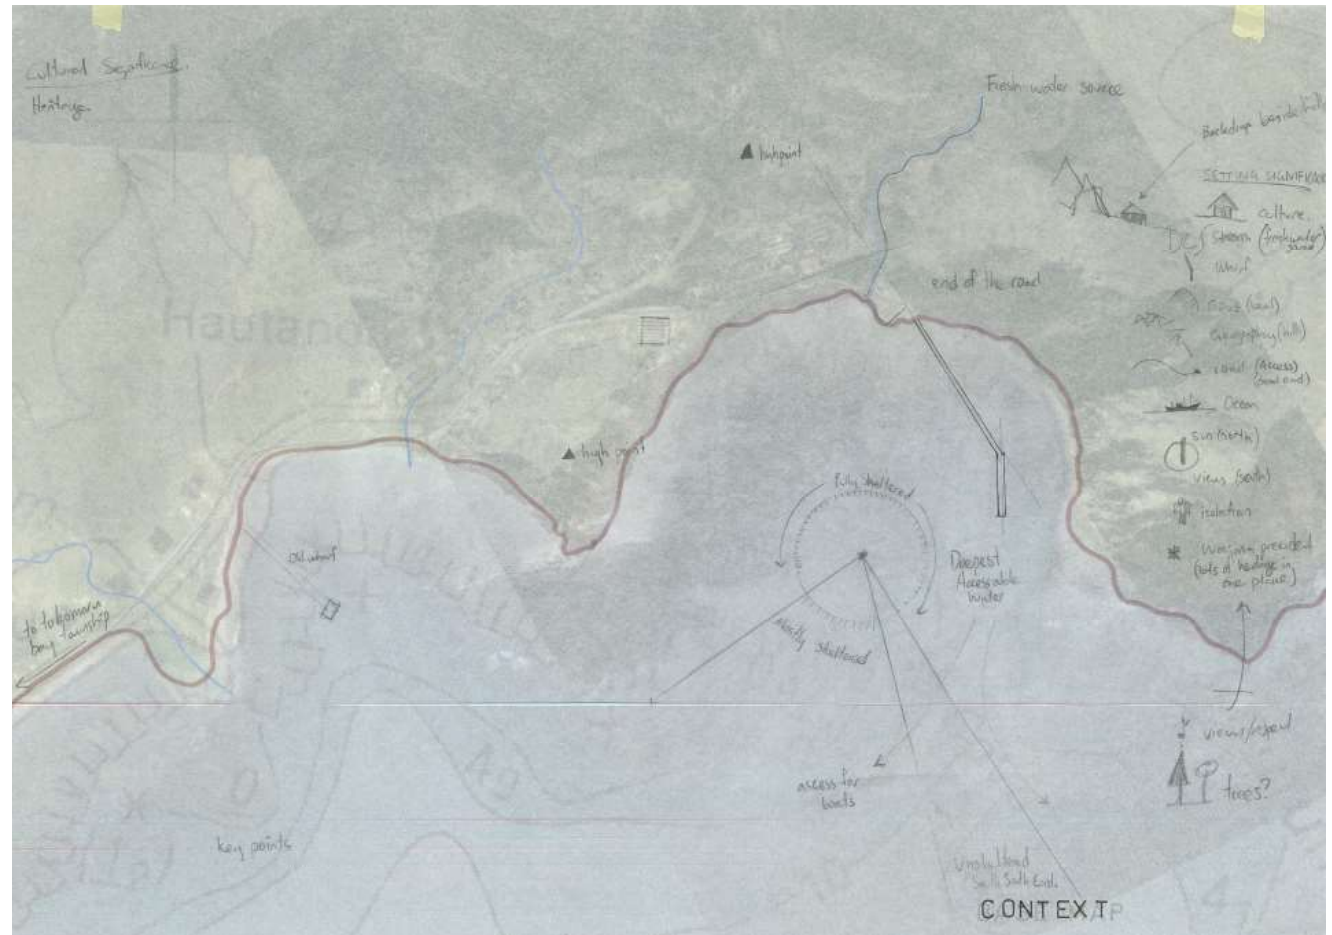
- Waima Cove is South facing, surrounded by hills.
- Waima Cove is shallow with a rocky bottom, the wharf stretches out to reach the deepest water.
- Located at the End of the road, 4km from Tokomaru Bay Township (off the main highway).
- Surrounded by hills and high points.
- Waihi Stream provides fresh water source
- The wharf dominates Waima Cove, and is a natural attraction, providing amazing vantages of Waima Cove and Tokomaru Bay.
- Heritage buildings/structures all in disrepair reminding of times gone by. The relationship between one another is being lost over time.

Figure 88 Waima Cove site analysis.  
Source: Author's Image

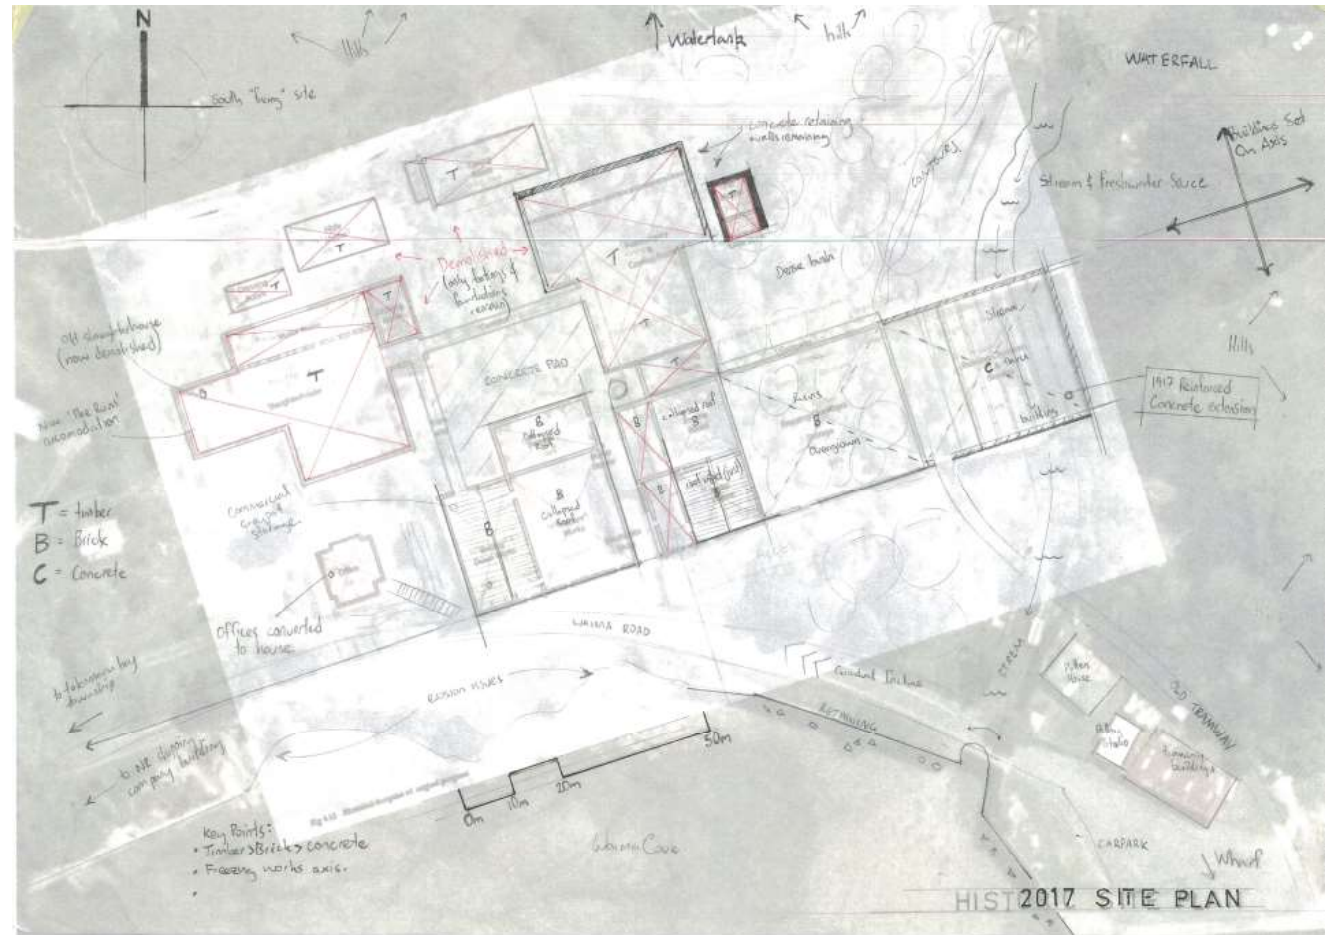
- Reinforced concrete extension over the stream is the most impressive part of the ruins, due to its sheer monumentality.

Figure 89 Tokomaru Bay site analysis (see appendix 1, 2).  
Source: Author's Image

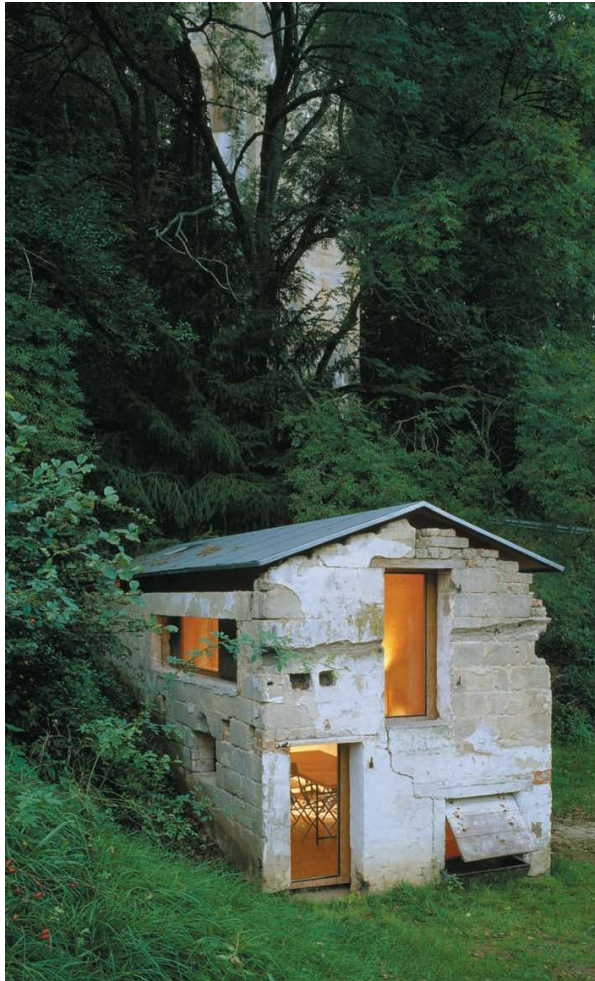
A humble design that captures the essence of this research. Built in the 18th century, damaged during WWII, and prior to its renovation, was being used as a pig sty (German for Schaustal). L.V.L has been delicately inserted within the existing masonry envelope. The adaptive reuse of this structure has enabled a new programme within the masonry building and serves its significant qualities.

Figure 107 S(ch)austal insertion.  
Source: FNP Architekten

Figure 107 S(ch)austal Insertion. FNP Architekten. Retrieved April 25, 2017 from <https://www.apartmenttherapy.com/schaustall-by-fnp-architekten-89439>

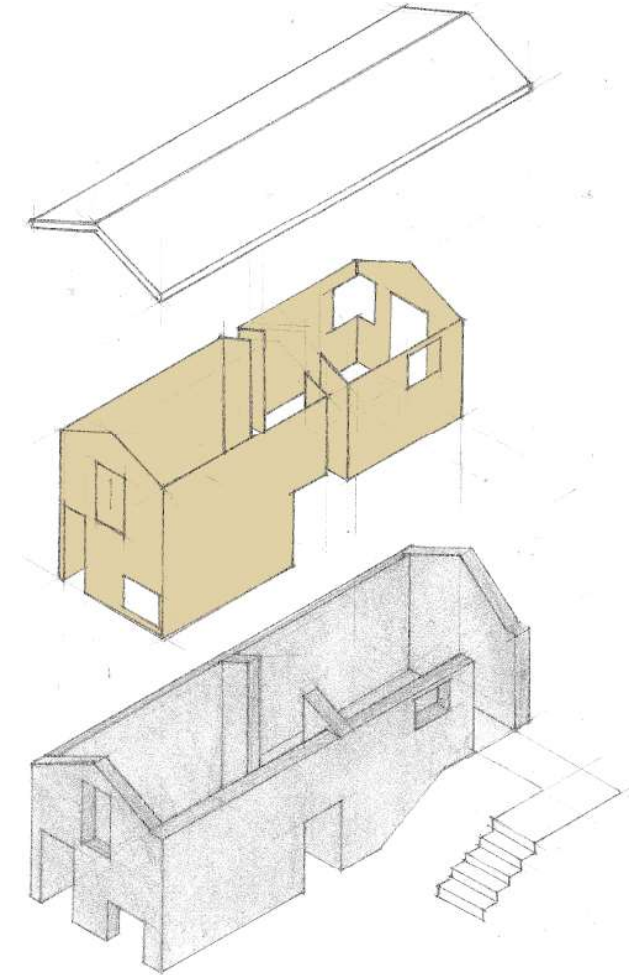
Figure 108 S(ch)austal exploded axonometric.  
Source: Author's Image

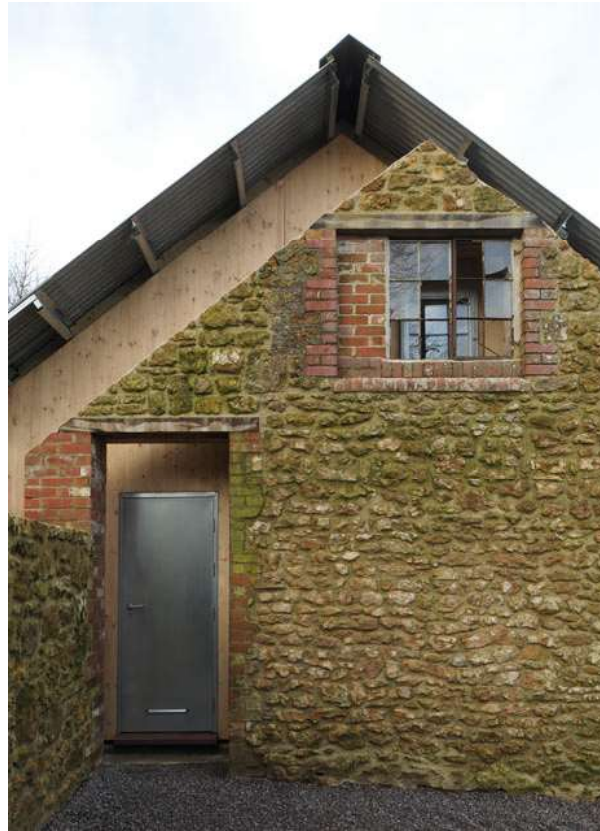
Constructed from C.L.T, the building has large roof overhang that makes up for the lack of exterior cladding.

Figure 111 Altered roof pitch between old and new.  
Source: James Pallister

Figure 111 Altered roof pitch between old and new. James Pallister. Retrieved April 25, 2017 from <https://www.dezeen.com/2014/03/05/hugh-strange-architects-archive-farmyard-barn/>

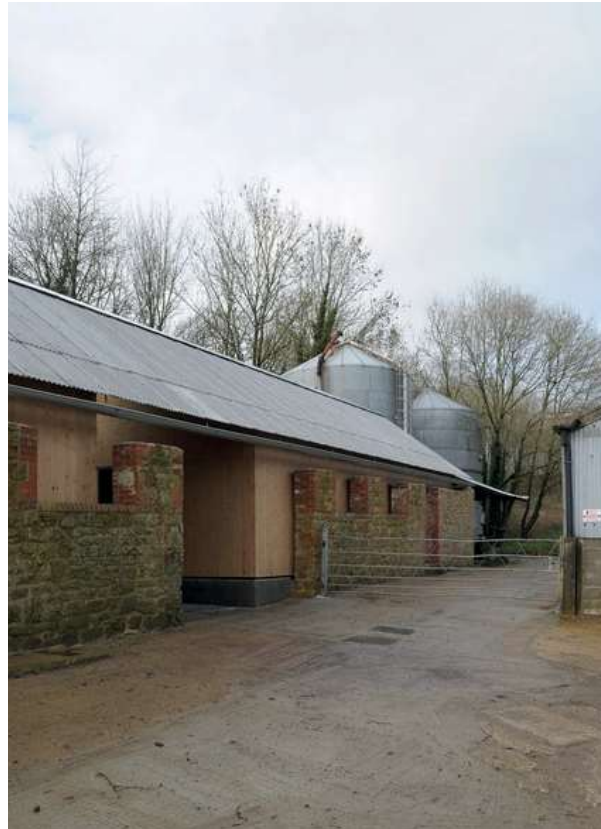
*Figure 113 New C.L.T is visible through existing U.R.M masonry.  
Source: James Pallister*

Figure 113 New C.L.T is visible through existing U.R.M masonry. James Pallister. Retrieved April 25, 2017 from <https://www.dezeen.com/2014/03/05/hugh-strange-architects-archive-farmyard-barn/>

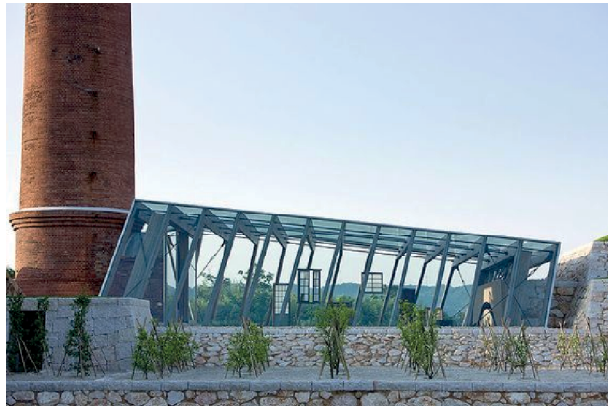
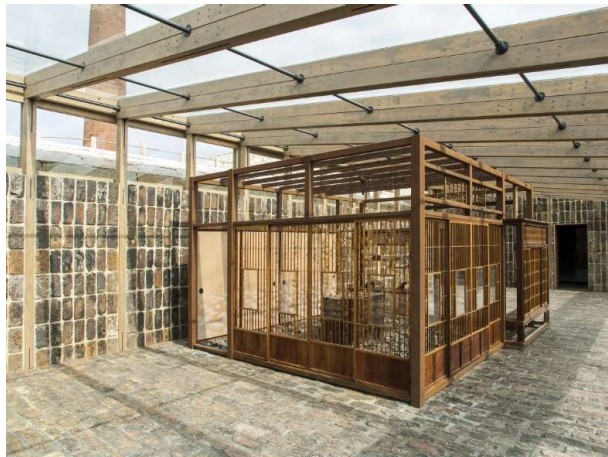
Figure 117 Angled glulam portal frames visible from exterior.  
Source: Alessio Guarino  
Figure 118 Light portal frames over heavy masonry.  
Source: Alessio Guarino.

Figure 117 Angled glulam portal frames visible from exterior. Alessio Guarino. Retrieved April 27, 2017 from <https://divisare.herokuapp.com/projects/365431-hiroshi-sambuichi-alessio-guarino-inujima-seirenscho-art-museum>

Figure 118 Light portal frames over heavy masonry. Alessio Guarino. Retrieved April 27, 2017 from <https://divisare.herokuapp.com/projects/365431-hiroshi-sambuichi-alessio-guarino-inujima-seirenscho-art-museum>

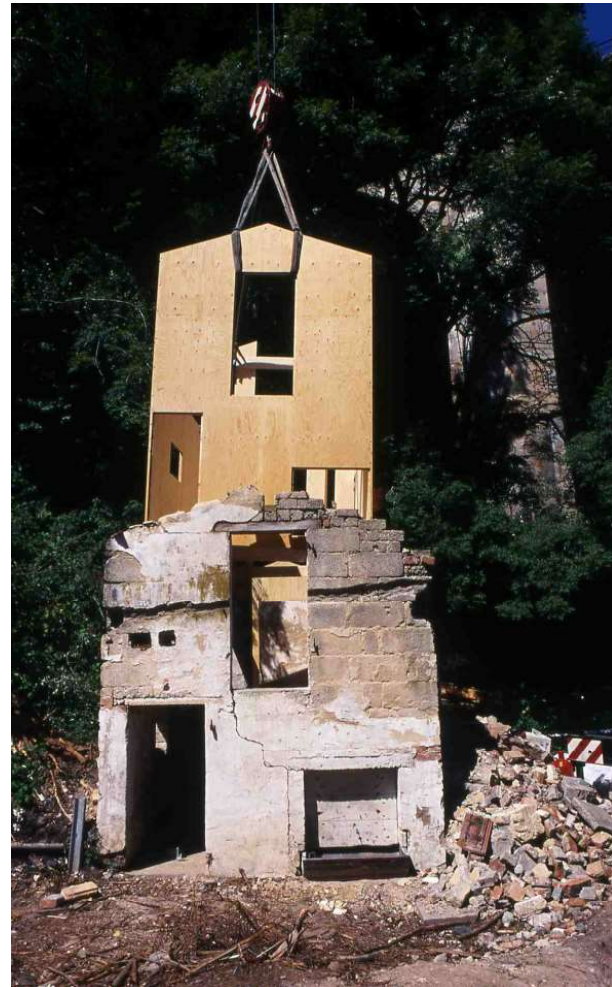
Figure 120 L.V.L. insertion into existing masonry shell.  
Source: Zoey Braun

Figure 120 L.V.L insertion into existing masonry shell. Zooey Braun. Retrieved April 25, 2017 from [http://www.tectonicablog.com/docs/tectonica\\_fnp\\_rehab%20red.pdf](http://www.tectonicablog.com/docs/tectonica_fnp_rehab%20red.pdf)

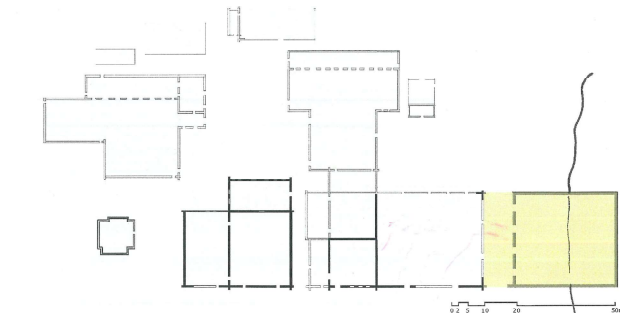
- Reinforced Concrete
- Structural damage from stream below.
- Most interesting part of site
- Poor access
- Risky
- Cost
- less visible from site
- Potential to leave as ruin

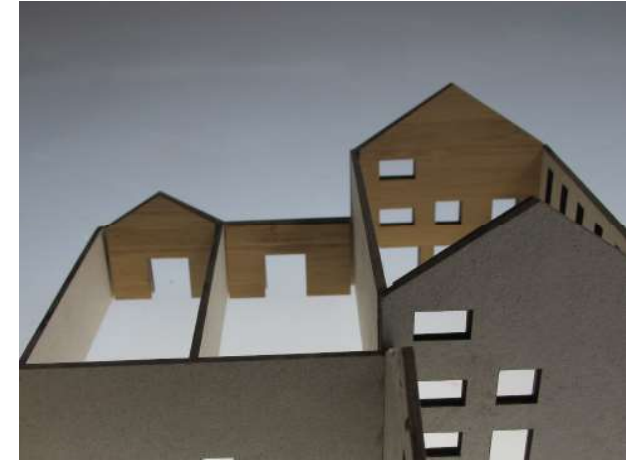
#### 2. Aligned Openings

Laminated timber openings are aligned with existing masonry openings to allow maximum permeability between inside and out.  
[design principle 4d].

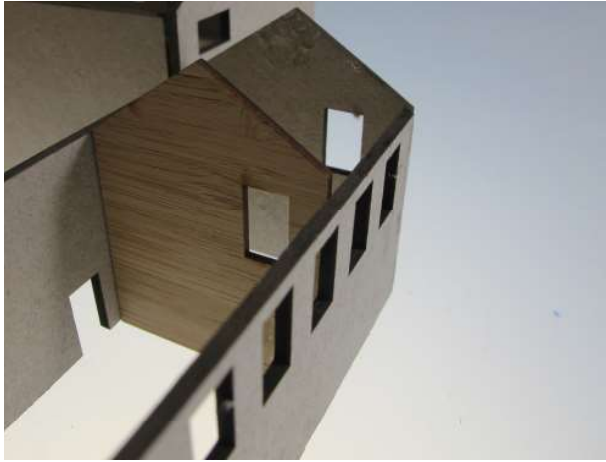
### 3. Aligned Walls

Rather than laminated timber and masonry wall being back to back, the C.L.T wall that replicates the existing masonry wall is set apart to create a usable space between the two materials.

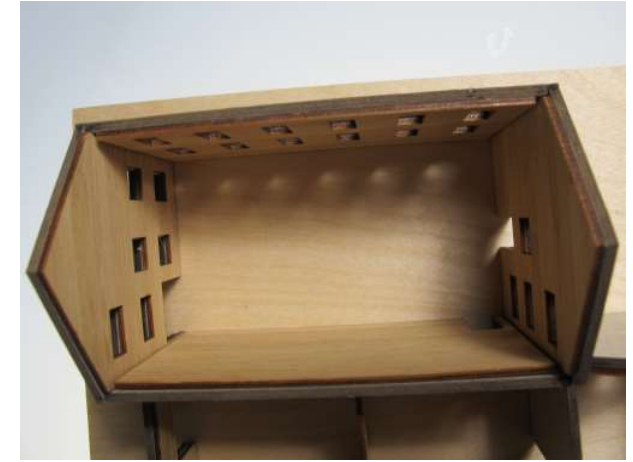
### 5. Insertion

Laminated timber inserted inside provides blank canvas for the new programme. By concealing all masonry from the interior it does not allow connection between old and new.

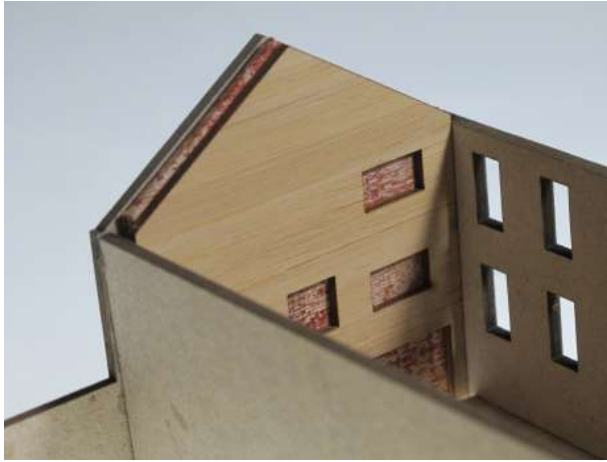
### 7. Visible Masonry

Openings are created through interior C.L.T panel to reveal existing masonry behind.  
[design principle 3d]

*Figure 160 Masonry visible through C.L.T opening.  
Source: Author's Image*

Figure 160 Masonry visible through C.L.T opening. Author's Image.

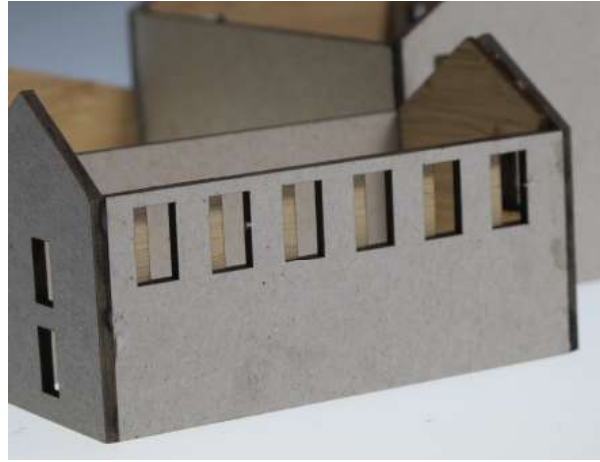
### 9. Offset Window Openings

Offset window openings allow laminated timber to be visible from the exterior, which hints at the building's adaptive reuse. On a small scale this is a delicate detail, on a larger scale it reduces permeability between inside and outside. This is similar to strategy 14 (offset door openings).  
[design principle 4d]

*Figure 162 C.L.T openings offset from masonry openings.  
Source: Author's Image*

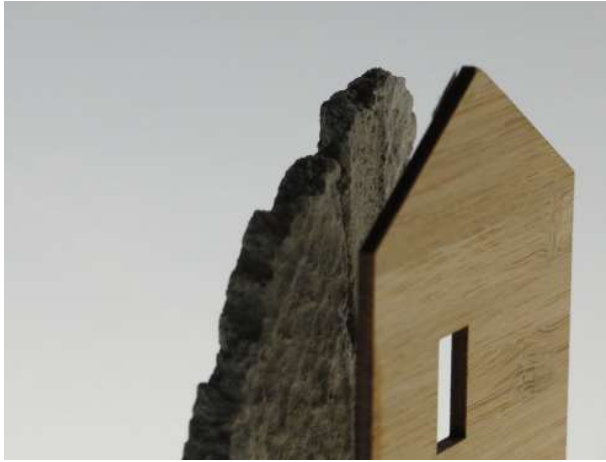
### 12. Masonry in Ruins

Areas of existing masonry can be left in ruins, to show the historical highs and lows of the site.

Figure 163 C.L.T panel next to masonry ruins.  
Source: Author's Image

Figure 163 C.L.T panel next to masonry ruins. Author's Image.

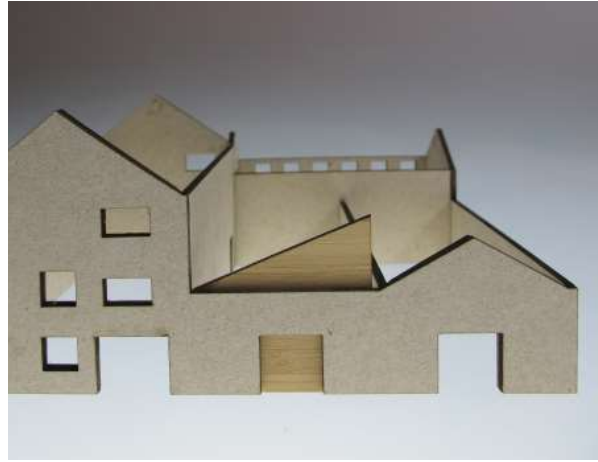
### 13. Offset Roof Pitch

A change in roof pitch to an existing building is introduced to differentiate what is new rather than replicating the original gable that has collapsed. This new geometry helps to create a new identity for the building.

Figure 164 Mono-pitch roof in place of existing gable.  
Source: Author's Image

Figure 164 Mono-pitch roof in place of existing gable. Author's Image.

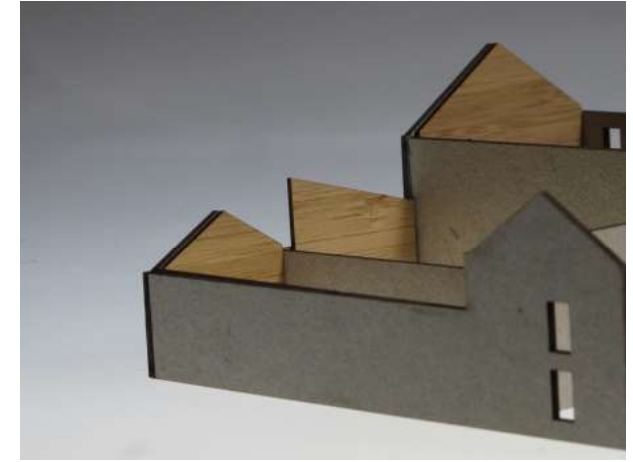
### 15. Light above Heavy

Laminated timber is projected above existing masonry to accentuate the old and new. The introduction of laminated timber to heritage building is reversible, incase change is needed in the future.

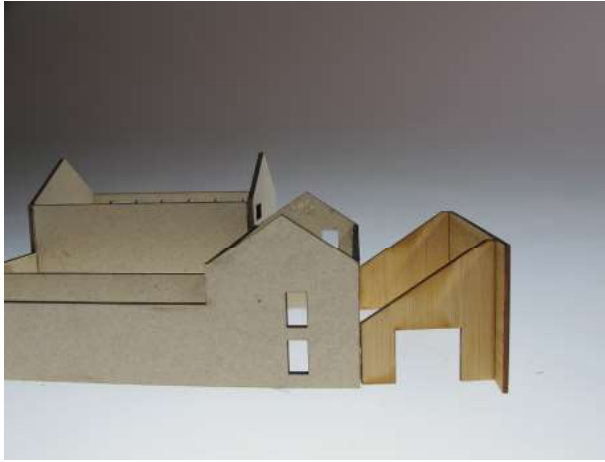
### 16. New Addition

Laminated timber addition is not trying to replicate or blend in with the existing masonry. Clear distinction between new and old is created. The new addition is located at the rear of the site to preserve the masonry facade on the street front.

*Figure 166 Laminated timber addition at rear of site.  
Source: Author's Image*

Figure 166 Laminated timber addition at rear of site. Author's Image.

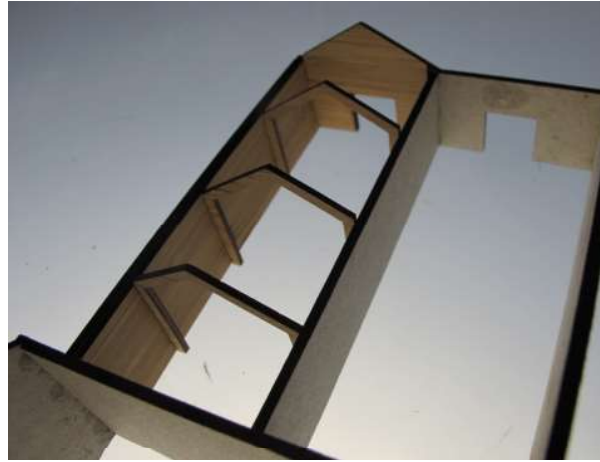
### 17. Laminated Timber as Structure

Laminated timber structural elements can serve the new build as well as strengthen the existing U.R.M. Structural elements can be expressed in the design.

*Figure 167 C.L.T inserted within masonry exterior walls.  
Source: Author's Image*

Figure 167 C.L.T inserted within masonry exterior walls. Author's Image.

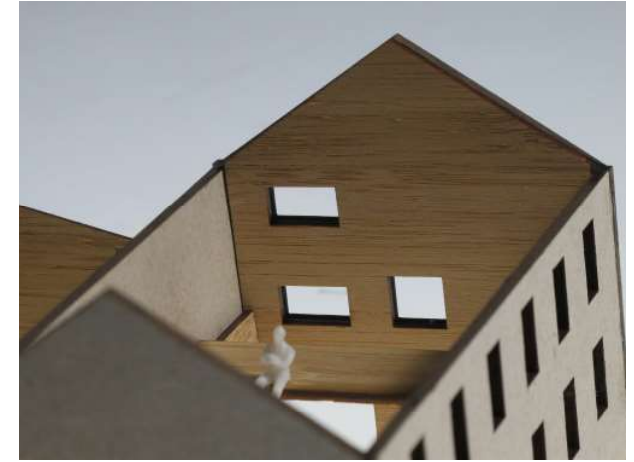
### 18. Change of Floor Height

Introduction of a new floor level reduces the scale of the interior from a large industrial area to a smaller, more habitable space. It also creates a separation of zones in the honey factory.

*Figure 168 Introduction of mezzanine floor level to reduce the industrial scale of the building and re-inhabit the space.  
Source: Author's Image*

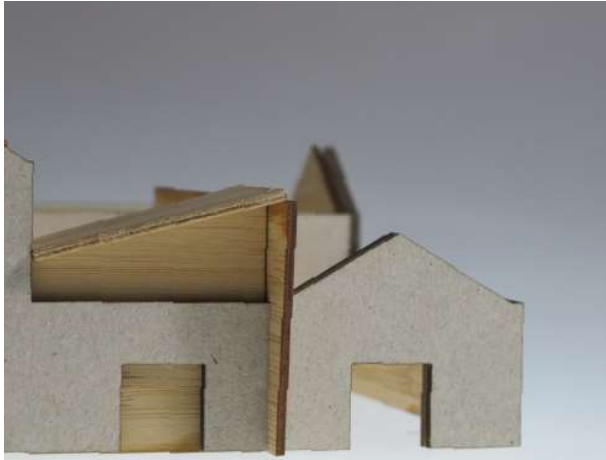
## 20. Introduce a New Geometry

Use of laminated timber on a geometry that is different from the traditional, rectilinear layout of industrial buildings with gable roofs. By introducing this new form it distinguishes the new and old from each other.  
[design principle 1a]

Figure 169 Geometry introduced into existing rectilinear grid.  
Source: Author's Image

Figure 169 Geometry introduced into existing rectilinear grid. Author's Image.

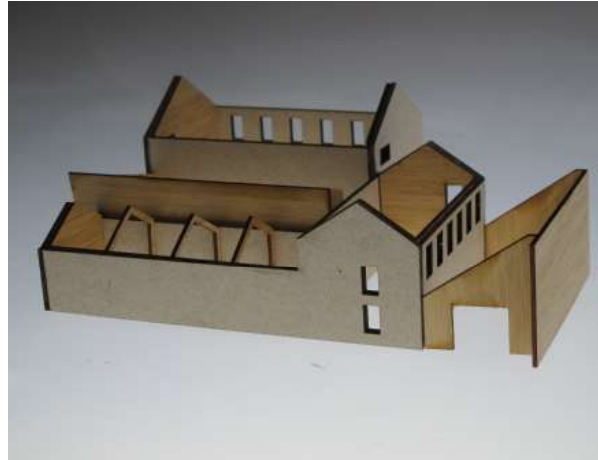
## Integrated Strategies

A range of design strategies using laminated timber are combined to develop an integrated response within the selected masonry building.

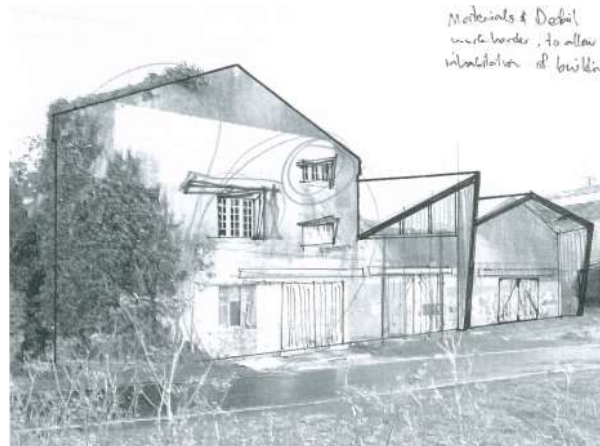
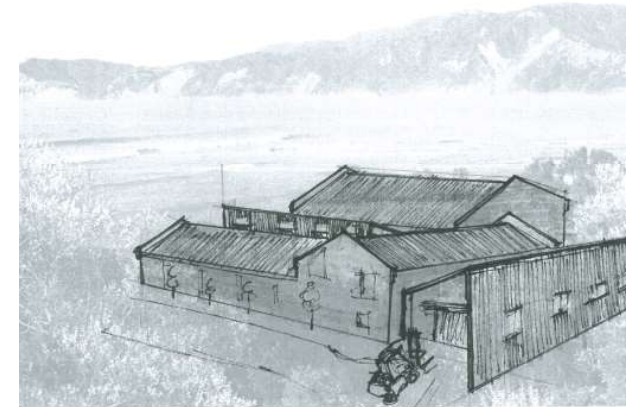
From the approach of the main road, the first thing people will see is the laminated timber shard protruding from the main facade of the building, drawing attention to the honey factory.

Figure 175 (top left) Front of factory with two protrusions.  
Source: Authors Image

Figure 176 (top right) Rear of factory with new addition.  
Source: Authors Image
