# Flight of the Factory

Design guidelines for the use of laminated  
timber in the adaptive reuse of unreinforced  
masonry industrial heritage buildings in rural  
New Zealand

A thesis  
submitted to the Victoria University of Wellington  
in fulfilment of the requirements for the  
Masters of Architecture (Professional)

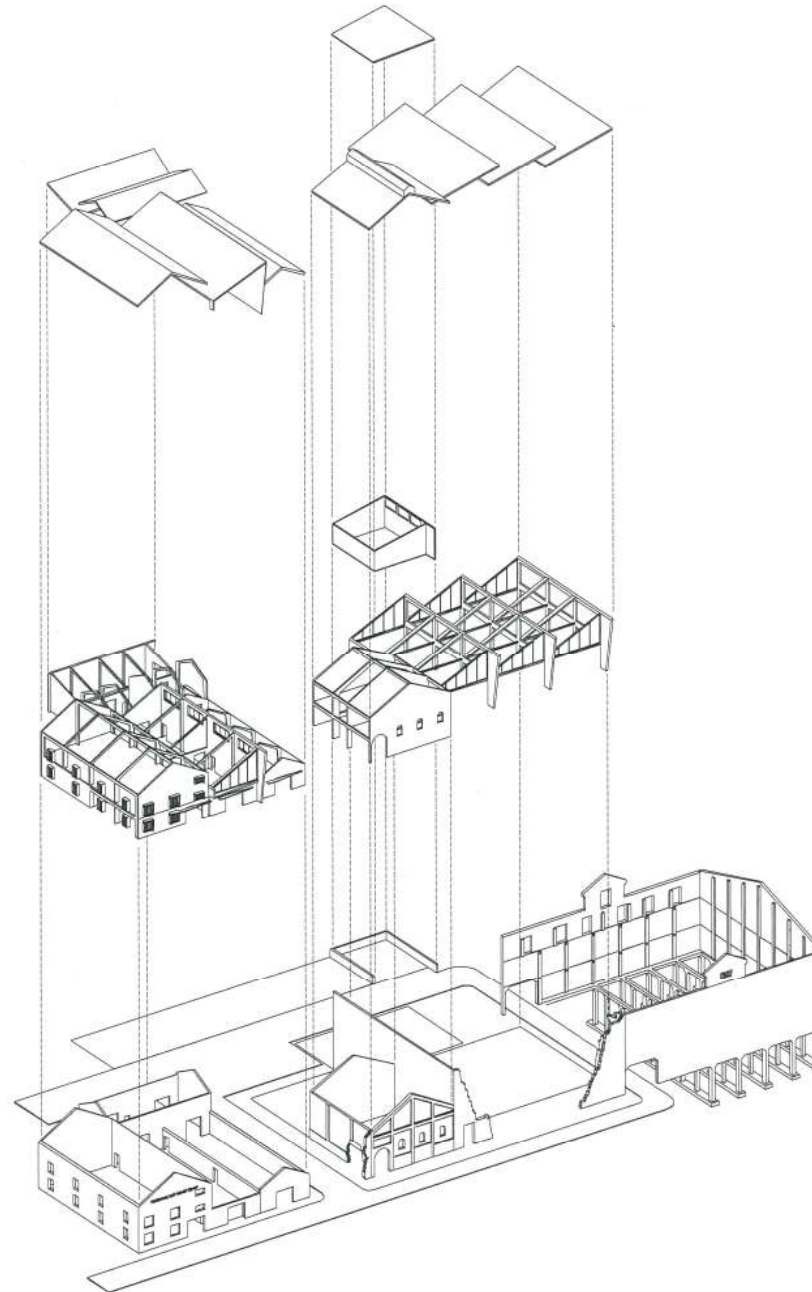
The structural laminated timber members are set out on a grid that aligns with the masonry walls and original floor plan. The large spans allowed by laminated timber means that floor plans can remain uninterrupted allowing large open space for the honey programme.

Figure 180 Exploded axonometric showing existing masonry, structural laminated timber and roof.  
Source: Authors Image

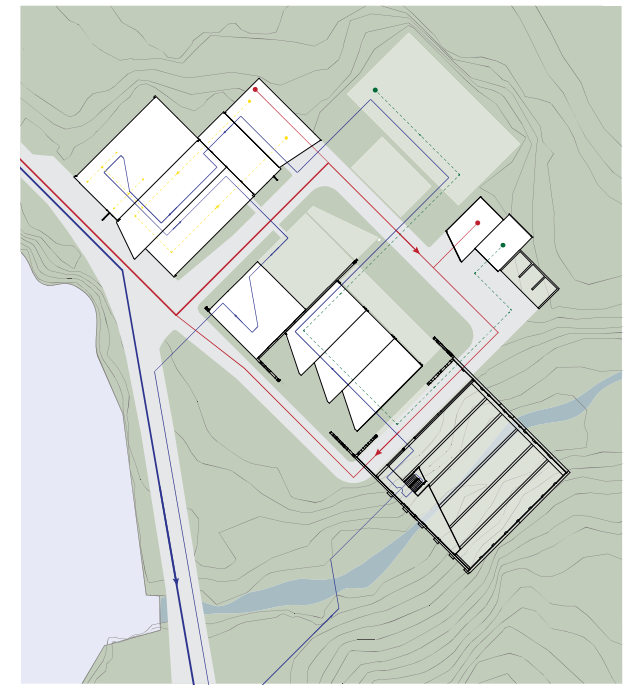
## Circulation

- PRIVATE VEHICLES
- HONEY PRODUCTION
- MANUKA PRODUCTION
- PUBLIC VEHICLES
- VISITORS TOUR

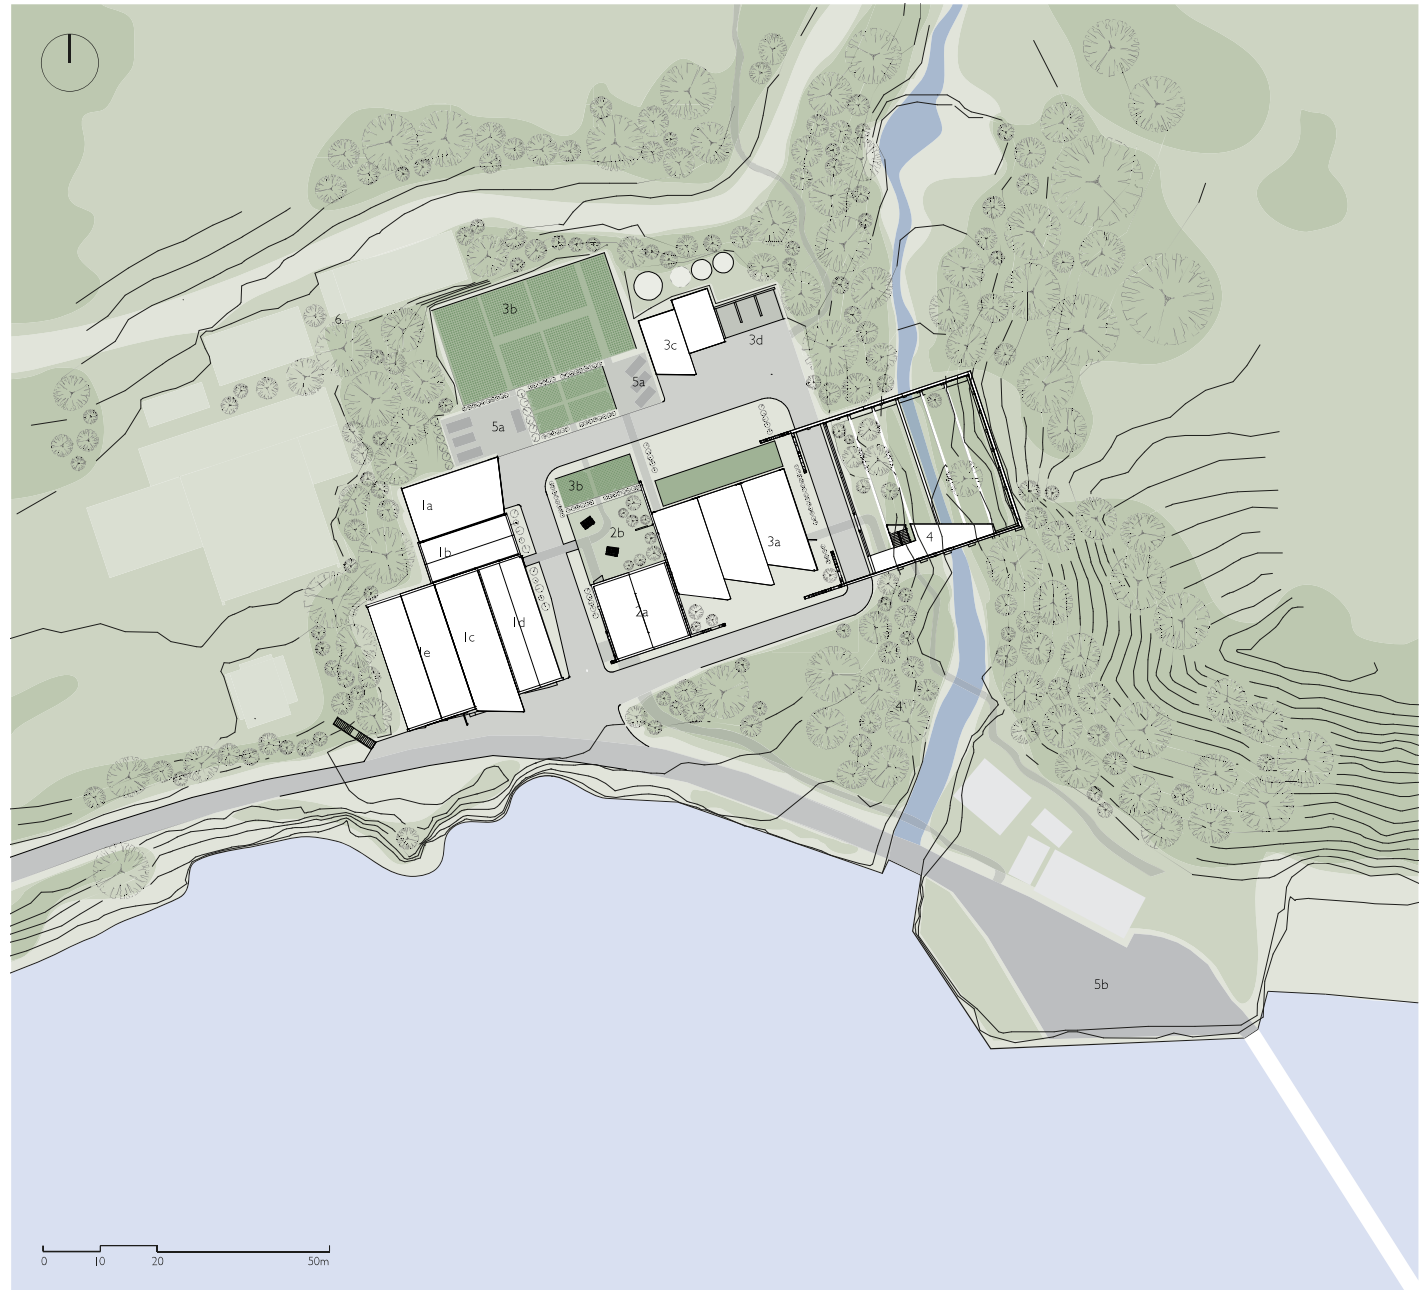
The site plan shows the proposed development for the Tokomaru Bay Honey Co-operative. The varying condition of existing buildings contributed to their new function in the final design. Four distinct zones make up the final design for the honey co-operative:

*Figure 191 Tokomaru Bay Honey Co-operative site plan.  
Source: Author's Image*

Four distinct zones make up the final design for the honey co-operative. The honey factory and visitors centre are in the most intact buildings. The Mānuka nursery is located on former building platforms of demolished buildings. The fourth zone is the remains of the freezing works over the stream, which will be left to decay over time.

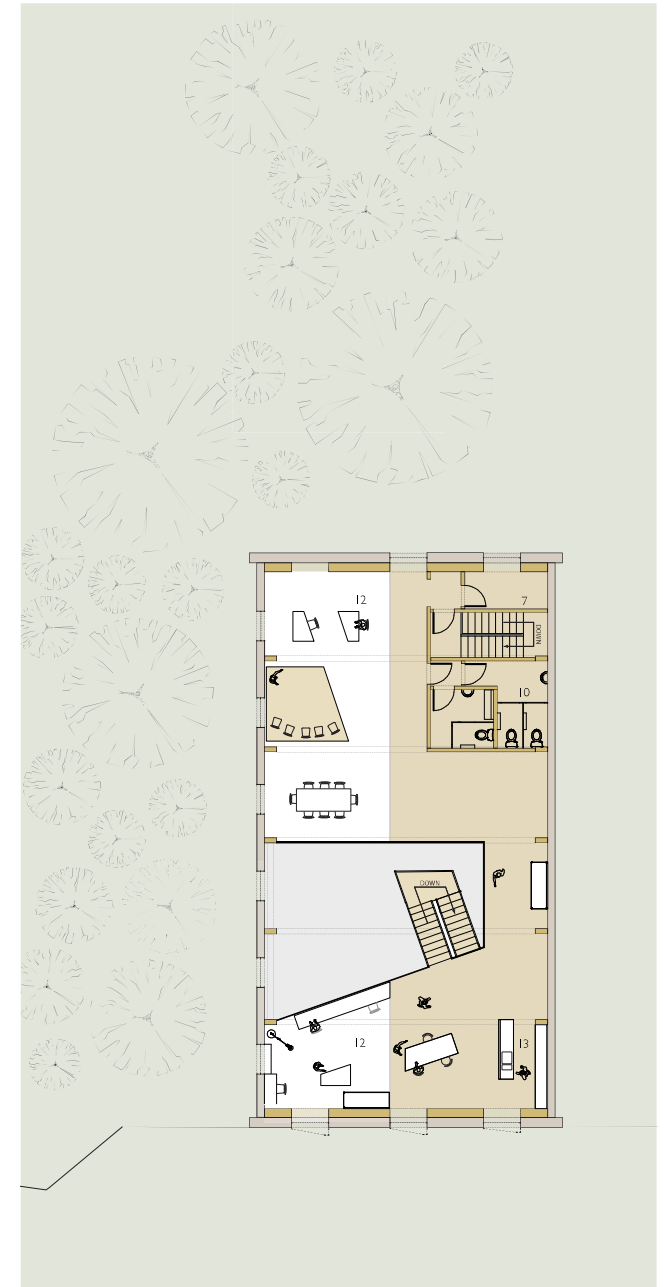
*Figure 194 (far right) Honey factory, ground floor plan.*

The entire factory is housed within the masonry footprint of the existing building except for the loading bay, which is a new building. This allows for a large opening that enables trucks and forklifts to enter the building and removes the need for irreversible damage by creating a large opening in the existing buildings.

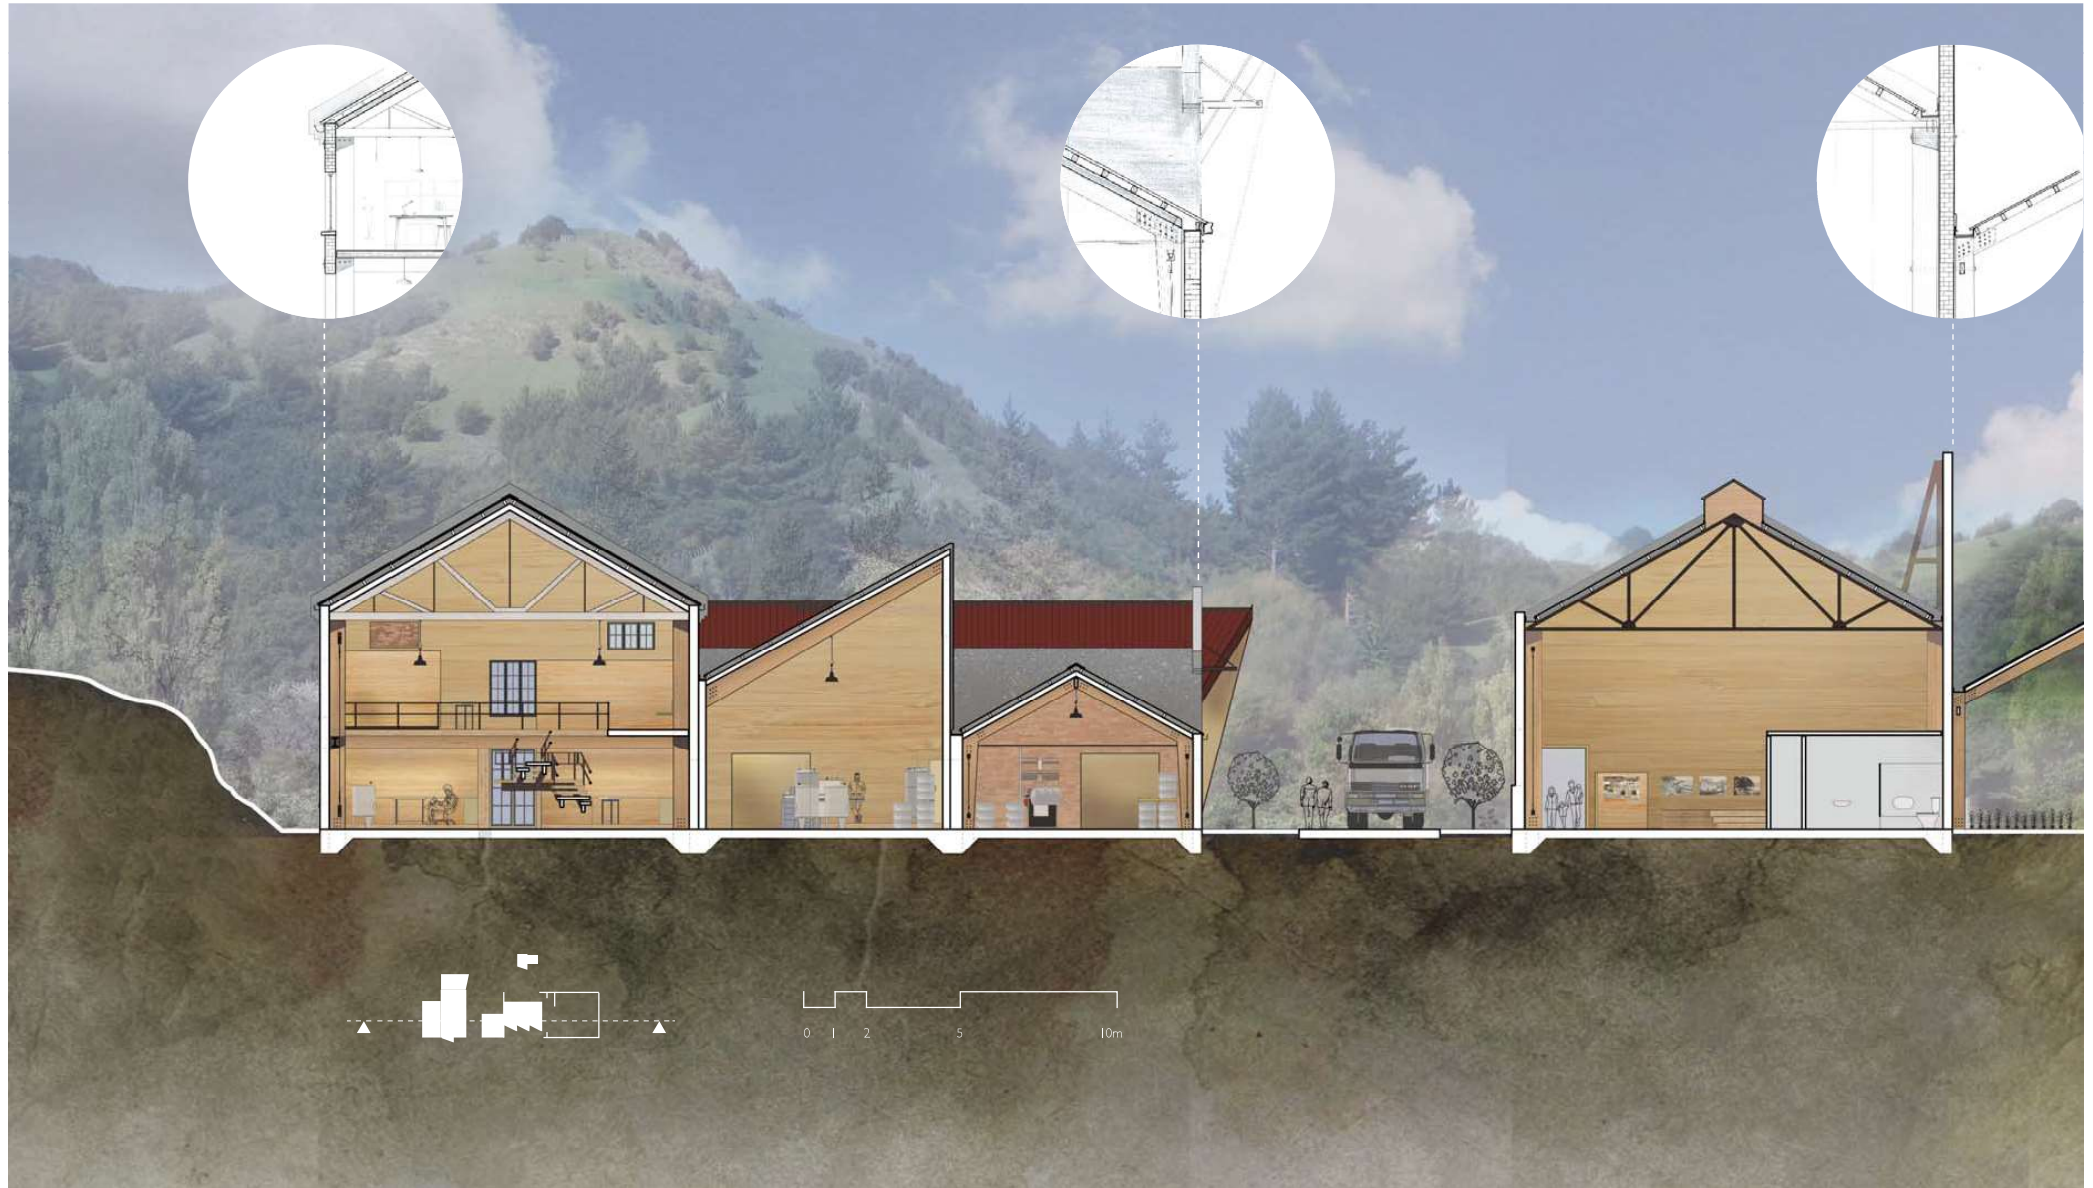
Figure 195 Long section through honey factory, visitors centre, nursery and ruins.  
Source: Author's Image

(refer figures 202, 203, 204 for larger details)

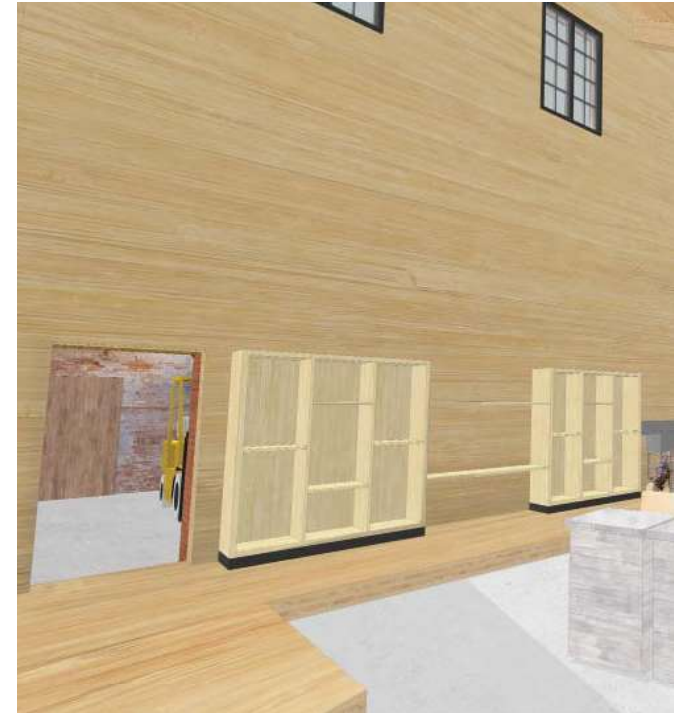
Figure 200 Honey extraction room.  
Source: Author's Image

C.L.T panels in the honey extraction room create a controlled environment. However, they do create large flat walls (see figure 210), which is good from a functional sense, but the architectural result is uninspiring and sanitised. Use of portal frames to break up the sameness of the walls would have made this space more appealing to inhabit.

Figure 200 Honey extraction room. Author's Image.

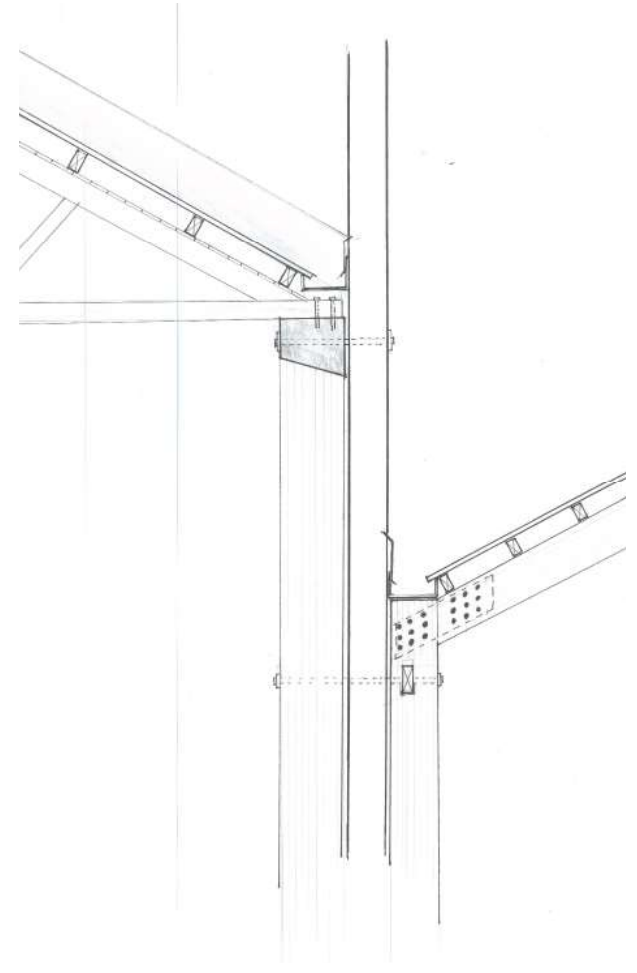
Figure 203 Glulam beam to existing roof truss on left of U.R.M wall. Internal gutter above portal frame on right of U.R.M wall.  
Source: Author's Image

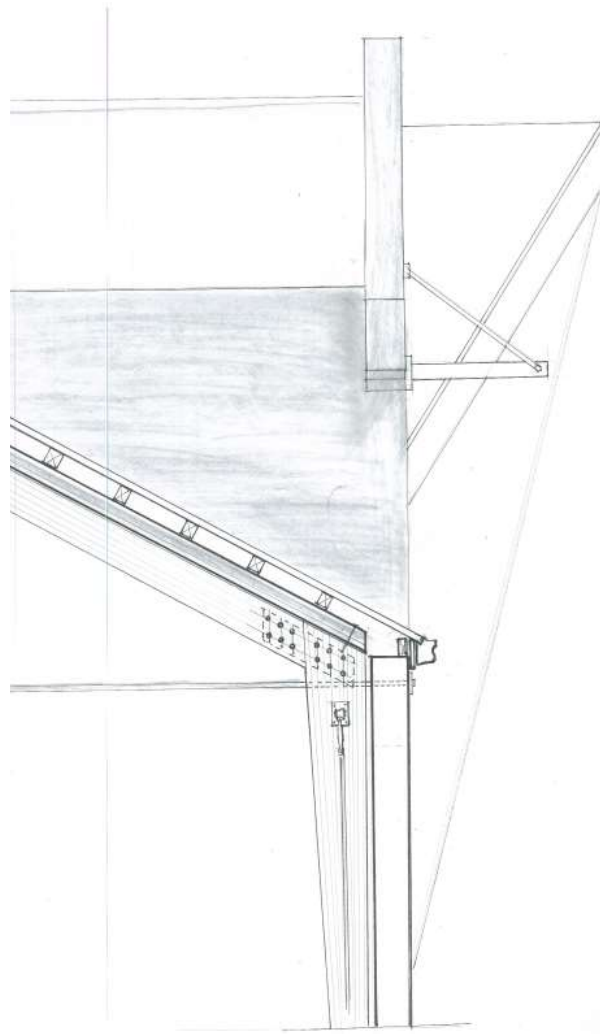
*Figure 204 Glulam frame with C.L.T. roof diaphragm next to single storey U.R.M wall.  
Source: Author's Image*

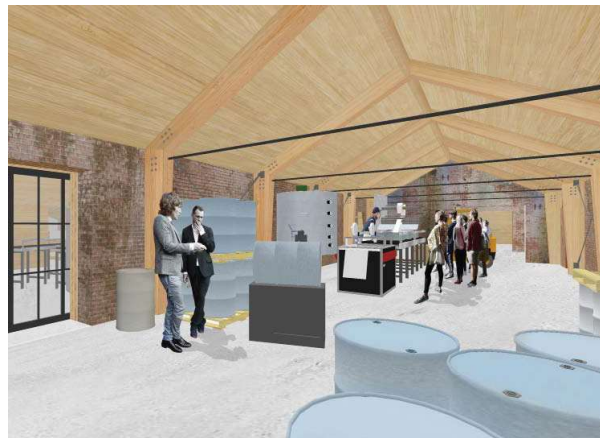
No irreversible changes to the existing heritage ruins have been proposed. As laminated timber is inserted within the existing ruins, it can just as easily be removed in the future if need be.

Figure 208 Existing masonry is visible between portal frames.  
Source: Author's Image

Figure 208 Existing masonry is visible between portal frames. Author's Image.

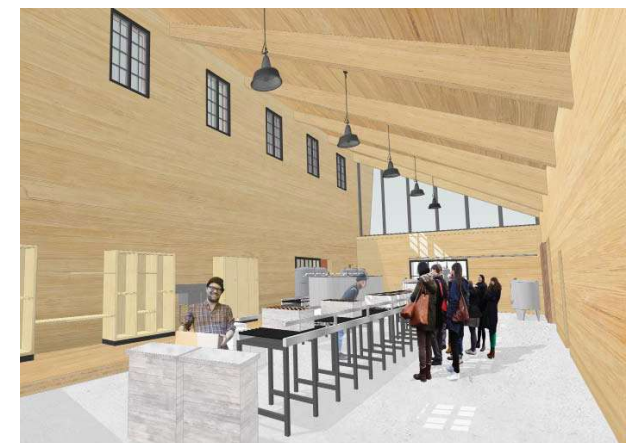
High windows that allow daylight into the building have been included where possible. Clerestory lights, orientated away from the north were used instead of skylights which would have let direct sunlight.

Figure 210 High windows allow day light into internal spaces.  
Source: Author's Image

Figure 210 High windows allow day light into internal spaces. Author's Image.

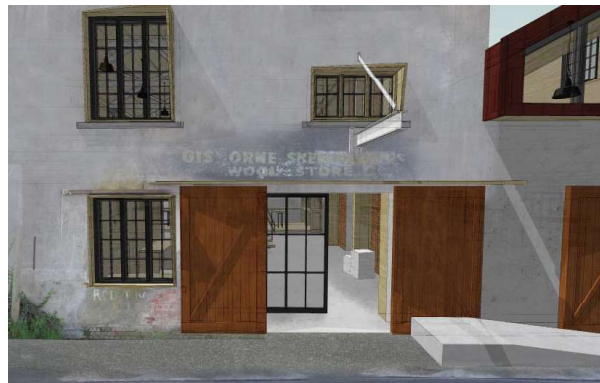
Large barn style sliding doors have been included to keep the honey factory secure outside of business hours. This enables the facility to be locked down.

Figure 211 Openings that impact user interaction between inside and out.

Figure 211 Openings that impact user interaction between inside and out.

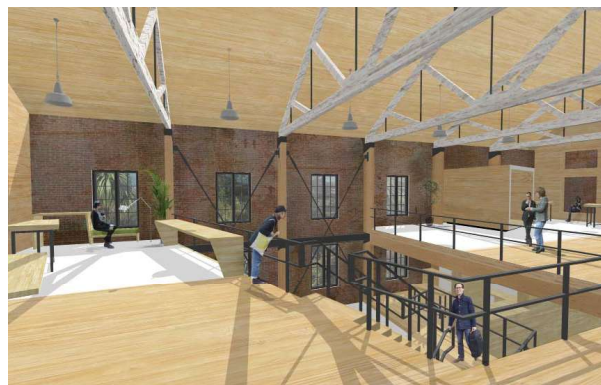
Figure 212 Laminated timber enabling new program to occur.  
Source: Author's Image

Figure 212 Laminated timber enabling new program to occur.
