Associations of house characteristics with indoor dampness and measured moisture: Results from three New Zealand House Condition Surveys in 2005, 2010 and 2015

Phoebe Taptiklis^{a,b,*}, Robyn Phipps^c, Mark Jones^d, Jeroen Douwes^a

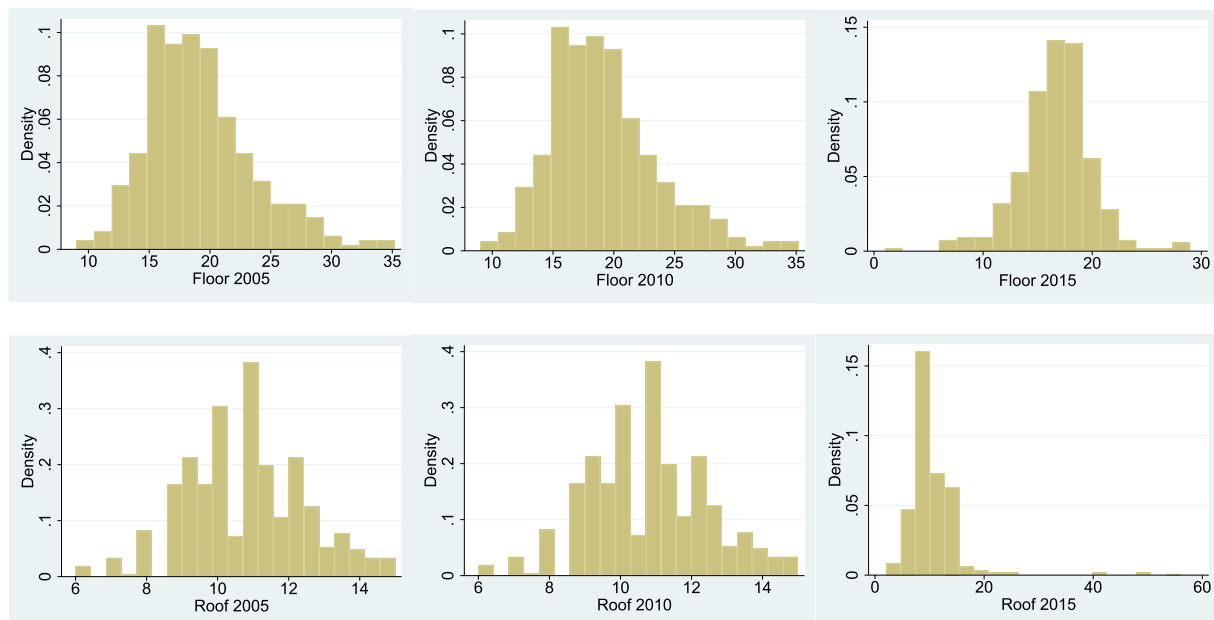
Fig. 1. Histograms showing moisture content in floor and ceiling joists.

Subjective dampness was reported most frequently in 2010 (26%), compared to 12% in 2005, and 15% in 2015. Roof moisture and 30-day rainfall was also highest in 2010 (Table 1). In contrast, floor joist moisture was highest in the 2005 survey (19.2% moisture content (MC)) compared to approximately 16.5% MC for the two later surveys. Histograms demonstrating the range of moisture measurements are presented in Fig. 1.
