The Structural Reuse of *Pinus Radiata* in New Zealand

A 120 point thesis submitted to
Victoria University of Wellington
In fulfilment of the requirements
Of a Masters of Building Science (MBS)

2018

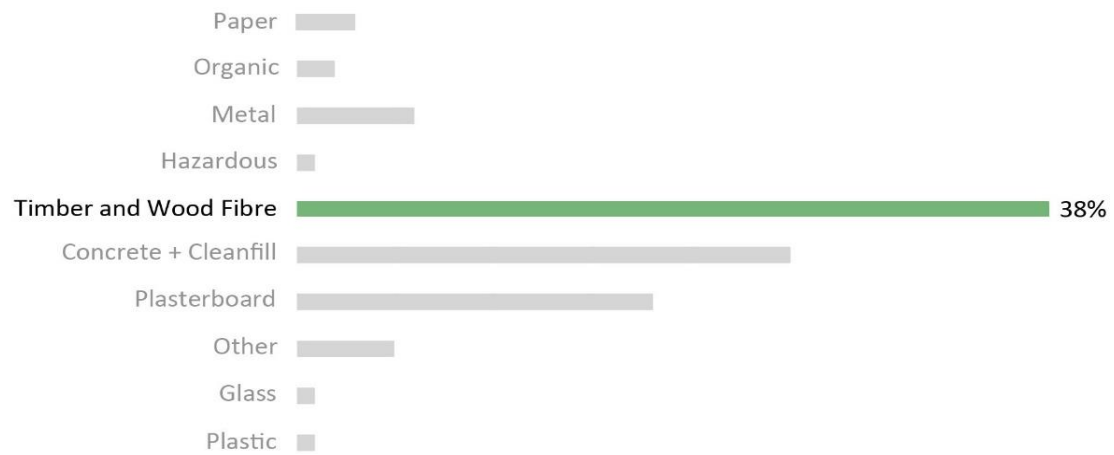
Figure 2 C&DW Composition (Authors Own) Based on (Inglis, 2009)

CCA timber is also one of the largest components of landfill waste (Figure 1). Therefore reducing the amount of treated timber going to landfill will, in turn, reduce landfill waste and chemical accumulation by the largest amount.

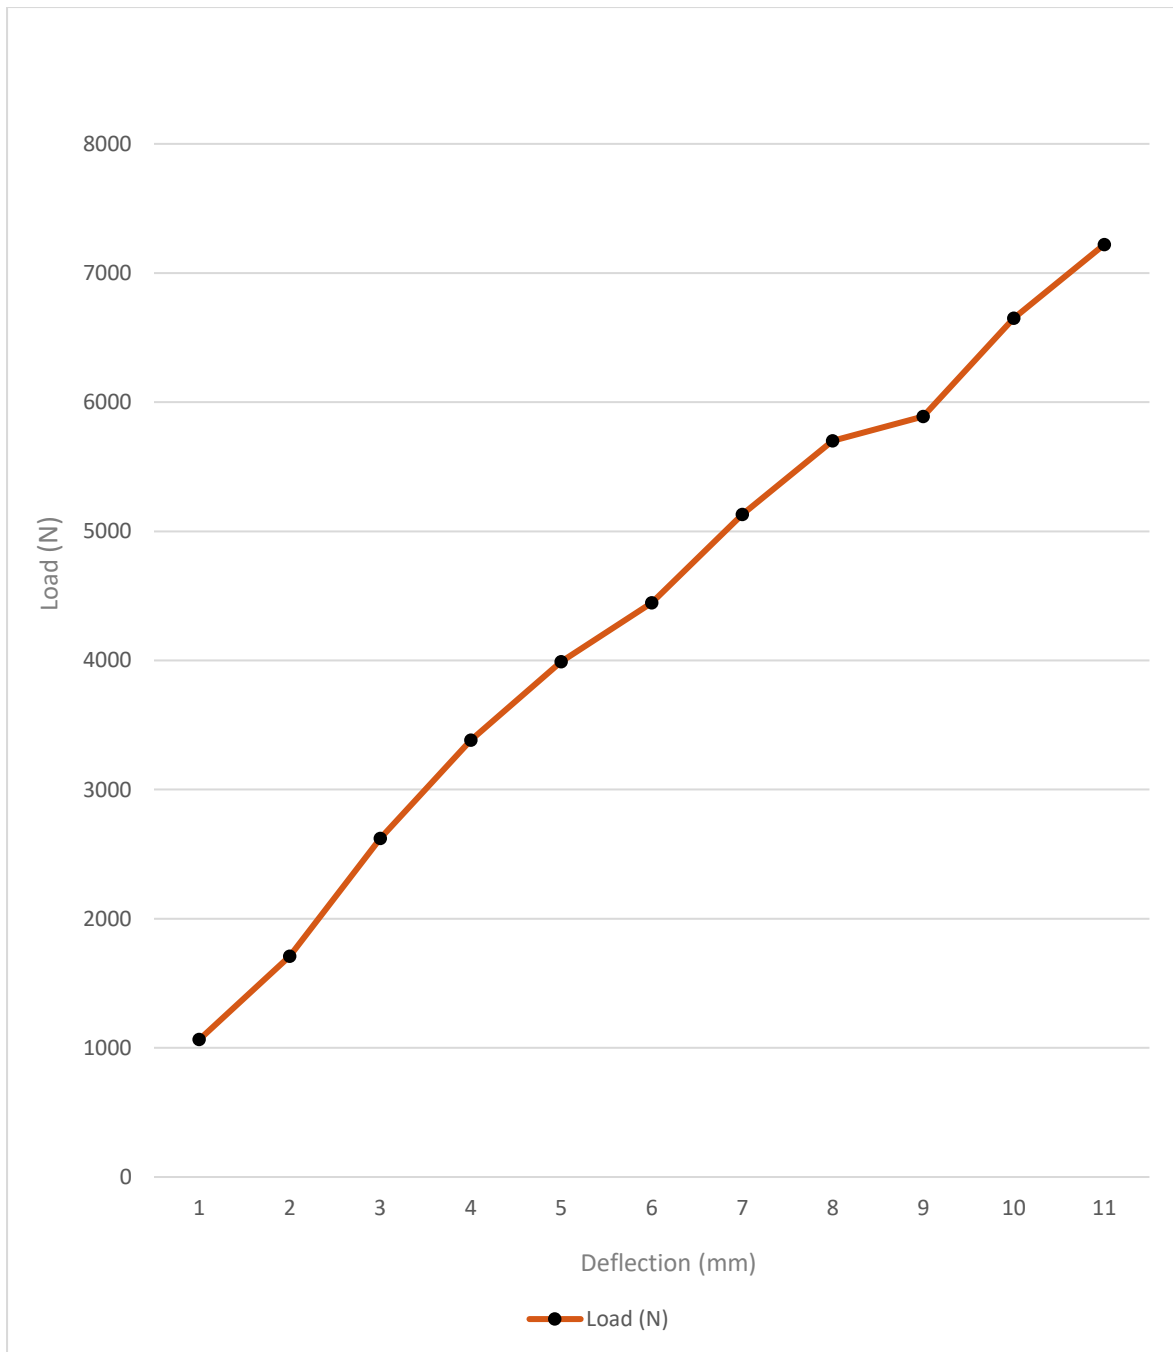
Figure 6 Load vs. Deflection, Constructed from Table 14

Provided all inserted numbers are accurate, the solution will be calculated. But to accomplish accurately this must be calculated at three point's minimum along the bending strength line shown in the graph below Figure 5.

This has been calculated at three points, the mean can be used as Young's Modulus of Elasticity. This was done through the first stage of testing, and with this information it is clear to see that there is a trend line across the graph. Thus enforcing the Young modulus of elasticity, and allow this thesis to move forward into the next stage.

In this equation the force acting is multiply by the spanning length which has been cubed. All of this is then divided by the inertia calculation, which is then multiply by the deflection and a constant force of 1000. Doing this gives the final figure, which is the Young's modulus of elasticity, a crucial point in finding the materials overall strength.

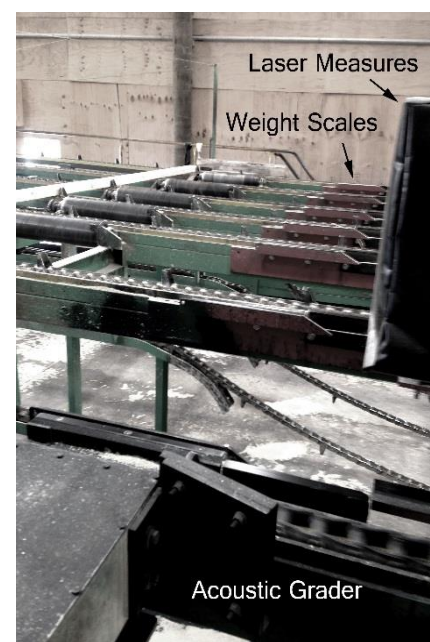
Figure 9 Crichton Mill Acoustic Grader

Once at the mill a tour was conducted on the different technologies operating around the shed, such as the hydraulic saw, responsible for sawing down the logs into workable sizes for industry. The boards then passed through a set of lasers which record the size, weight and length of each member. This information could then be coupled with the grading technology of the Acoustic grader Figure 8.

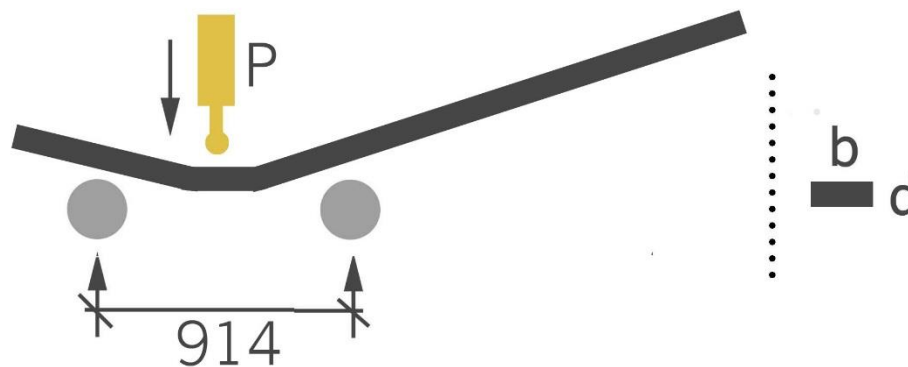
Figure 10 Constant load(authors own) based on (NZ Wood, 2007)

The three point bending test requires three separate points of contact to operate with meaningful results. This can be taken from the Plessey Computermatic, the Eldeco Dart, Metriguard Continuous Lumber Tester, and the Cook-Bolinder Grader machines, all of which work by running timber members through a set of weight inducing points, which relay the appropriate deflection.

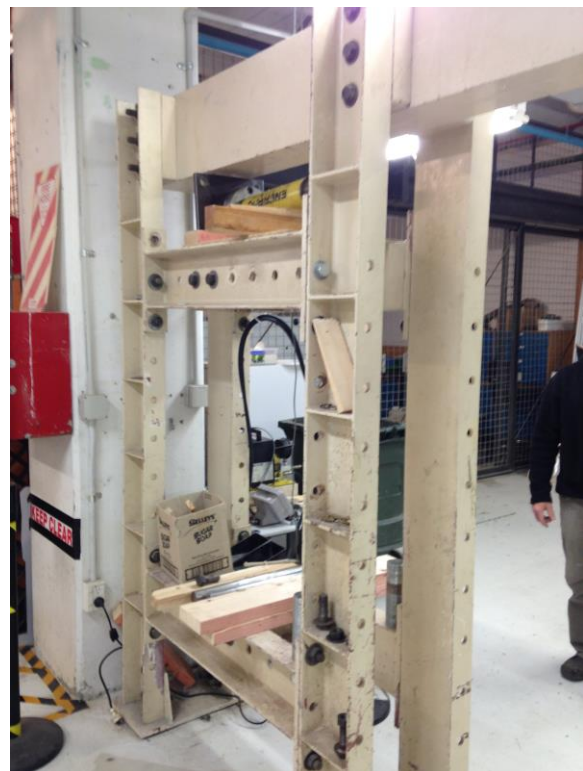
Figure 11 Location for New Rig

The main problem presented from the calibration stage was human interaction with the hydraulic ram. This generated results which were slightly different from what the Acoustics determined. To fix this problem, the rig was upgraded to one which worked from a machine.

The most problematic component of the pressure system has been the operators input. Removing this allows for a more consistent overlap, with how codes and compliance measure timber (New Zealand Government, 1990). Thus allow for more accurate test to be conducted, along with the increased ram size. Which intern allow for larger members to be tested, and therefore less issues with the picking-up of samples.

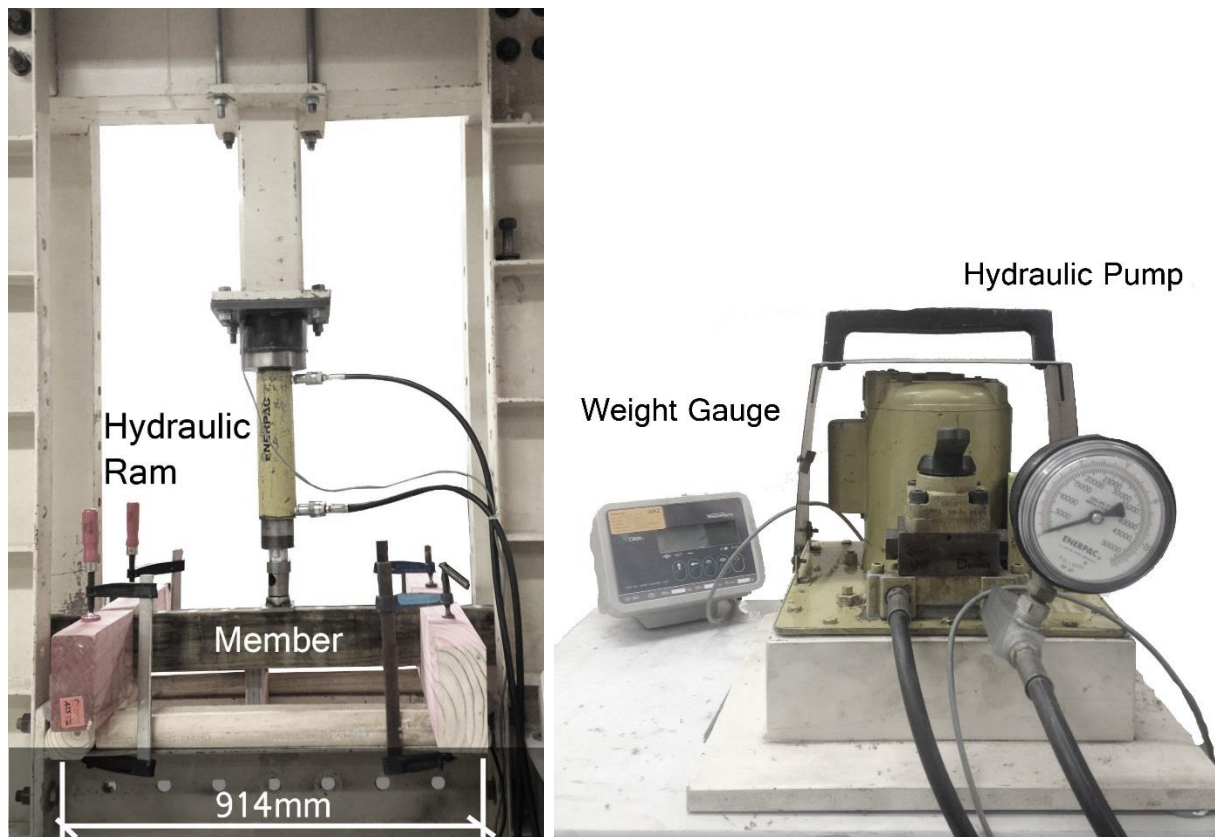
Figure 12 Hydraulic ram and Pressure gauge

This solution changed the recording of the load information, as due to the load cell, it is measured in kilograms. This leaves a situation where the calculation required to convert hydraulic pressure into load is not required, streamlining the process.

Continuing on with the above paragraphs, shown in Figure 11, it can be seen how this rig will function. The distance has been set in accordance with the Plessey Computermatic, and the Eldeco Dart system at 914mm. The reason for the 914mm span, is due to it being converted over from the imperial system, but not wanting to lose all previous testing results. 914mm centre are kept (refer to previous imperial measurement of 3 feet). This enable direct comparison to these test, as this system is used in the sample checking of modern assessments (NZ Wood, 2007).

The research involves the use of a three point hydraulic system Figure 4. This is represented through a hydraulic pressure gauge which reads the kilogram pressure being displaced through the hydraulic ram. This multiplied with the area of the ram gives the force acting on the member.

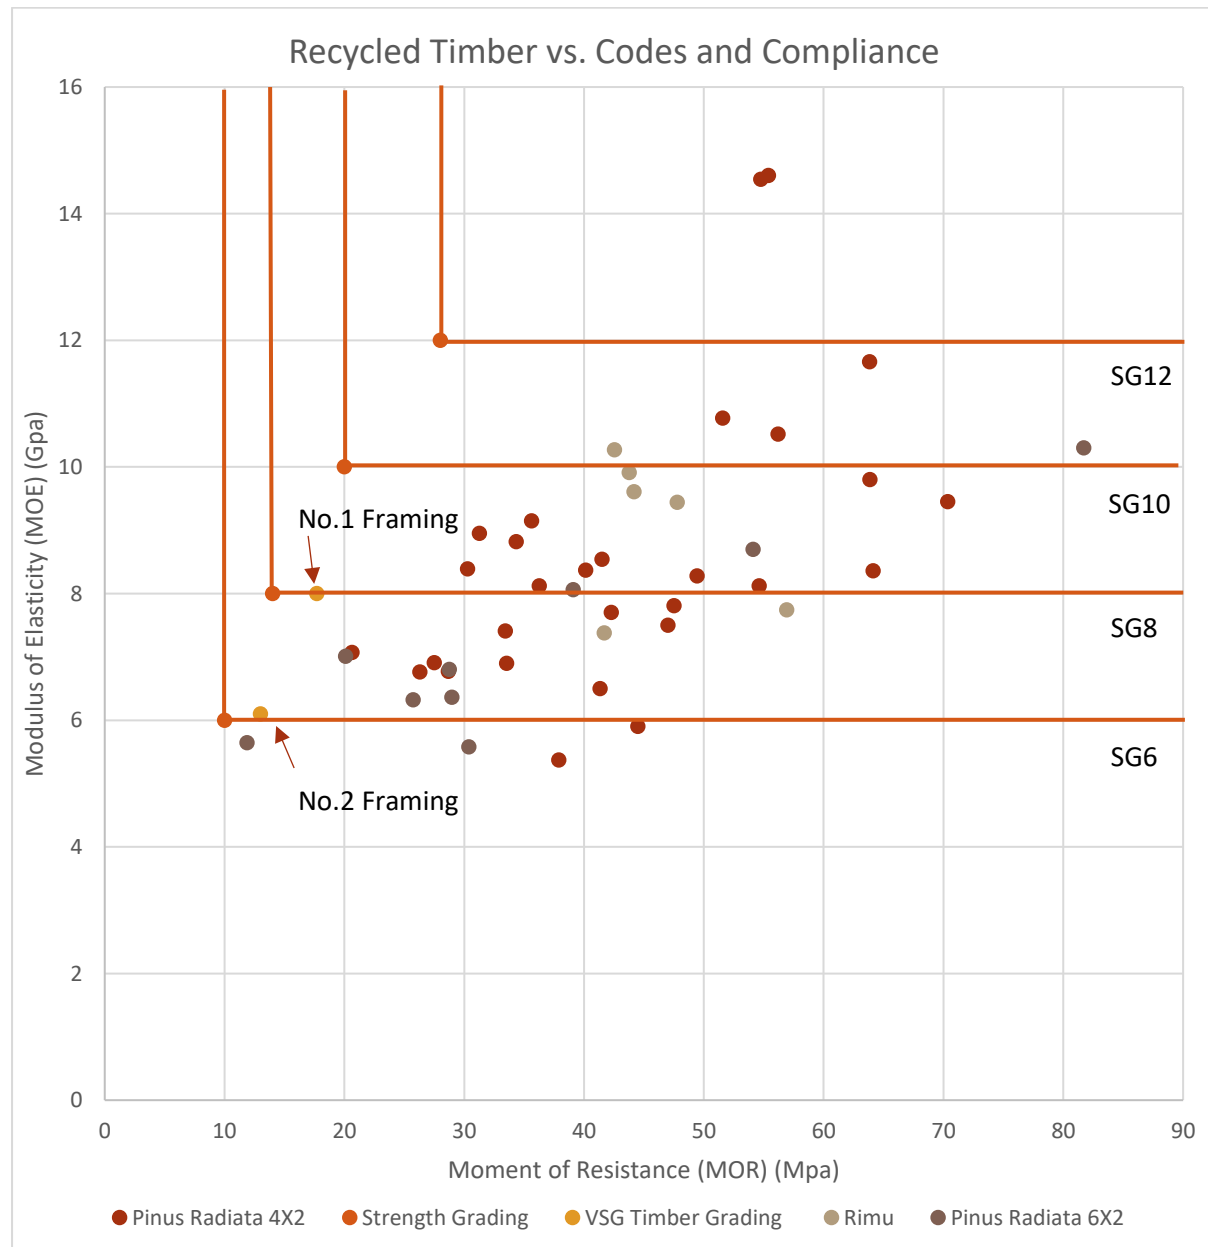
Figure 14 Test results Layout

The above graph is the first outline to understanding the results set out by the three point testing machine. In this graph it is clear to see that the *Pinus* 4x2 and 6x2 are the large plotting, as shown in the colour red and dark green, whilst the Rimu members are plotted in light grey. All of these are mapped against the framing standards, which have been highlighted in orange, making them the focus

As explained in previous sections VSG's grading rules run around Timber Framing grades of 1 and 2. These two grades run along the lowest SG rules, of 6 and 8 as displayed in the above Figure 146. This again is on the bottom two grading rules and again is met by a number of the test subjects.

From this it is clear to see that the reusable timber is almost all over the lower quartile of grading standards, which as the samples were picked based on their visual features. Features which both hinder and helped the material, allow the spectrum to be as broad as possible.

Over the course of the testing each member has performed itself towards the strength grading criteria. This direct comparison shows in Figure 14 that 91% of all results were within the strength grade requirements, with 55% of those being within the SG8 area, which is the most used strength grade that is sold.

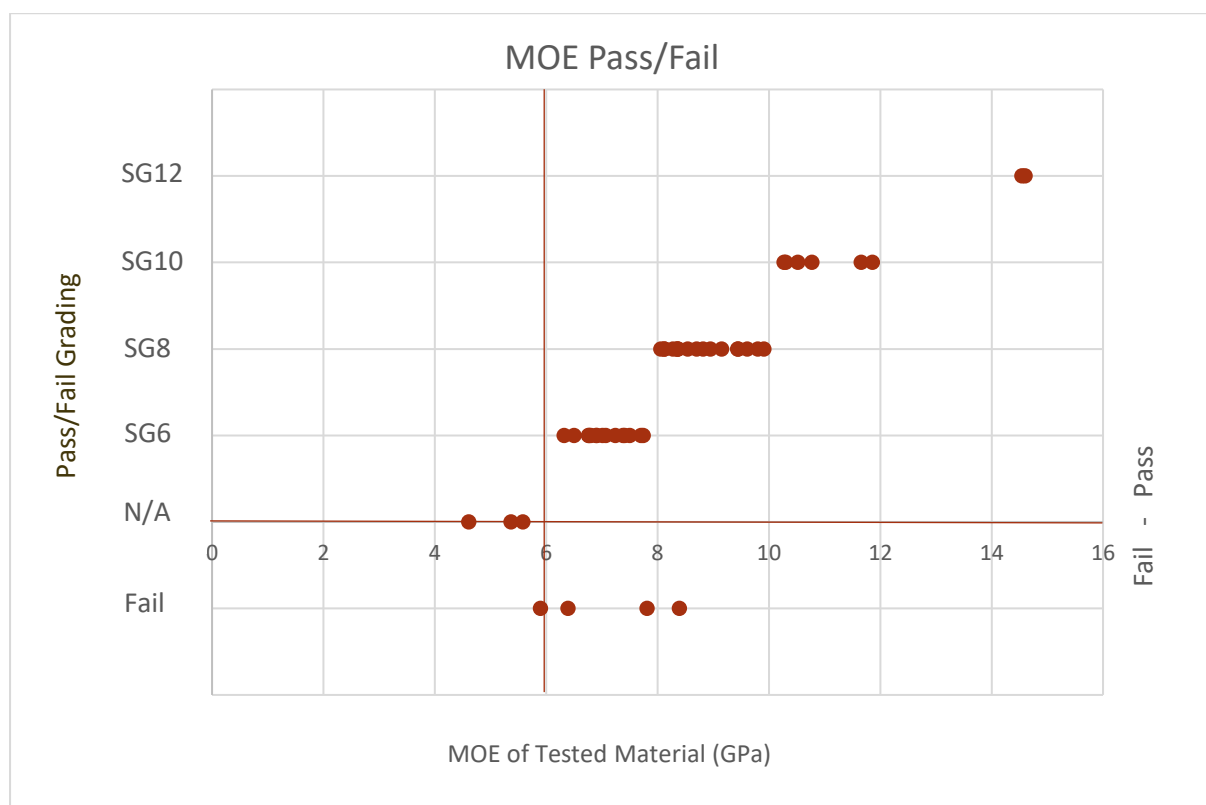
Figure 15 Pass/ Fail grading of tested material

The above graph explains how each material fits into failure or passing Figure 14. As can be seen in the middle of the graph on bar 6 there is a red line which holds the path between a good piece of timber and a bad piece of timber. This although is not bad as the timber that falls below this line is predominantly on the line of N/A, which has been allocated to timber which did not pass the VSG

These four members, all of which failed at different intervals, the first of which was a fence post, which was covered in mould, but did have the VSG's versions of a low grade timber member. This unfortunately was wrong, and possible something which could have been picked up on. The second failure happen just after the point break line, with the material showing under the visual inspection mark. This therefore gave a negative mark, as when tested the member performed above the mark, again another point which could have been foreseen, but due to the close proximity of the point break line all can seem to be justified.

The next two were both around the area of change between No.2 and No.1 standard grading. With the first being slightly under the point, and the second being slightly over, two area which could not have been really prevented against. As when going through a timber member the performance can only estimate and therefore not explained in the fullest until the testing.

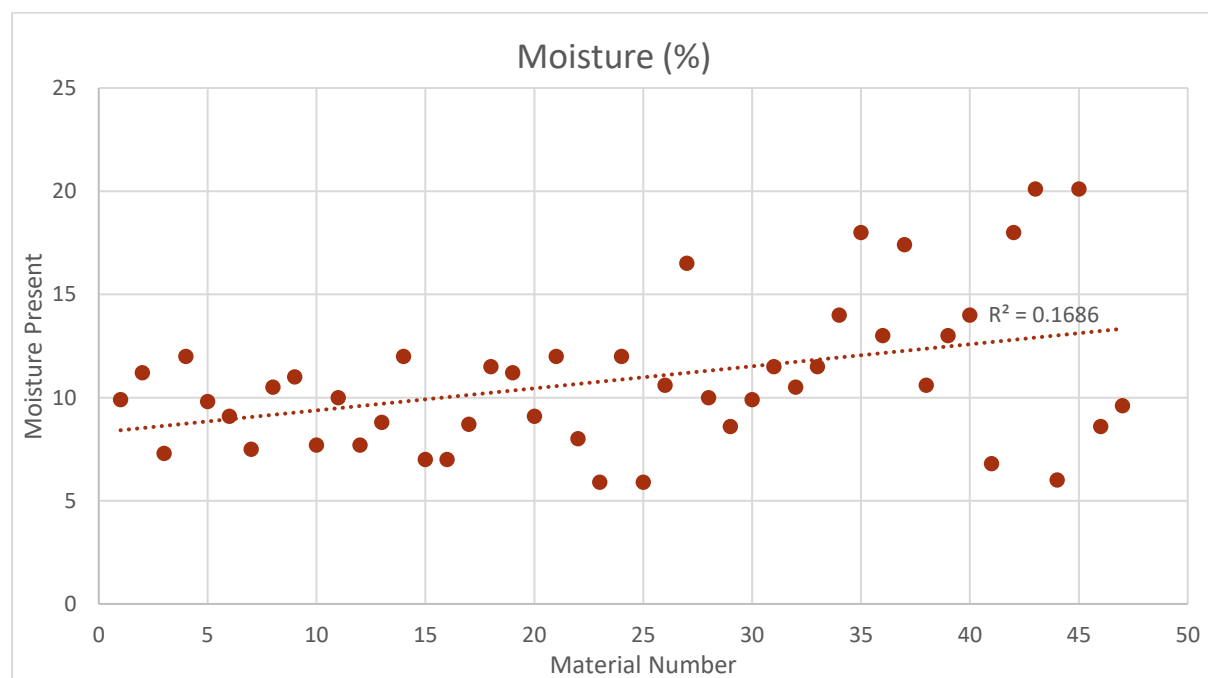
Figure 16 Timber Verses Moisture

One of the ways which could have helped with the ongoing ability for demolition companies to pull aside the correct timber, would be to test it in the building before demolition. Once the data had been tested this did not explain itself as the R^2 value displayed was much lower. This therefore create a situation were as through this tested data, there is no possible way to accurately estimate the strength of a member.
